## **Roeburndale Woods WEG**

# **Flood action plan for Backsbottom Farm March 2019**

prepared by Dr Rod Everett

**Context -Water Environment Grant 2018 Saving Roeburndale Woods** (Approved 25 Feb 2019)

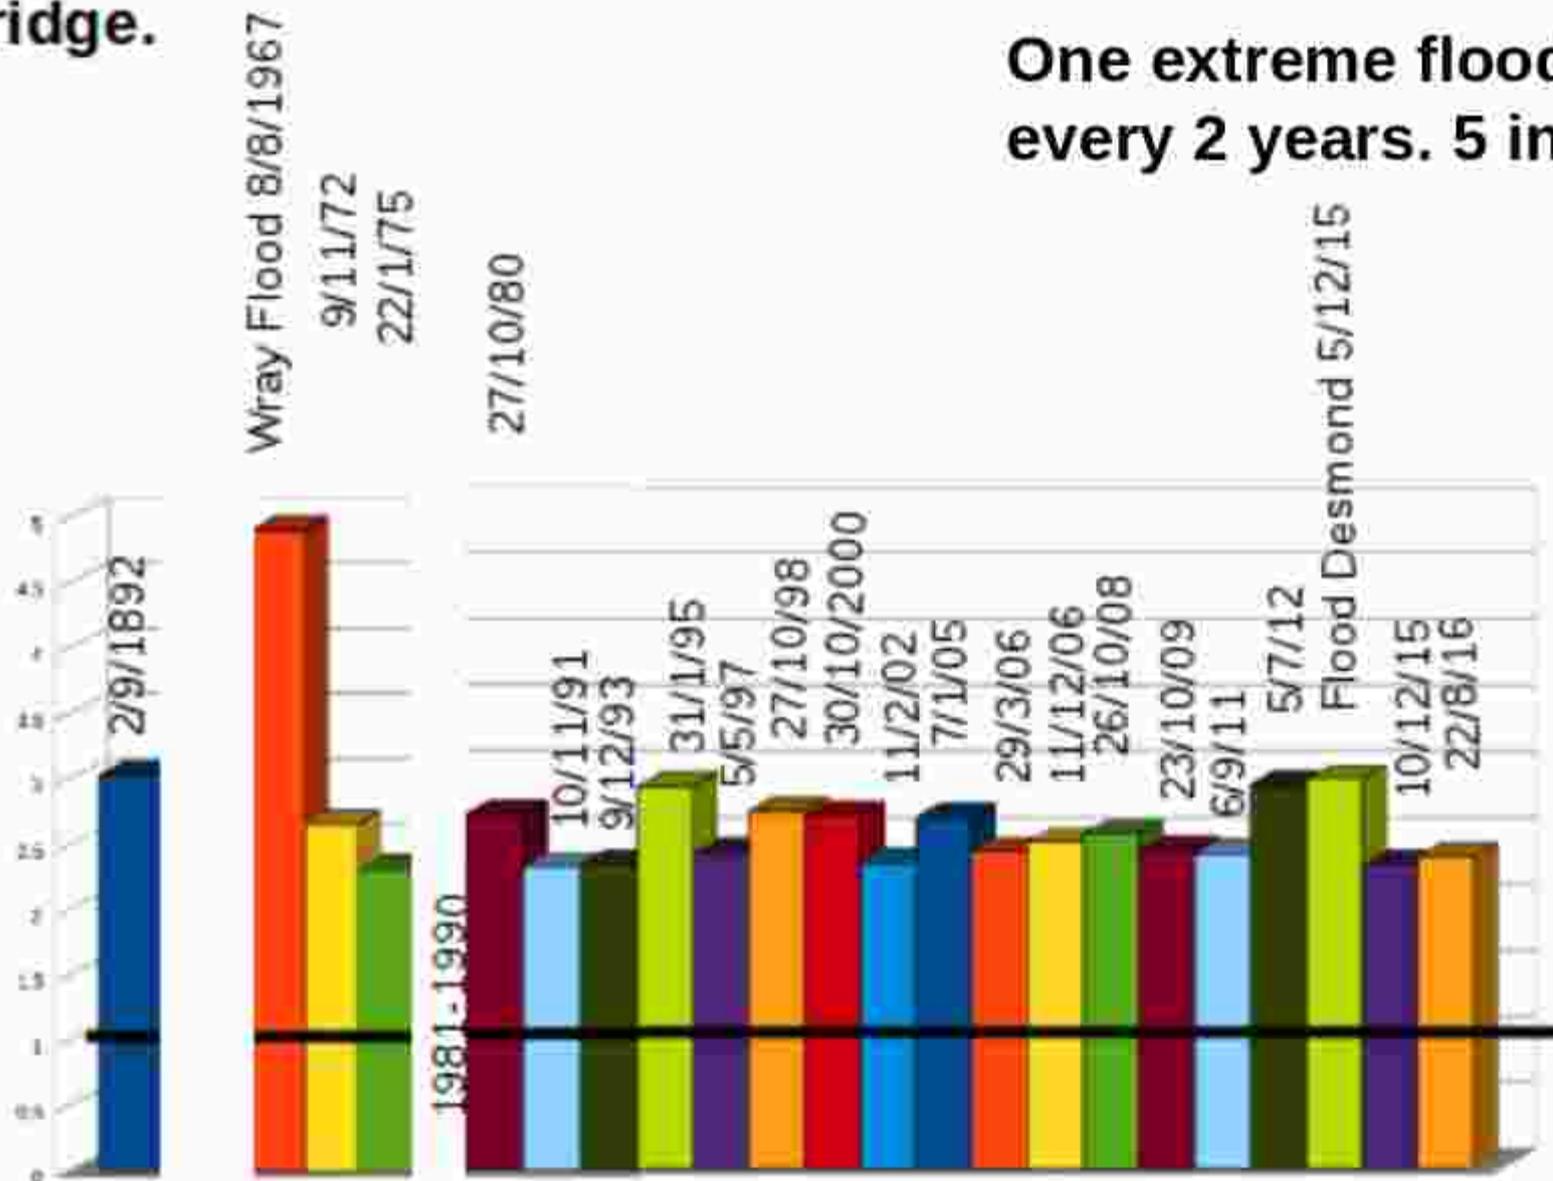
**Wray river levels for the Hindburn and Roeburn showing major flood levels over 2.3 metres high. Black line shows average high 0.9m. Full records from 1970 with missing dates 1981-1990. Wray Flood level height due to trees backing water by Mealbank Bridge.**

**One extreme flood on average every 2 years. 5 in last 2 years**

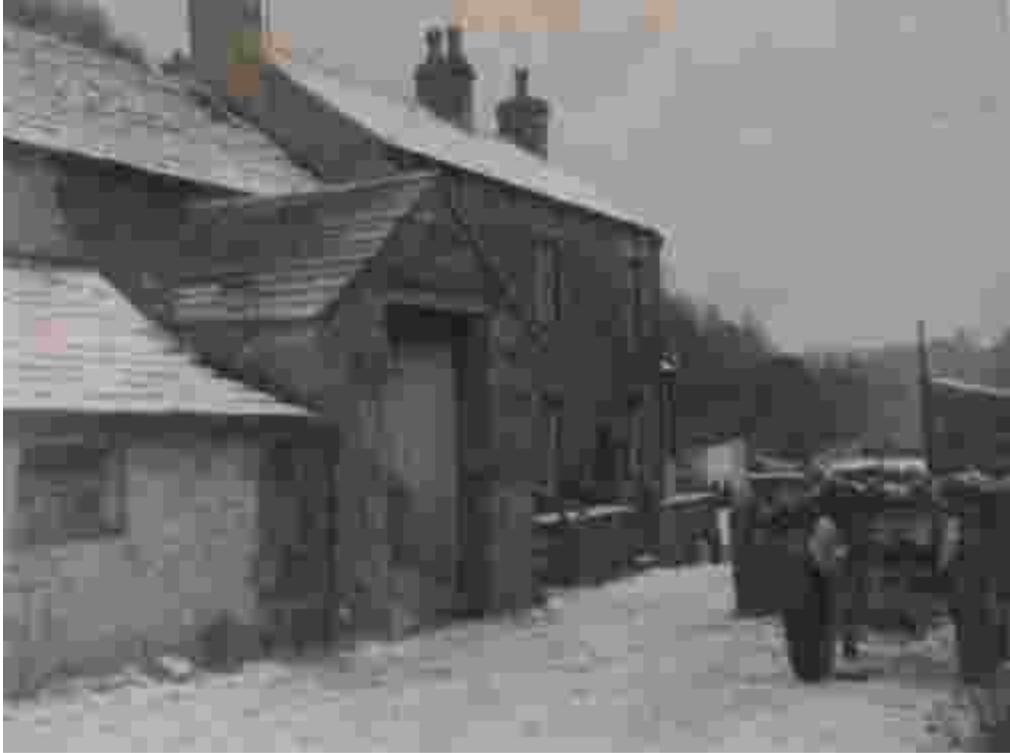
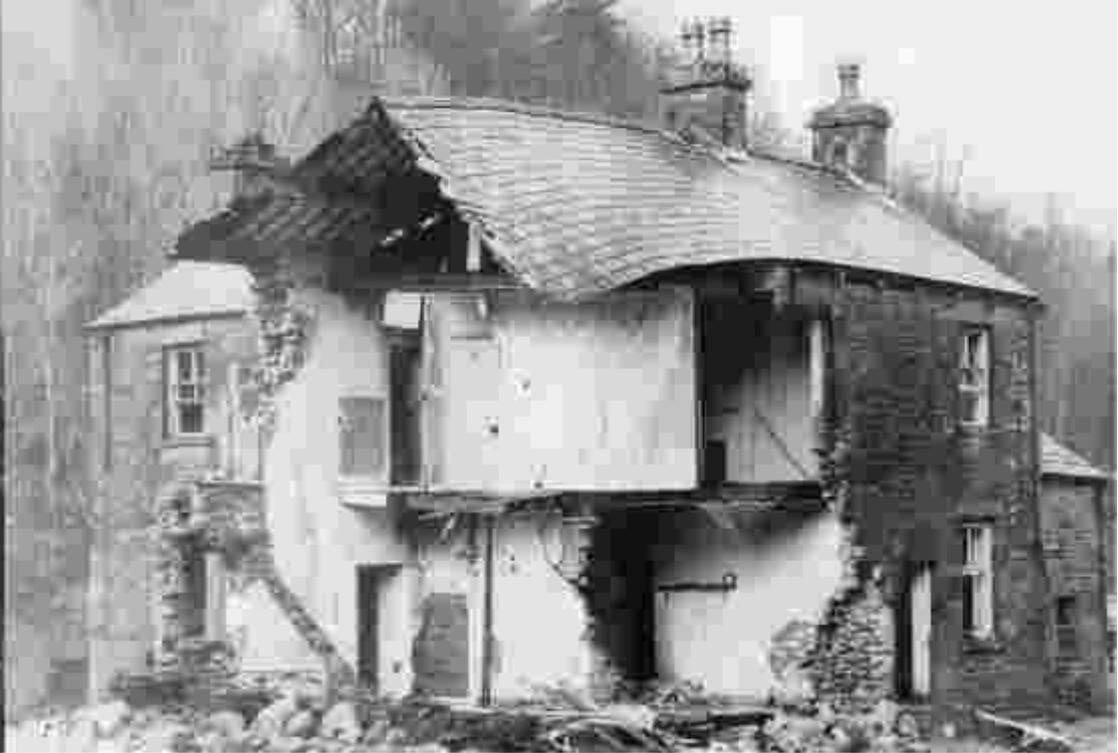
Backsbottom Farmhouse washed away 8 Aug 1967. Bill and Alice Brown were rescued from the bedroom above the kitchen. It was a 5 bedroom farmhouse with hay barn and shippon attached. In the yard there were other buildings such as machinery sheds and hen house.

The bridge next to the house and the sheep pens including lambs went as well. Lost 1 pig, 1 heifer, 45-50 lambs and a sheep dog.

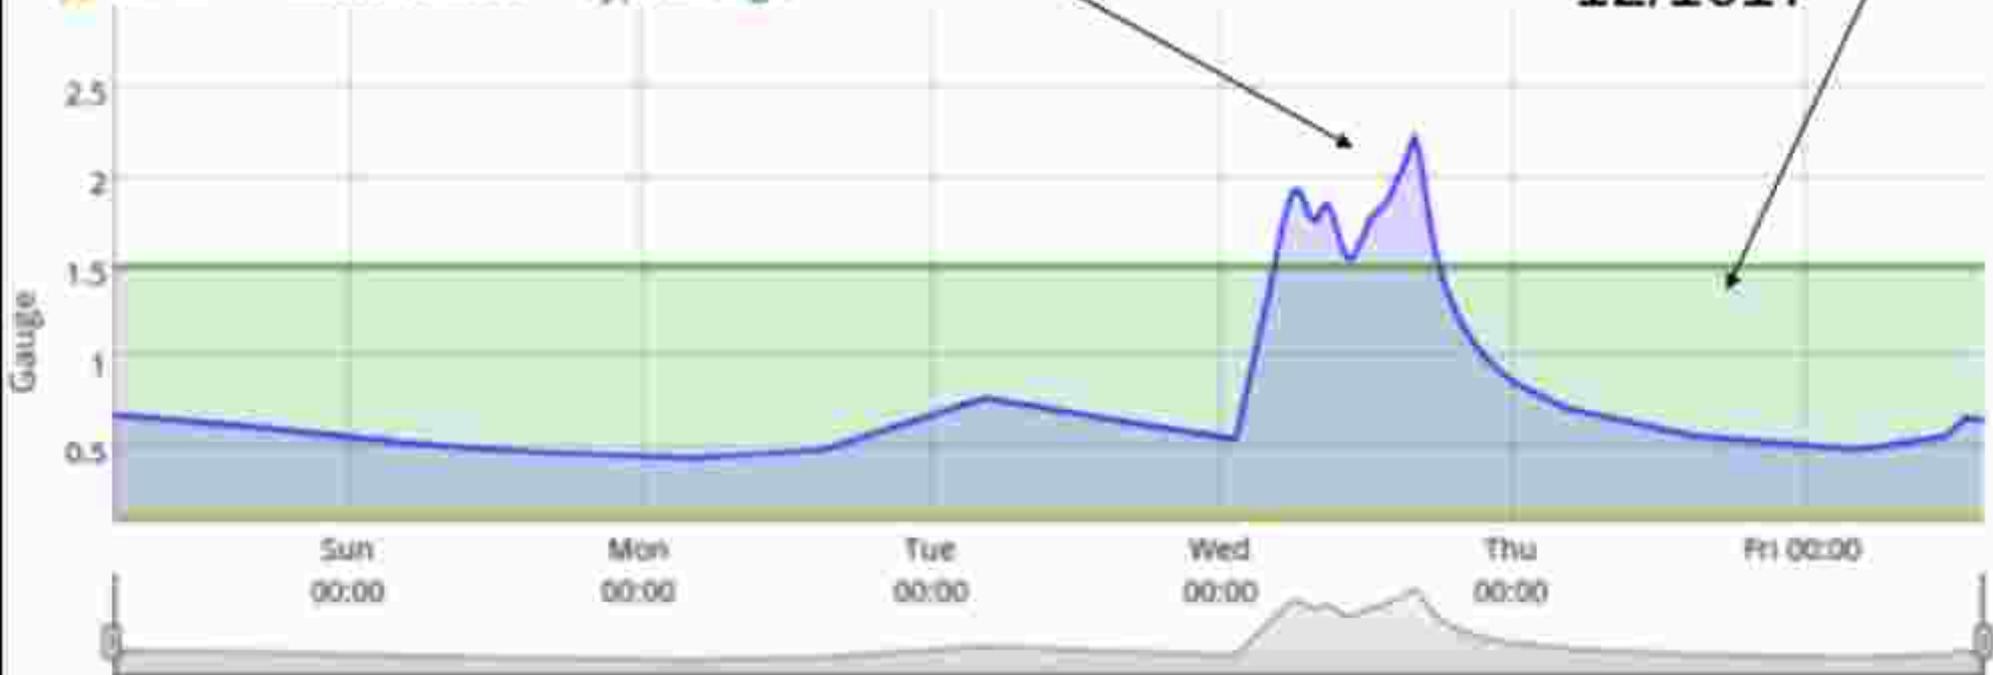
# River levels on Hindburn at Wray 6-13 Oct 2017

Peak flow 2.3 m. Flood Desmond 5/12/2015 peak 2.9m

— Typical Low — Measurement — Typical High

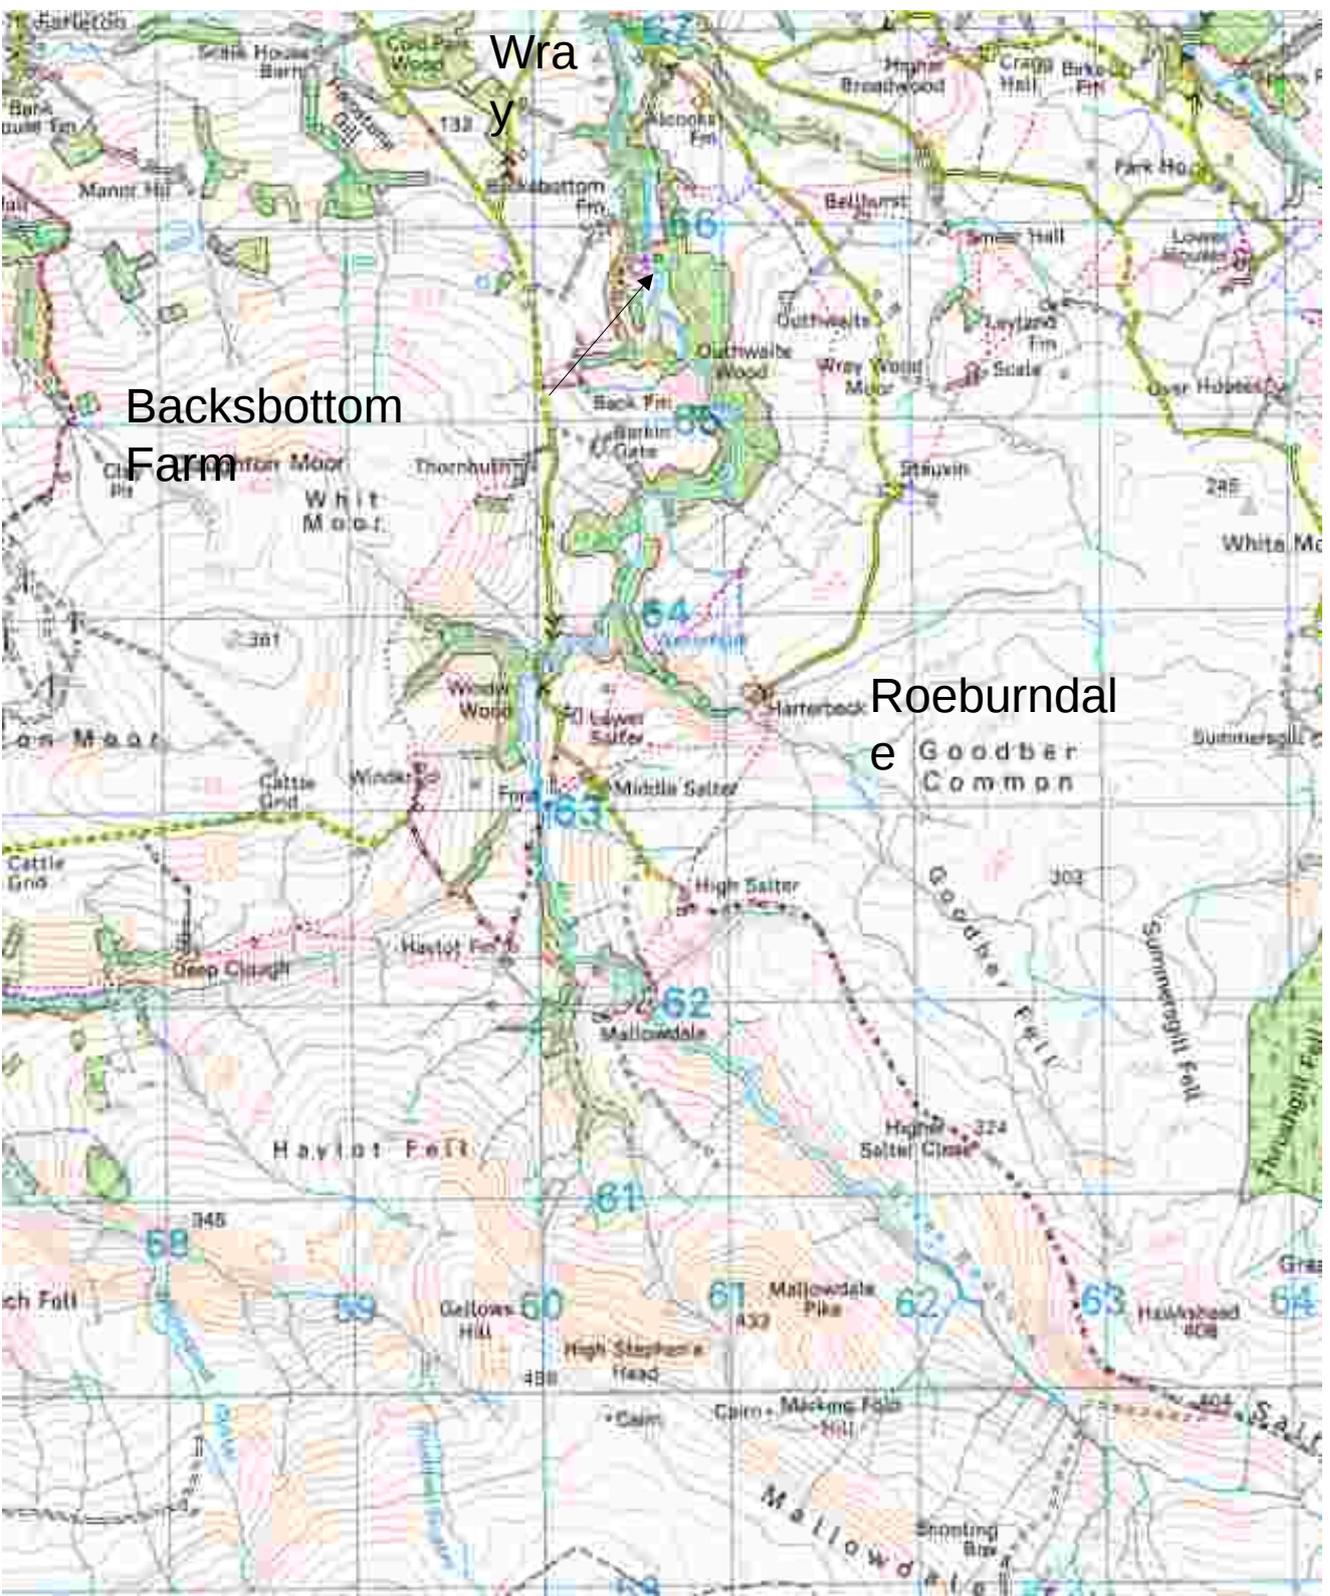
Map of Roeburndale showing contours, woodlands and the River Roeburn and Tributaries.

Outhwaite wood is part of Roeburndale Woods SSSI.

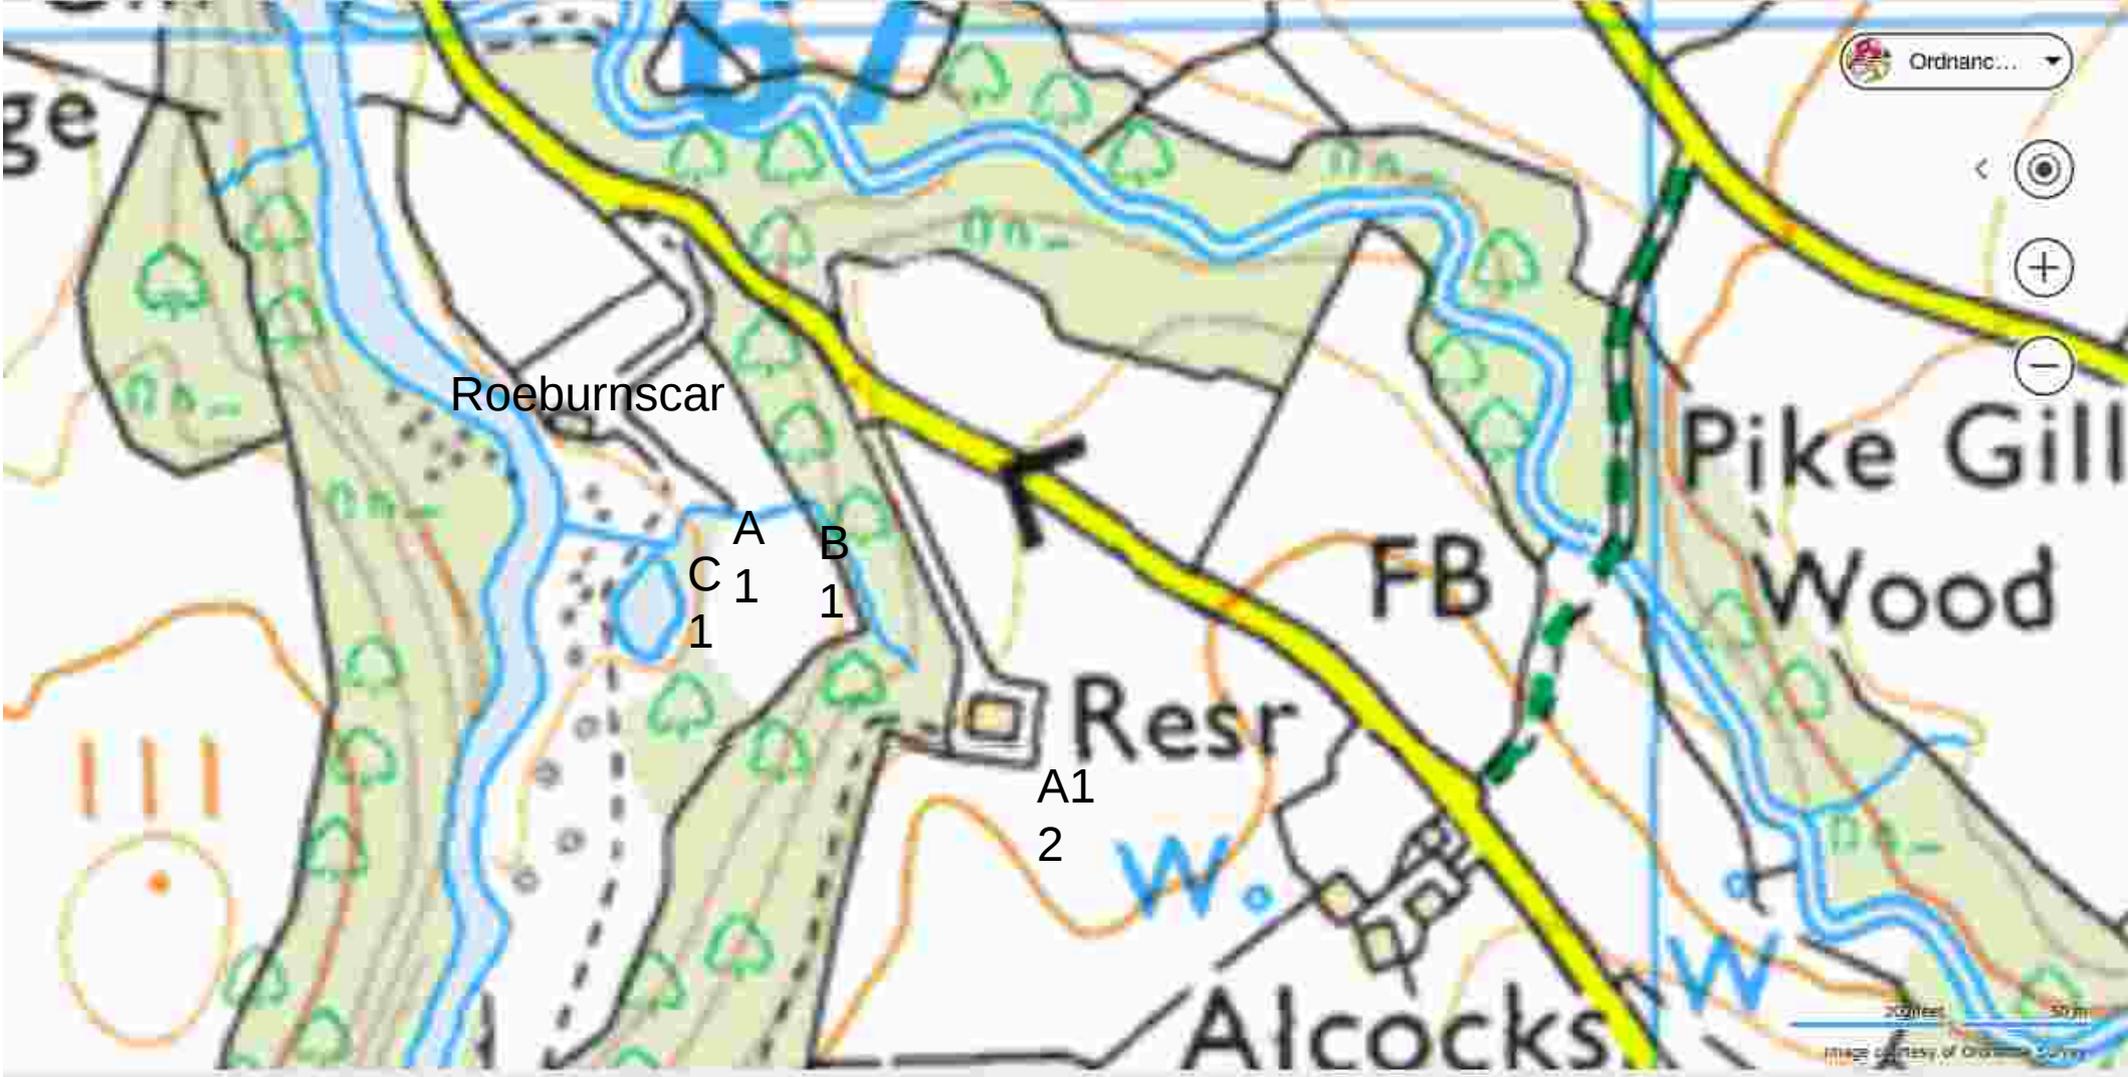
A1. 2 small woody check dams in stream

B1. 2 small ponds with leaky upper dam in wood (may have been historical pond)

C1. Create low flow diversion to pond to prevent drying up. Contains great crested newt

A12. Examine neighbours field to find source of flood water

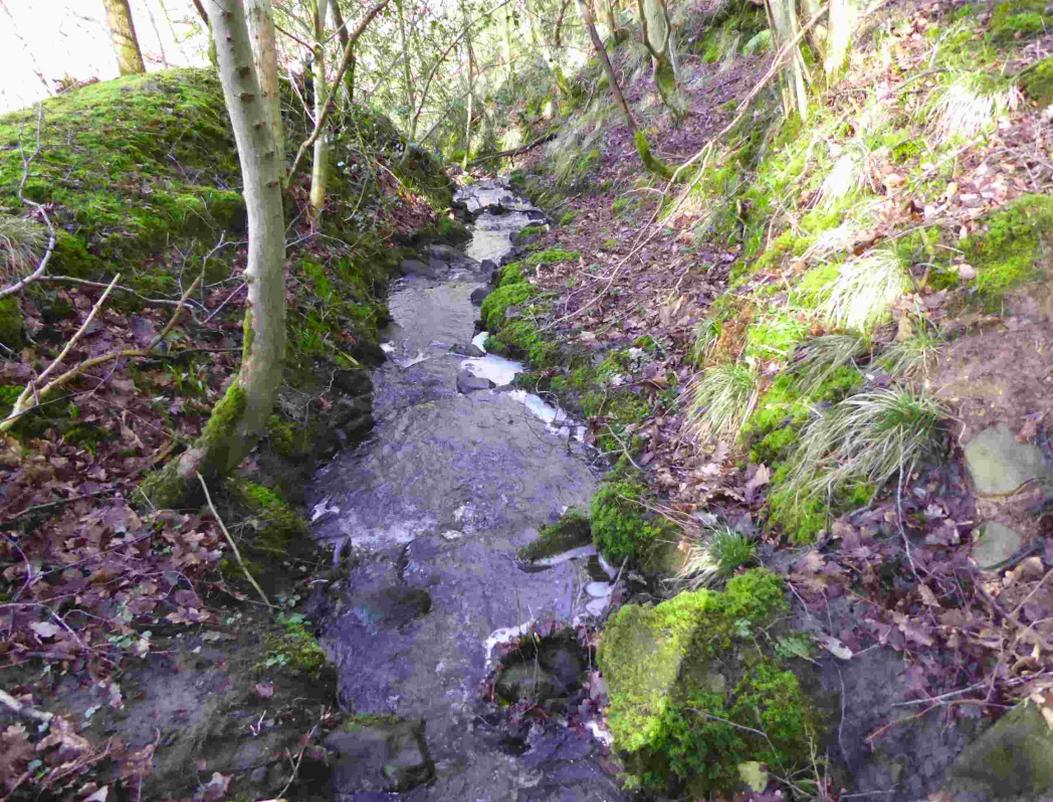
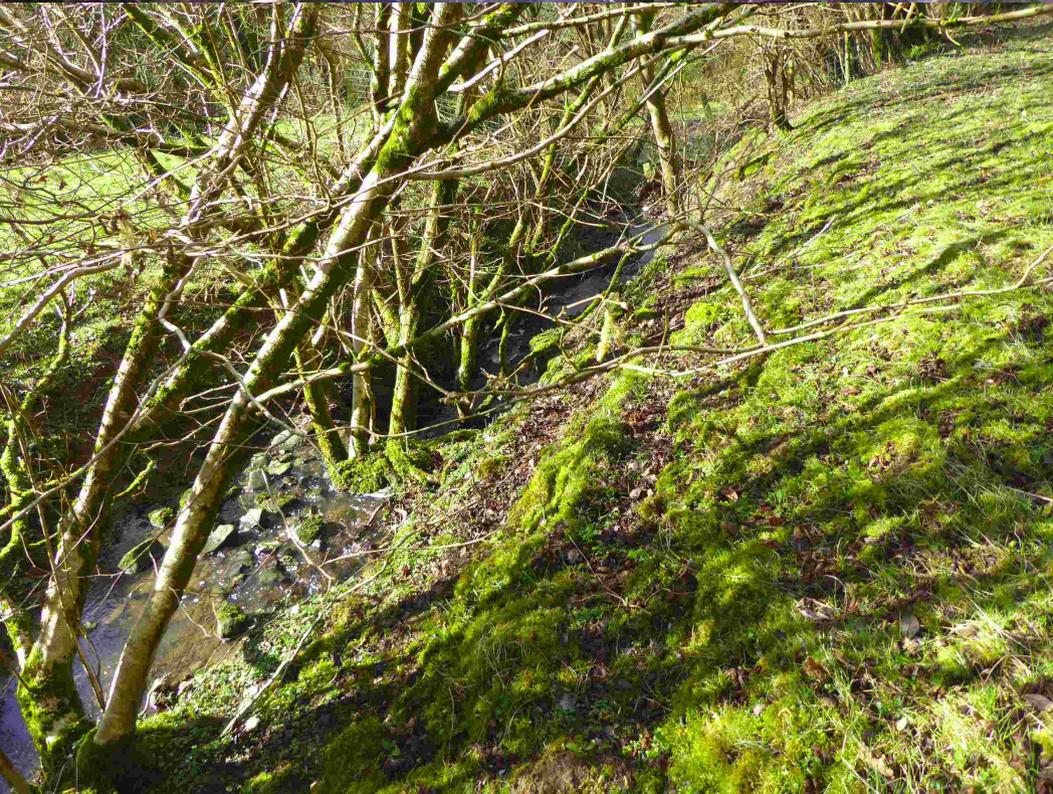
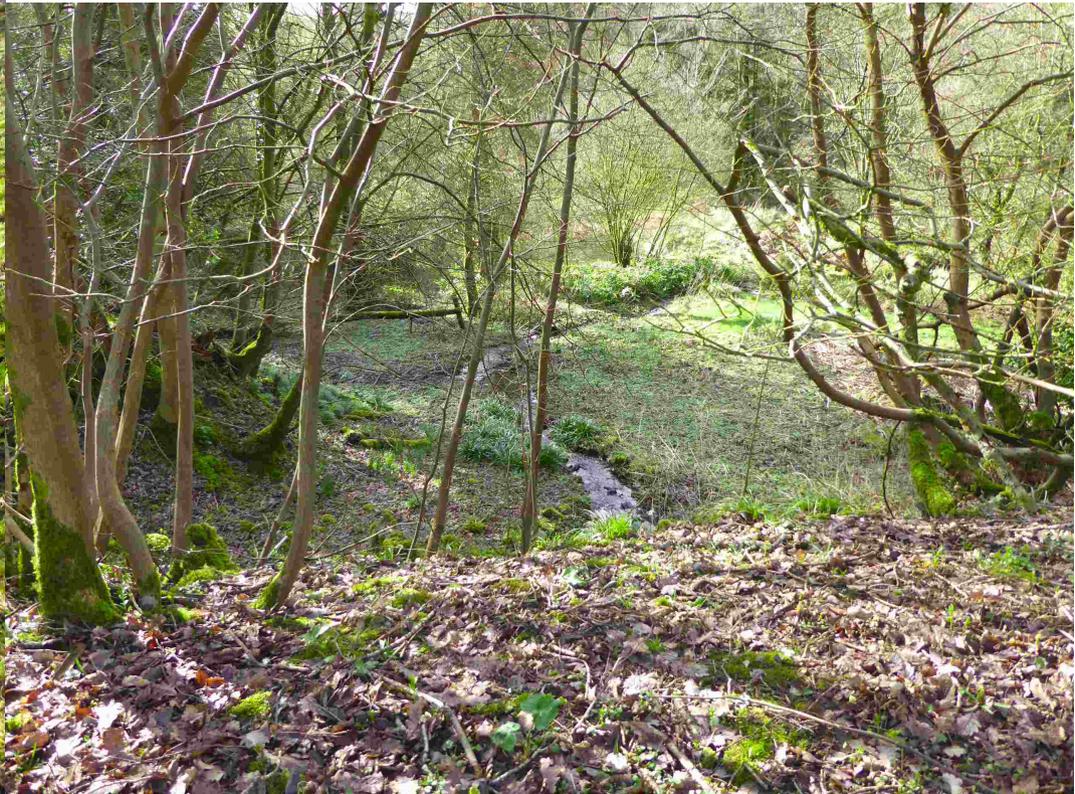
B1 Stream that can be slowed with 2 small dams with leaky overflow. Top left.

A1 Stream that can be slowed by 2 woody check dams. Below left

C1 Stream needs diverting to pond when very low flow to protect pond with crested newt from drying out.

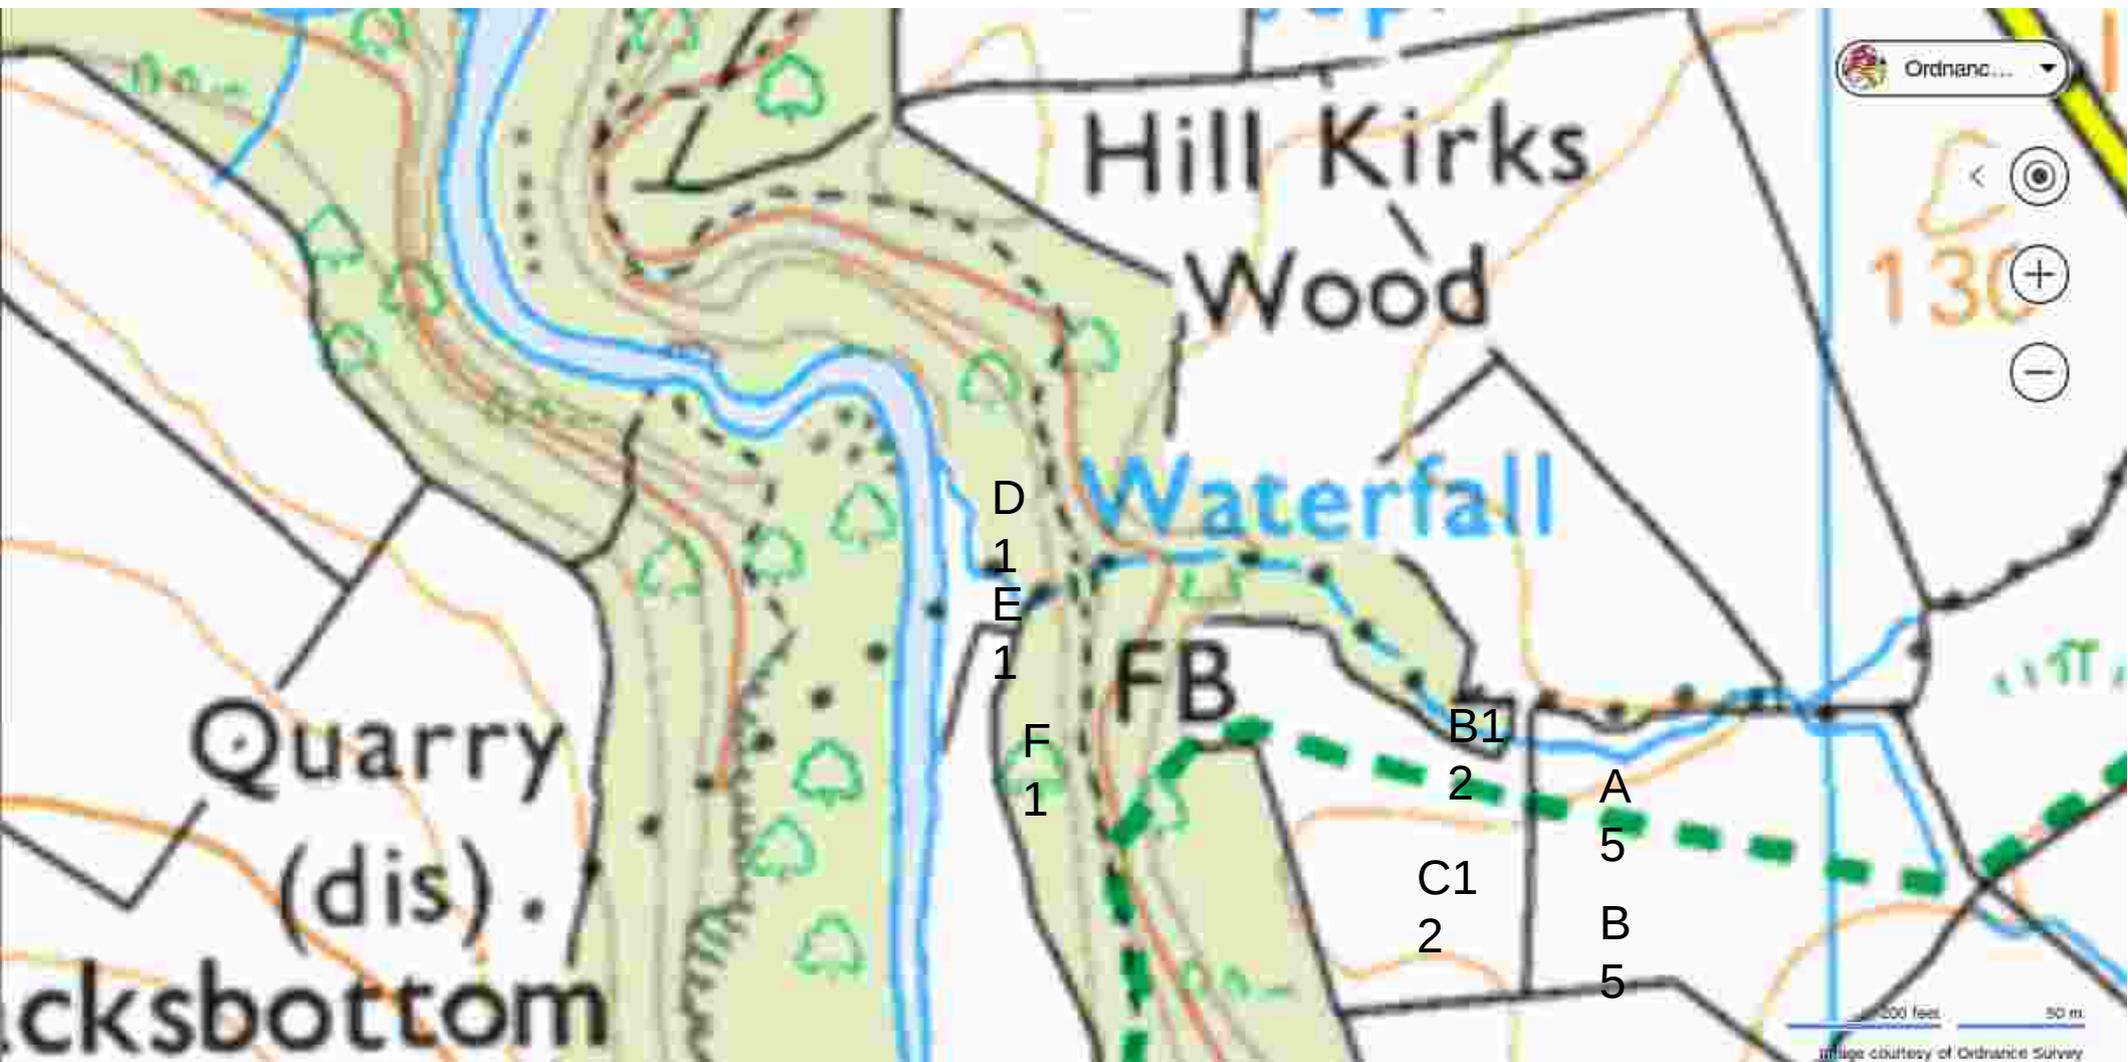
F1. Area of landslip from Storm Desmond caused by diversion ditch on footpath.

E1. Potential area for holding water. There is an old wall that could be used as barrier for water.

D1. Two small streams that could be slowed by small Woody Debris check dams x 4.

C12. Neighbours: In extreme events water flows through wall at East side of field then some goes N to stream and most makes its way over the field to run down footpath. Potential area for keyline plough and taking water into soil and towards stream.

B5. Water floods to west in this field. Potential Keyline plough to stream in North or swale or trees

B12. Potential for 2 leaky wood check dams.

A5. This stream could easily be slowed by 3 check dams.

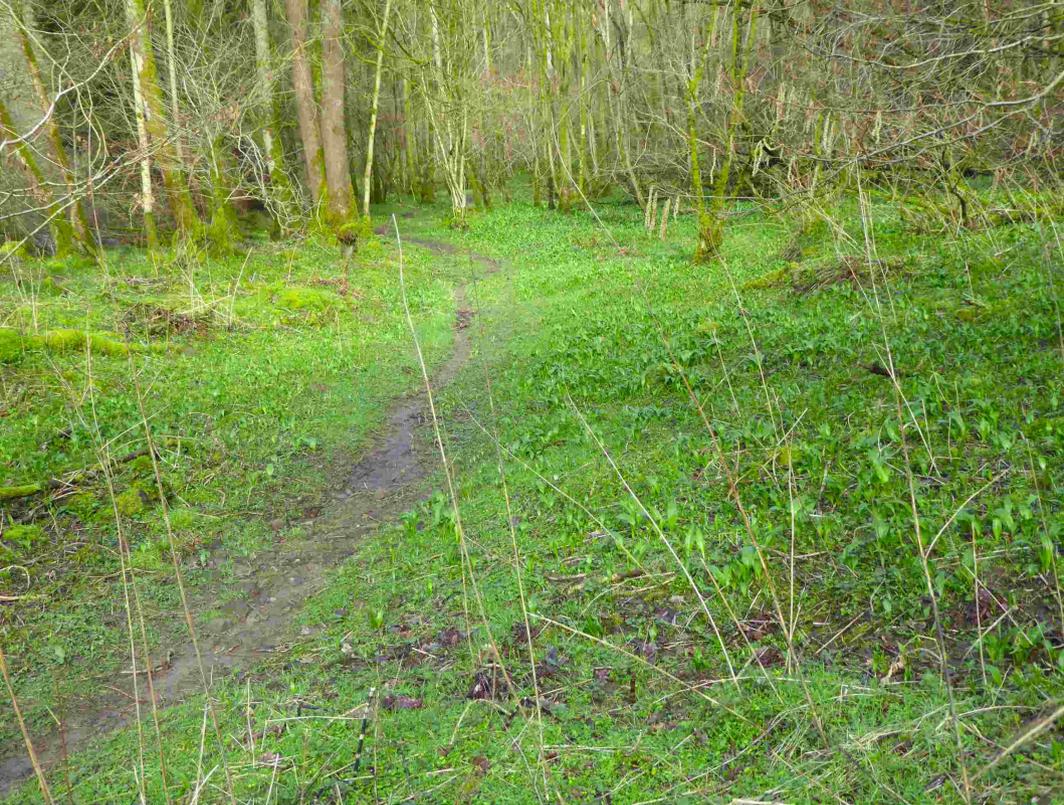
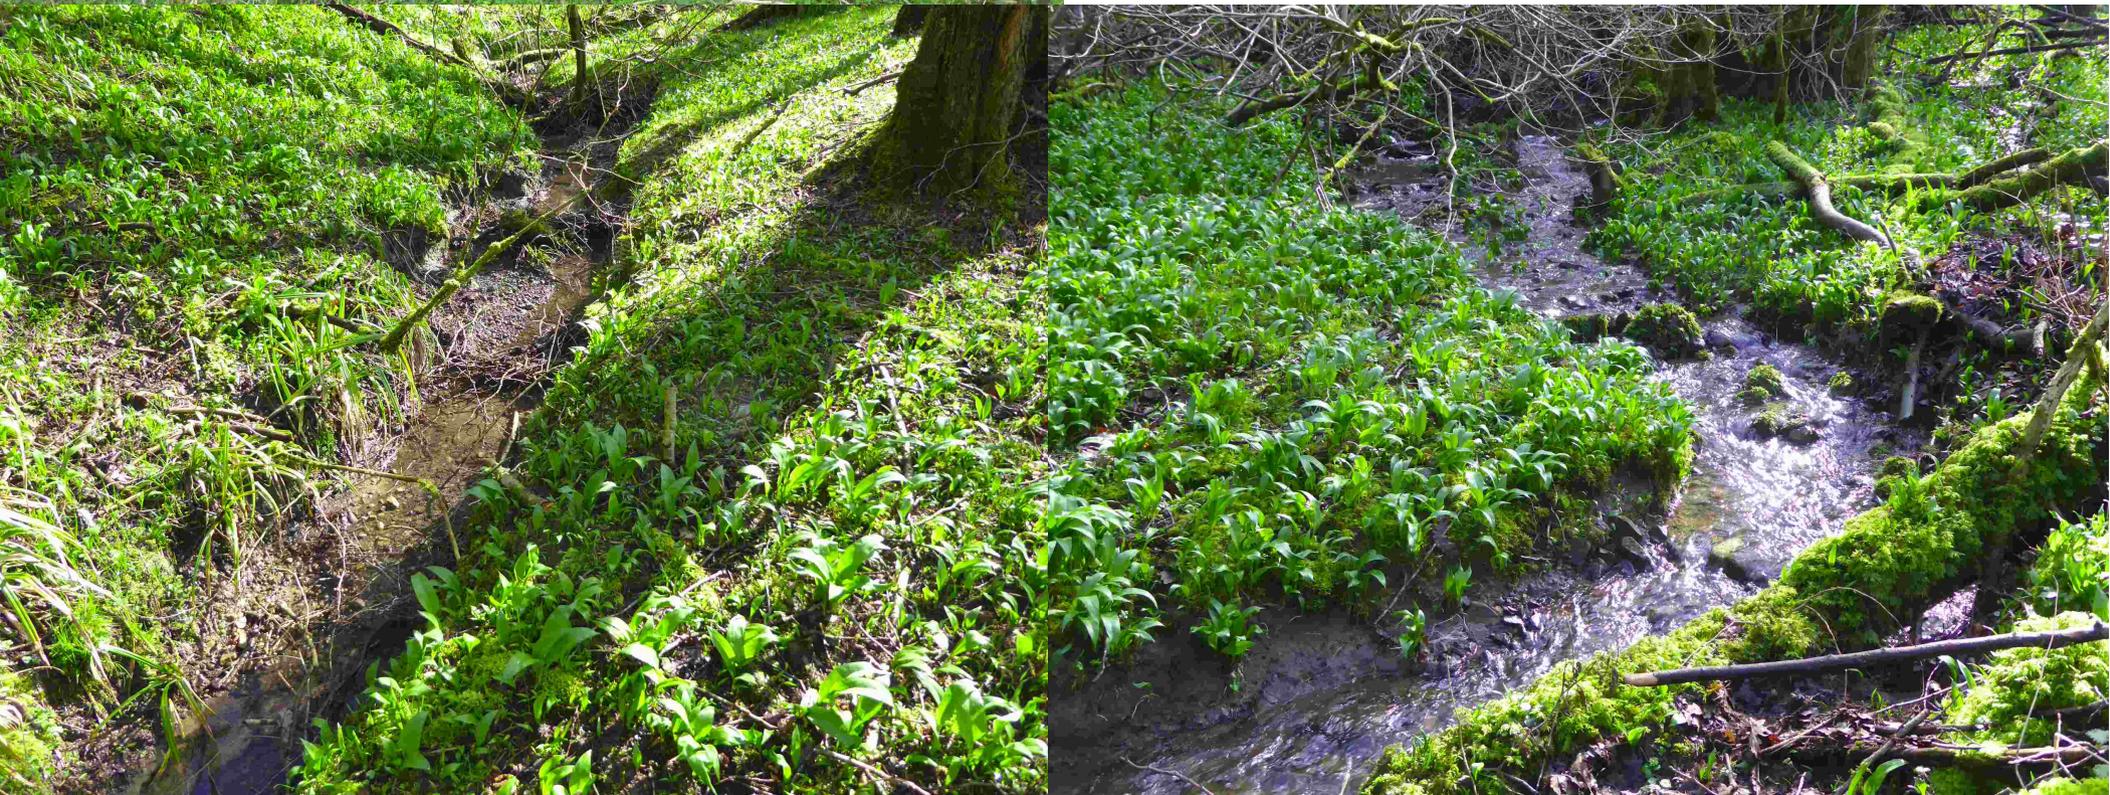
E1 Area to be flooded with stone check dam.  
This will hold back flood water in extreme rainfall conditions.

D1 2 streams can be held back with check dams x 4. Bottom photos.

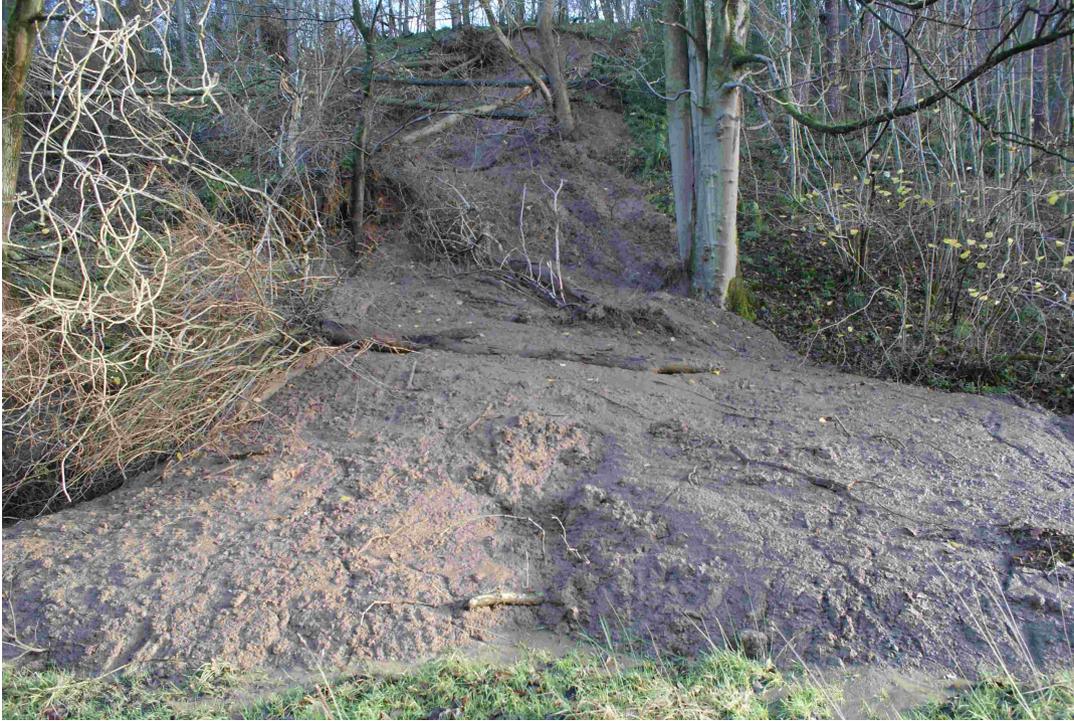
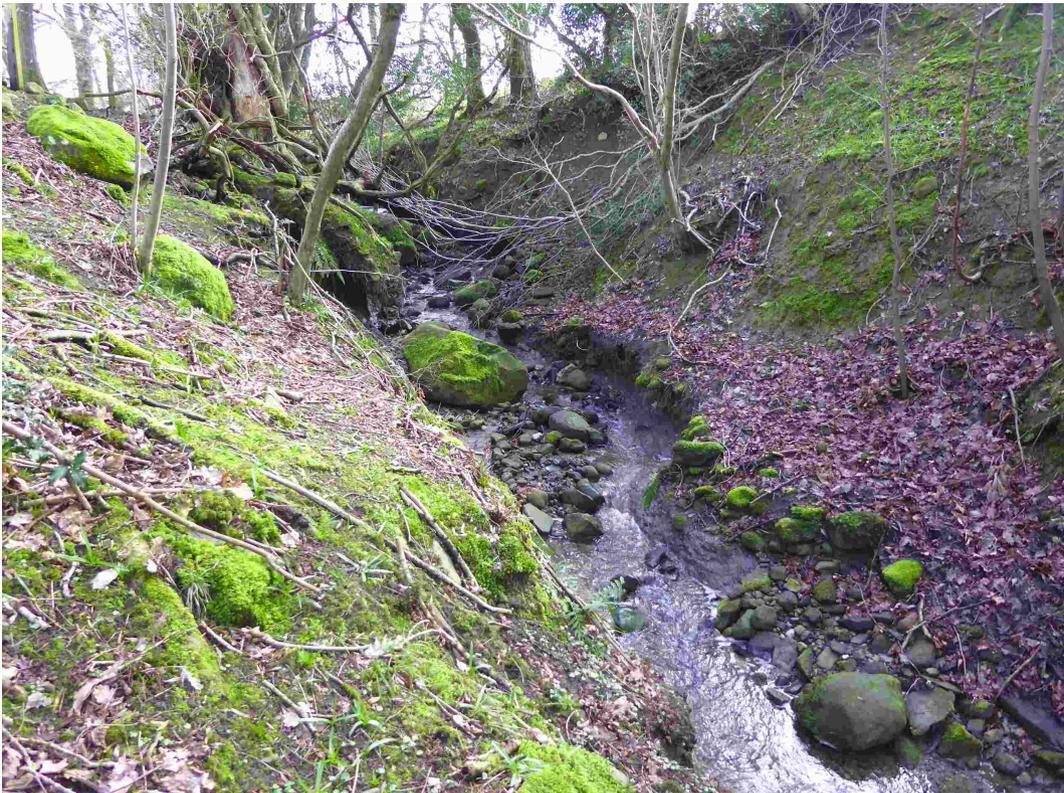
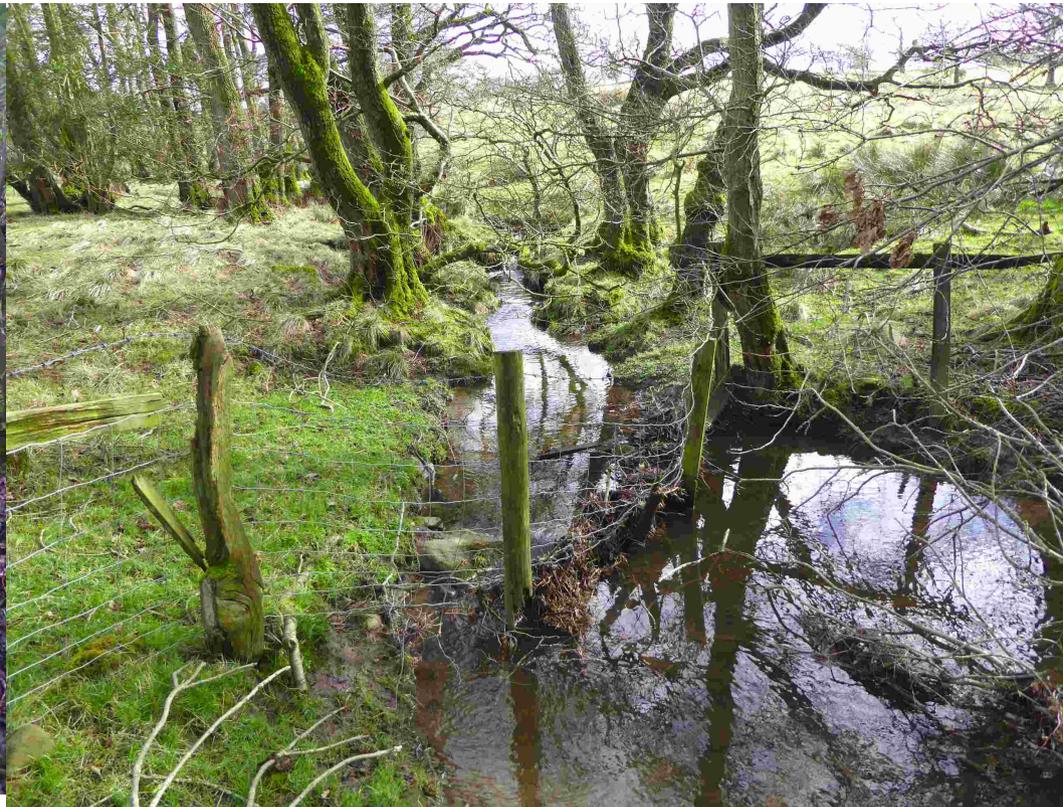
F1 Landslip caused by flood Desmond Dec 2015. Caused by water movement on C5 and B12. Swales, tree planting or keyline subsoiling would prevent this. Top left

On Neighbours land  
B12 Potential area for 2 woody check dams,  
reducing flow at D1 and E1.

A5 Potential for 3 woody check dams  
reducing  
flow at D1 and E1.
