## **Roeburndale Woods WEG**

# **Flood action plan for Backsbottom Farm March 2019**

prepared by Dr Rod Everett

**Context -Water Environment Grant 2018 Saving Roeburndale Woods** (Approved 25 Feb 2019)

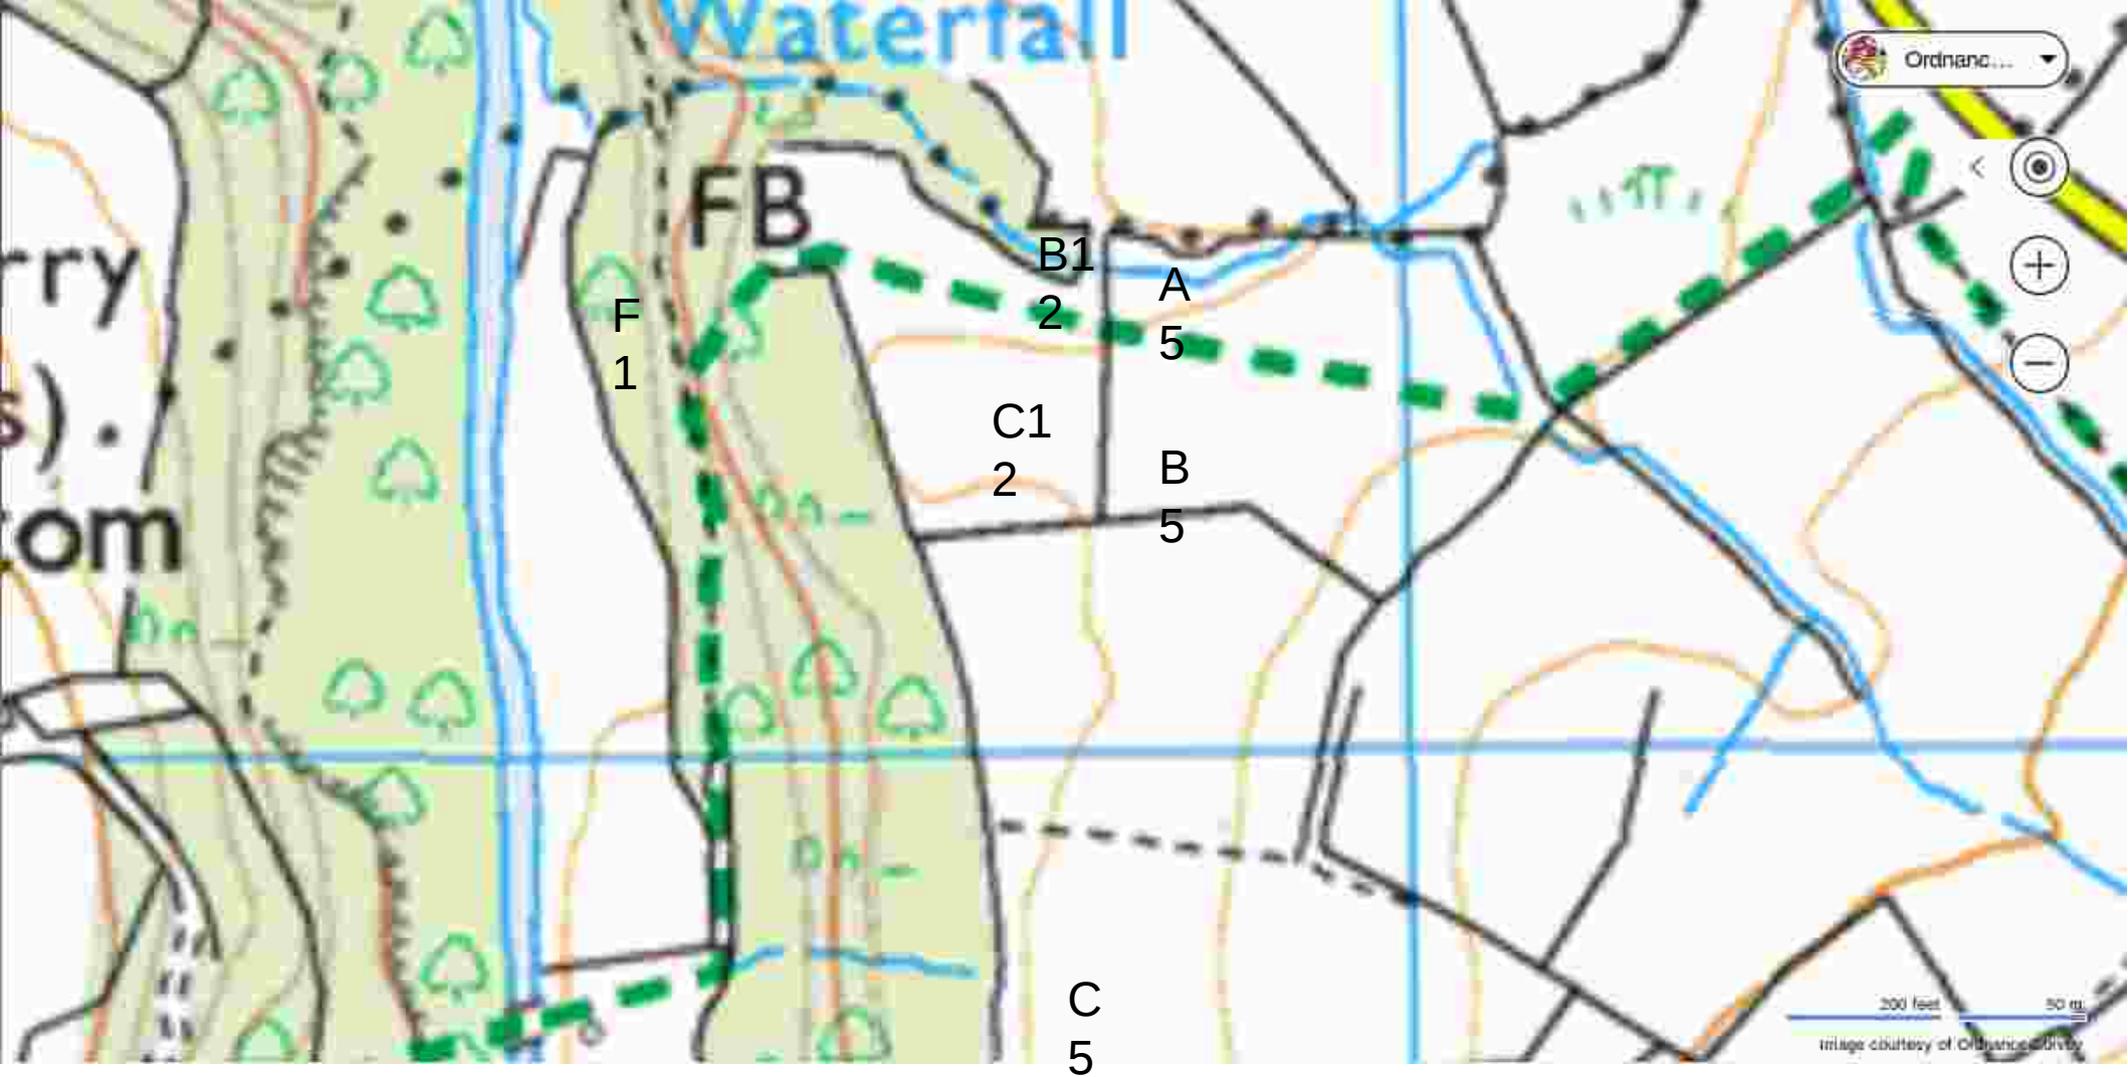
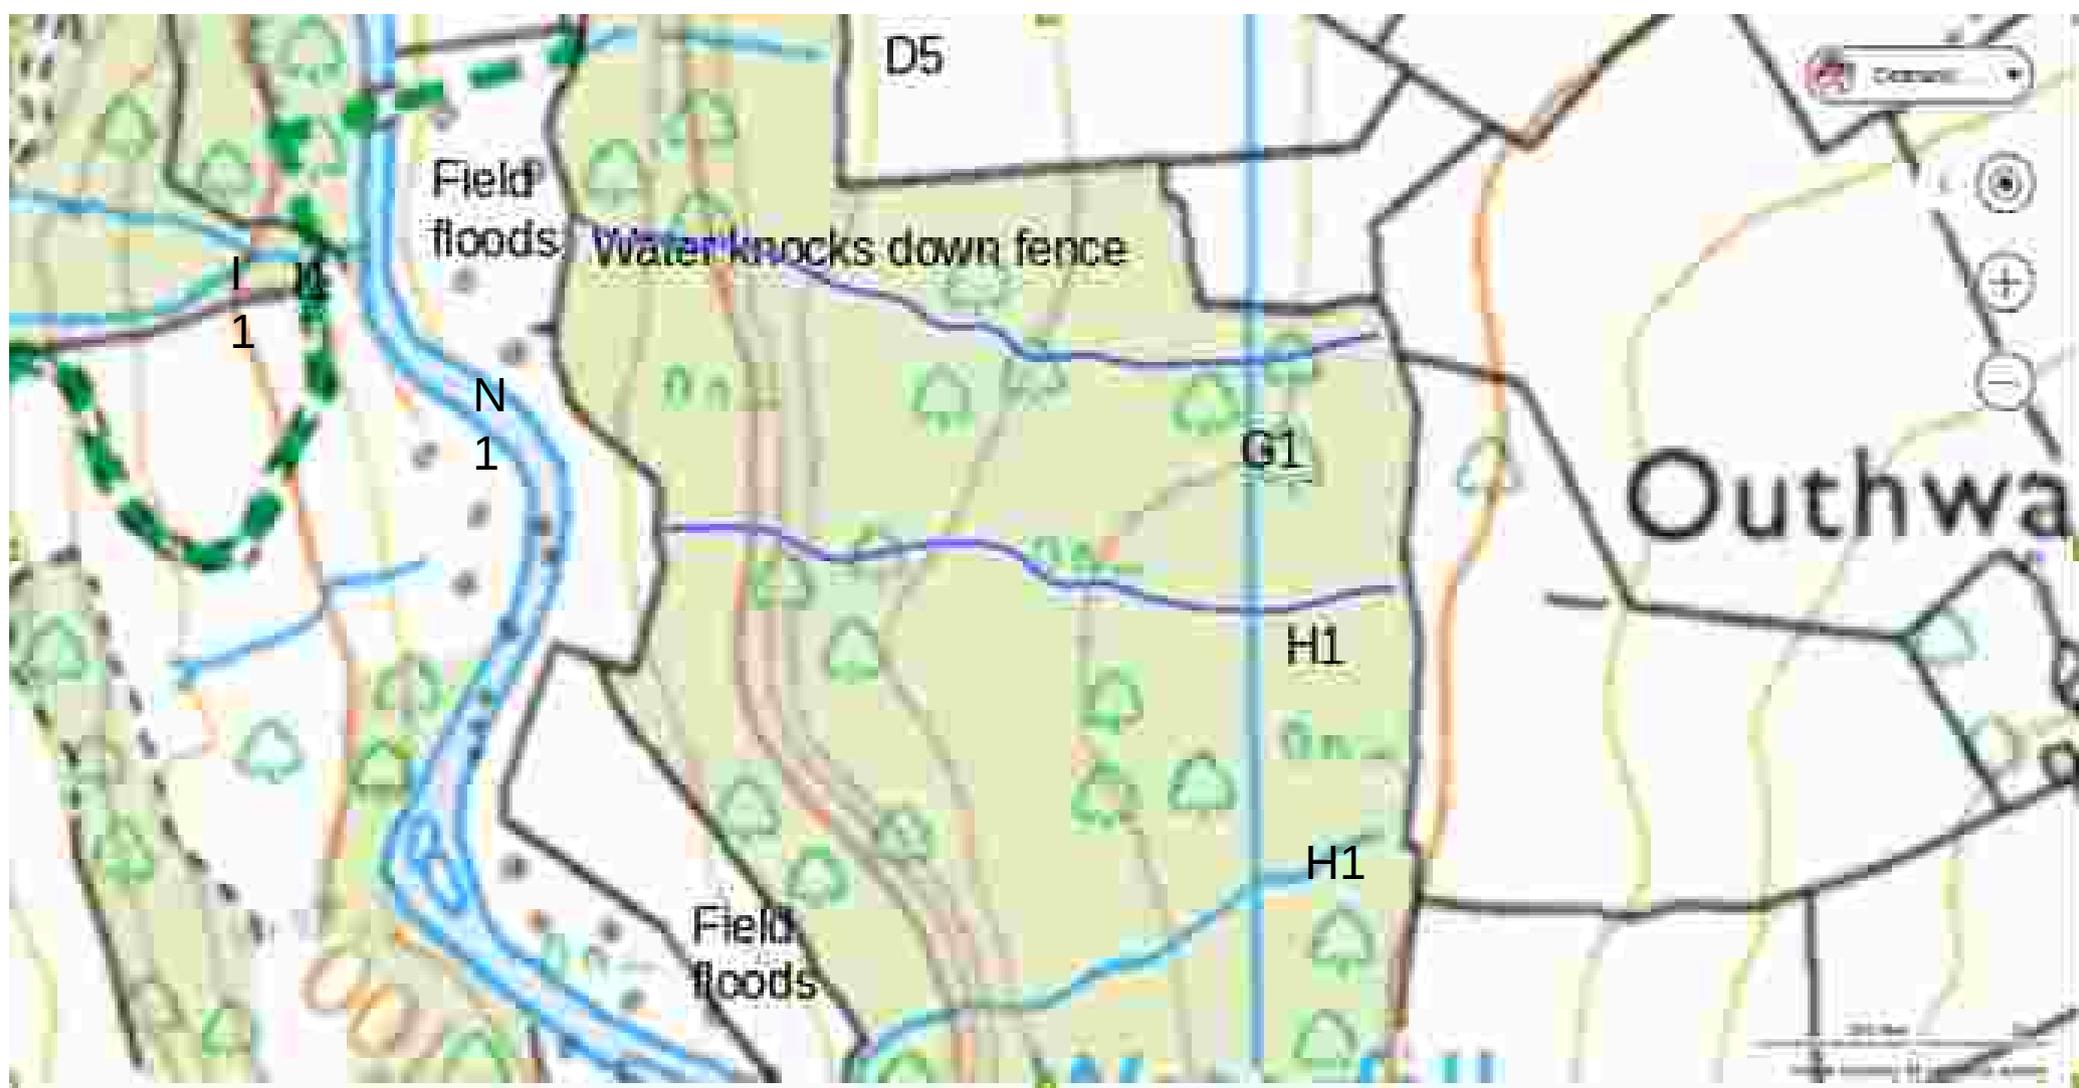
C5. Spring in field. There may be potential for small woody dam near woodland edge  
F1 Flood Desmond Landslip.

D5. There may be potential for slowing down in field.

G1. Good location for small woody debris dams to slow and spread water.

H1. Good location for small woody debris dams to slow and spread water.

I1. In flood culvert under track gets blocked with twigs and water flows into gate way. Below the culvert the stream is a deep gully into river. This stream can be slowed down on Whitmoor.

N1 After flood Desmond 2015 3 large rock vanes and a horseshoe shape were put into The river to reduce bank erosion and put the main river flow away from the banks.

This is called In River Training and has worked well. Similar vanes are proposed for K1.

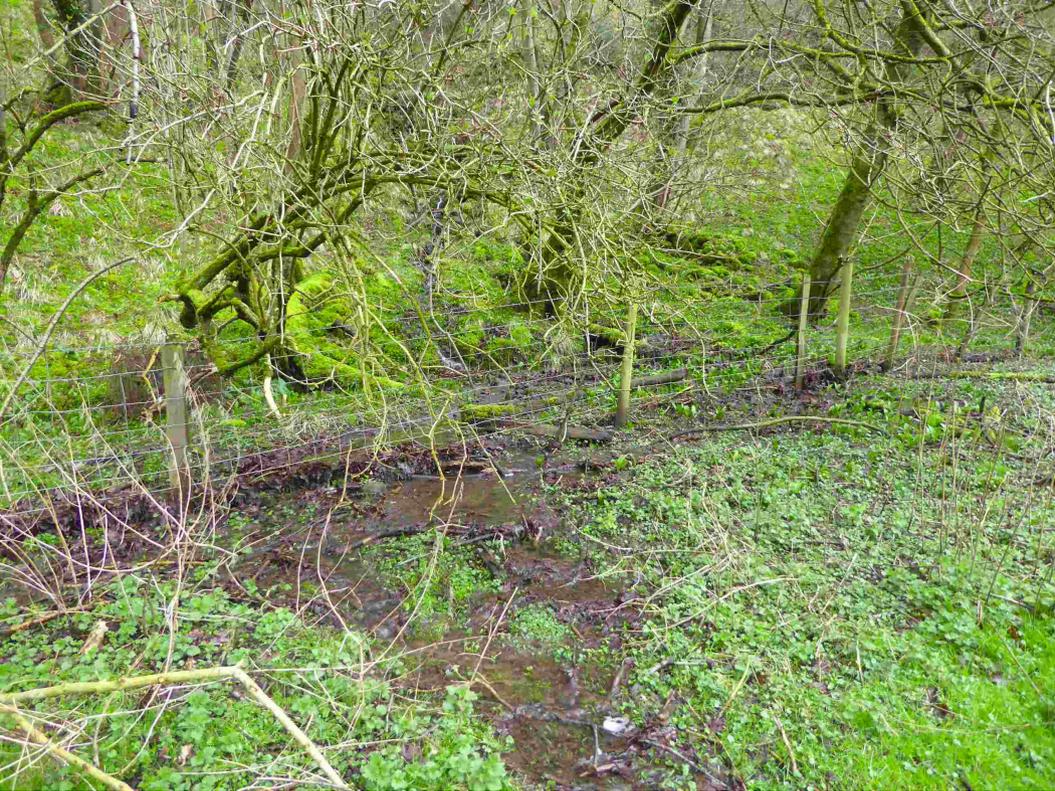
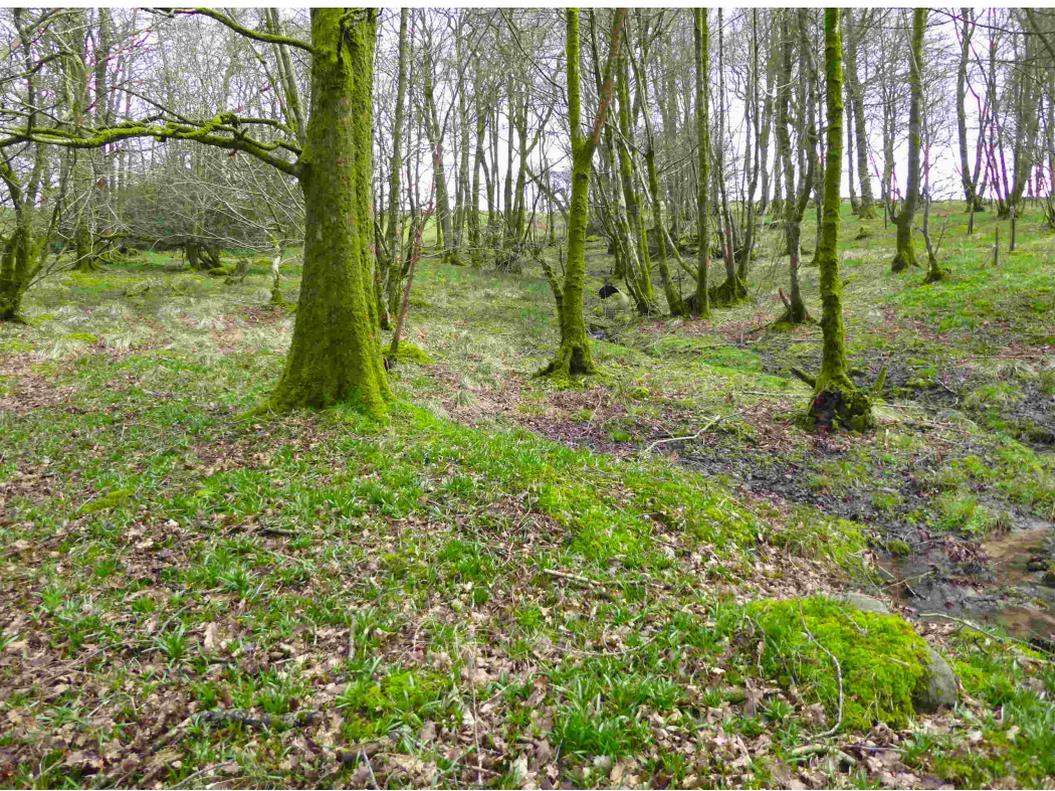
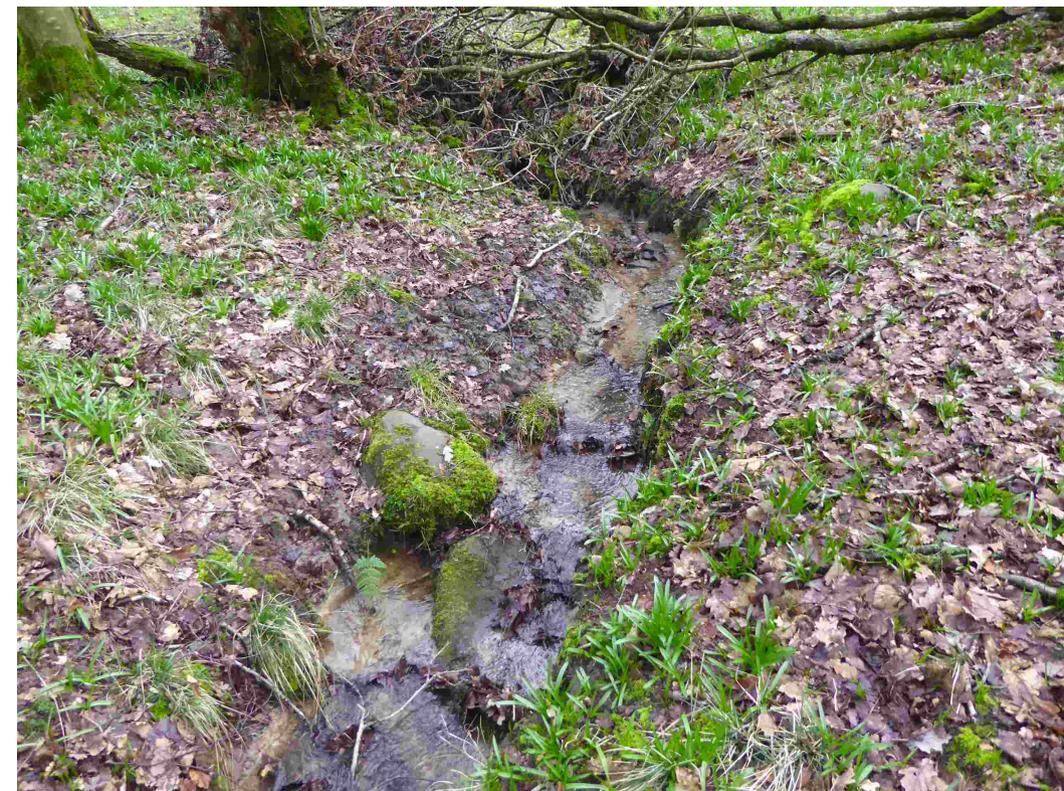
Place where G1 streams washes out fence-  
Top left.

G1 where 3x woody debris would help  
slow the flow. Bottom Left

H1 Place where 3x woody debris would  
slow  
the flow. Bottom right.

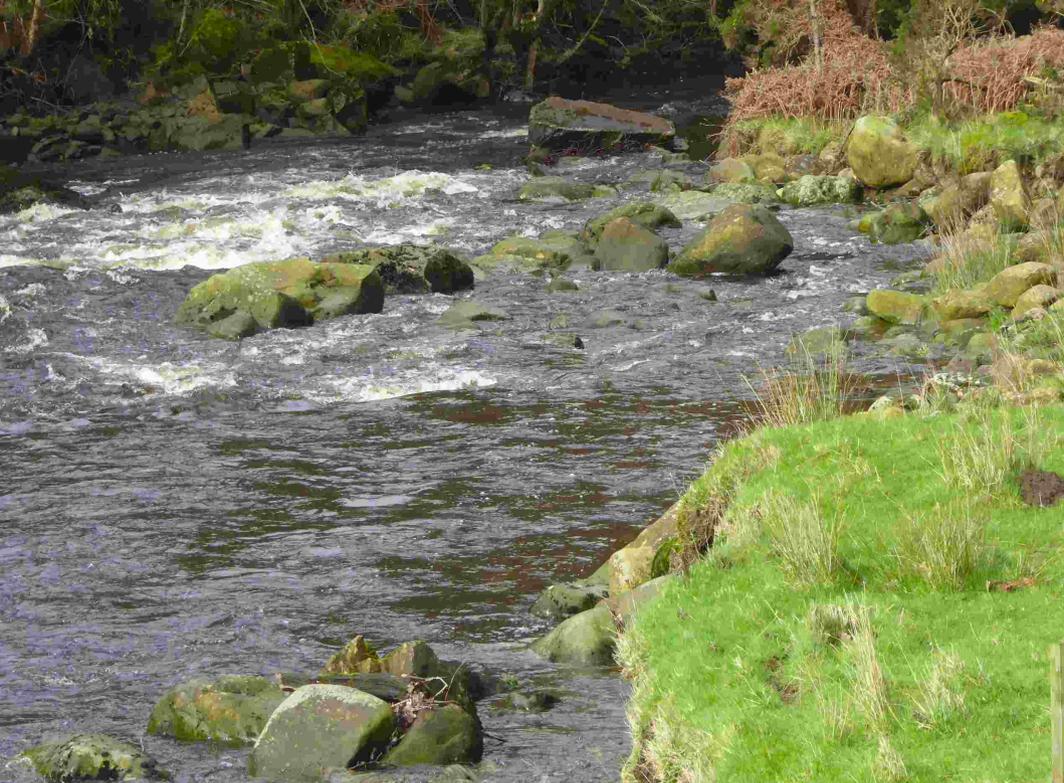
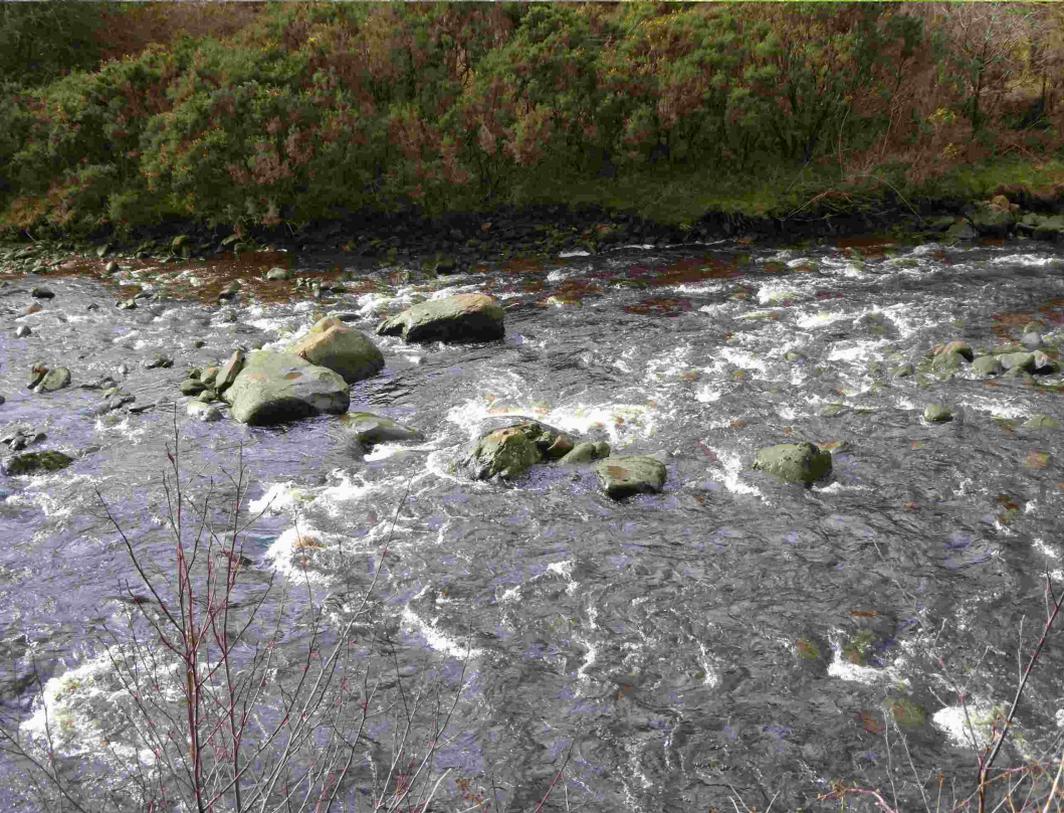
N1 Top left. This shows a vane of rocks coming out from the bank and angled up Stream. These capture rocks against the bank and divert the main water flow towards the centre of the river.

There are 3 of these put in to protect the bank.

Bottom left. This shows a horse shoe shape of that pulls the main water flow into its centre and deepens the river. This has helped pull the river away from an eroding bank.

These make a good demonstration of In River Training.

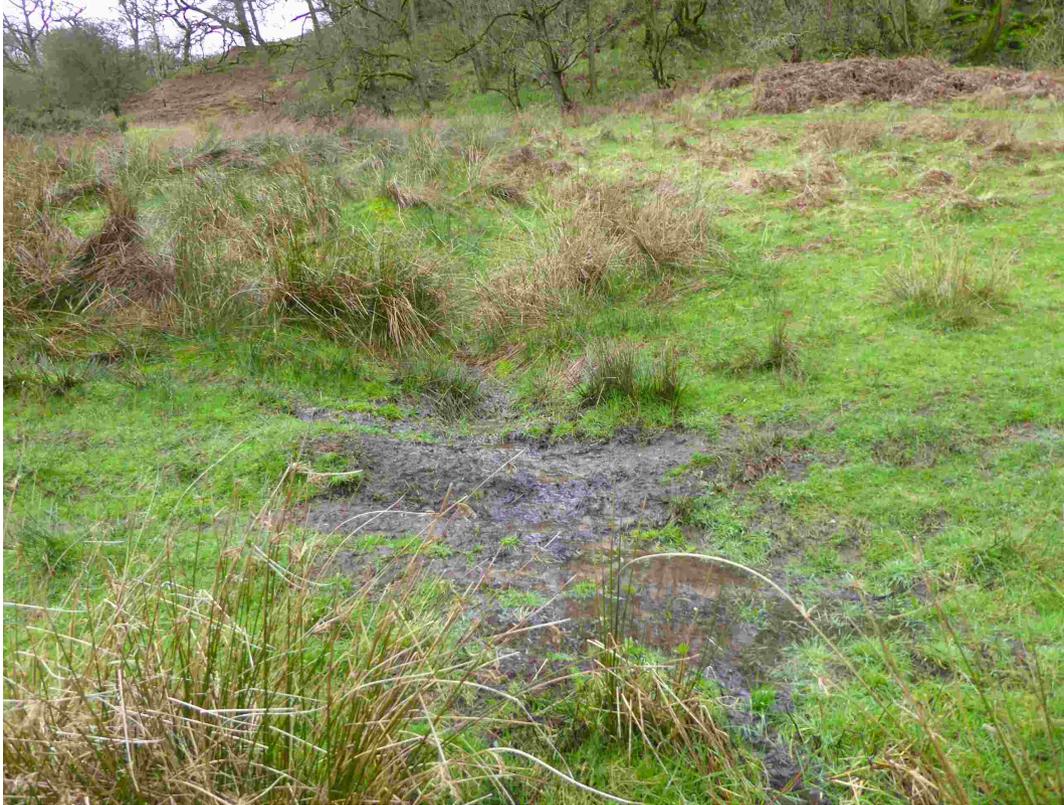
01 Wet flush that runs into an area prone to landslip. Make into a series of small ponds.

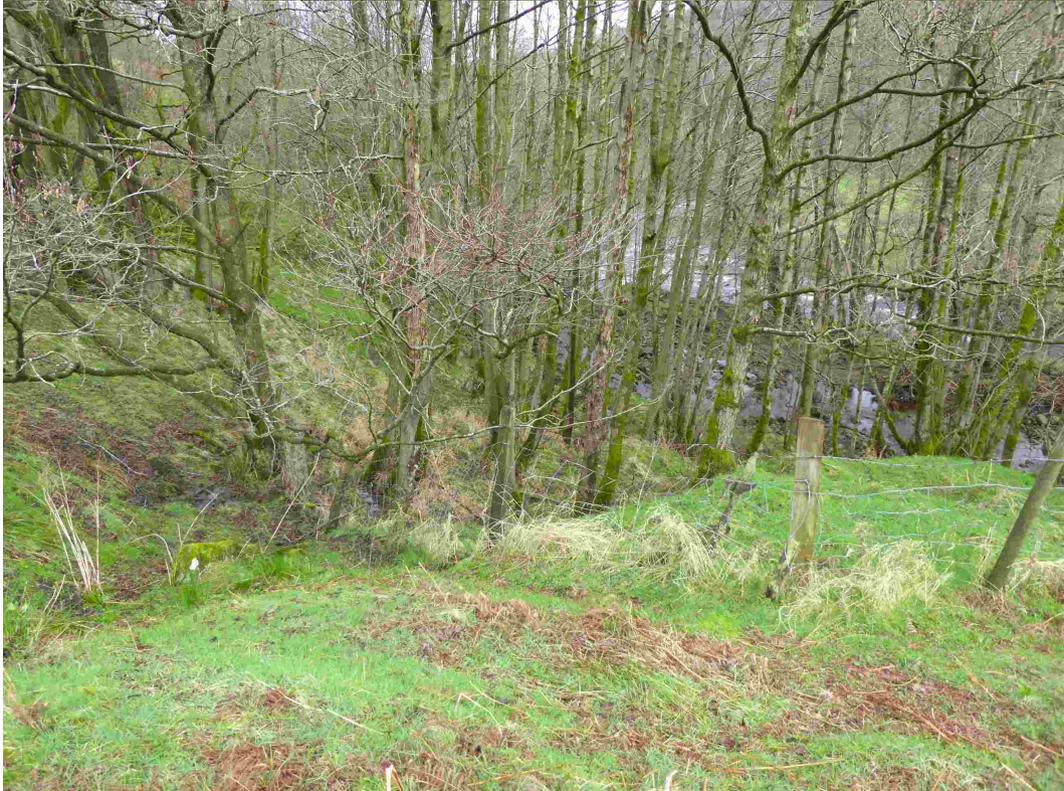
CS2 Area collapsing into river. Plant up this collapsing area with alder and fence from livestock. In longer term coppice trees to reduce weight that will contribute to this area landslipping.

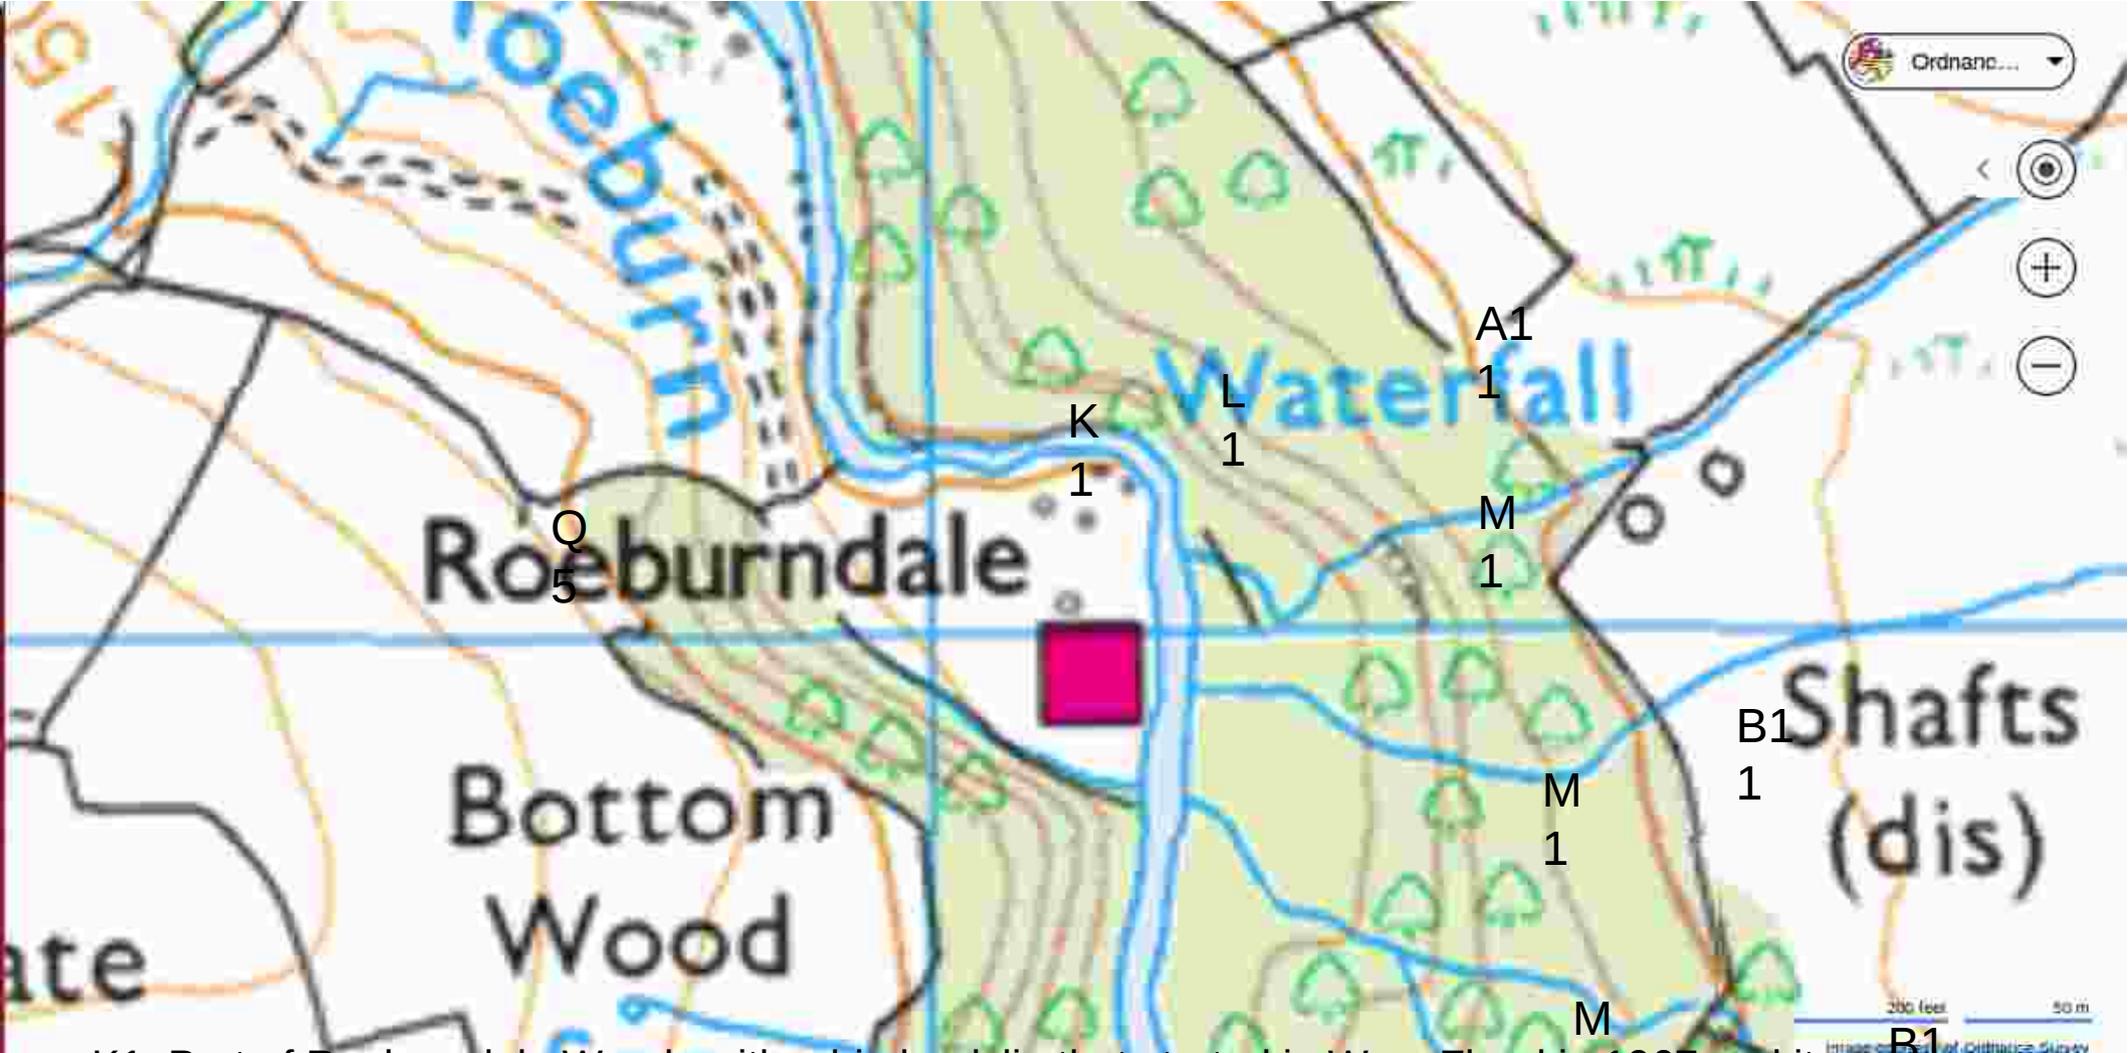
K1. Part of Roeburndale Woods with a big landslip that started in Wray Flood in 1967 and it is still eroding with water coming from above L1 and it is additionally being undercut by the river below as it sweeps around the corner. At the bottom of the slope In River Training with a vane of large rocks will encourage the river to move away from the base of the landslip. Once stabilized this should grow trees and be help more firmly.

L1. Is a footpath that in extreme rain events becomes a rushing stream. Explore the potential for slowing its flow either in the woodland or more preferable in the fields to the East. (A11).

M1 Thes 3 streams become rushing torrents in flood and cause some bank erosion. Explore the potential for slowing the flow upstream B11.

O5 Slope is landslipping regularly. Explore the potential for slowing flow on neibours field above.

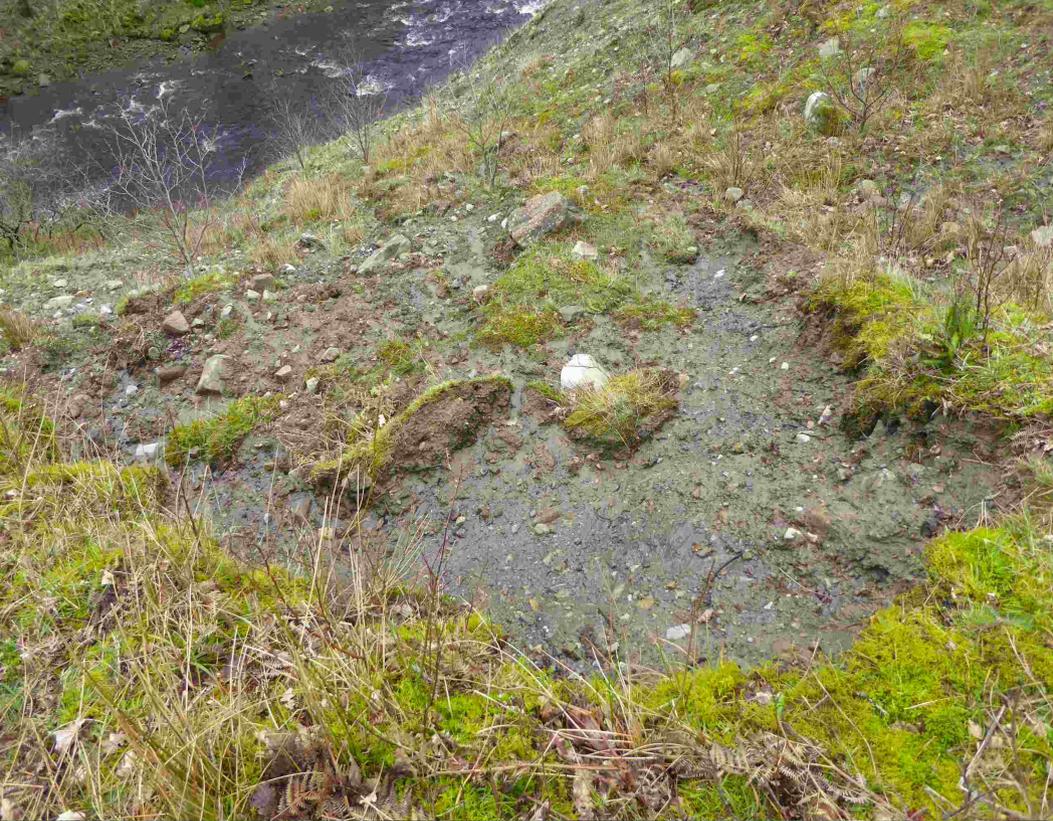
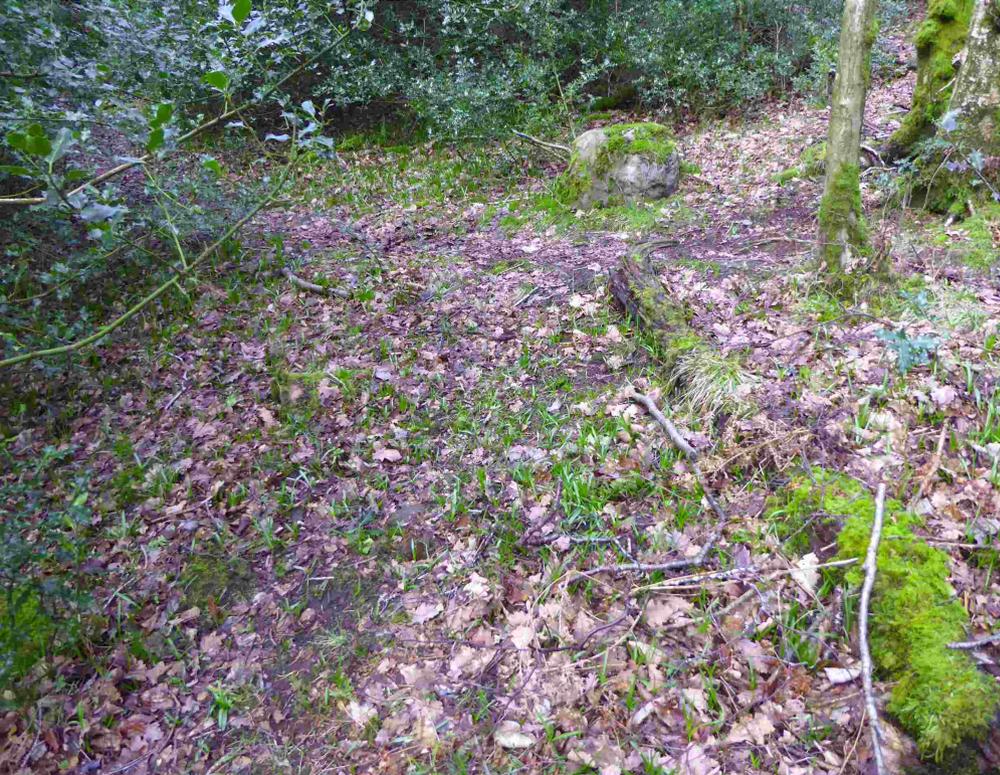
K1 A large landslip that started in Wray flood 1967. This is slowly establishing alder trees in places. The base of the landslip is being undercut by the river. Proposal to build 3 rock vanes for In River Training to pull the river away from the bottom of the bank. Top left.

L1 Footpath during a storm in Nov 2017 (bottom right). This over flows in 2 places that contribute to erosion of K1. One is shown bottom left. The proposal is to divert this stream down an old packhorse track where it will do no damage. Investigate to see if this flow can be reduced in neighbours field A11.

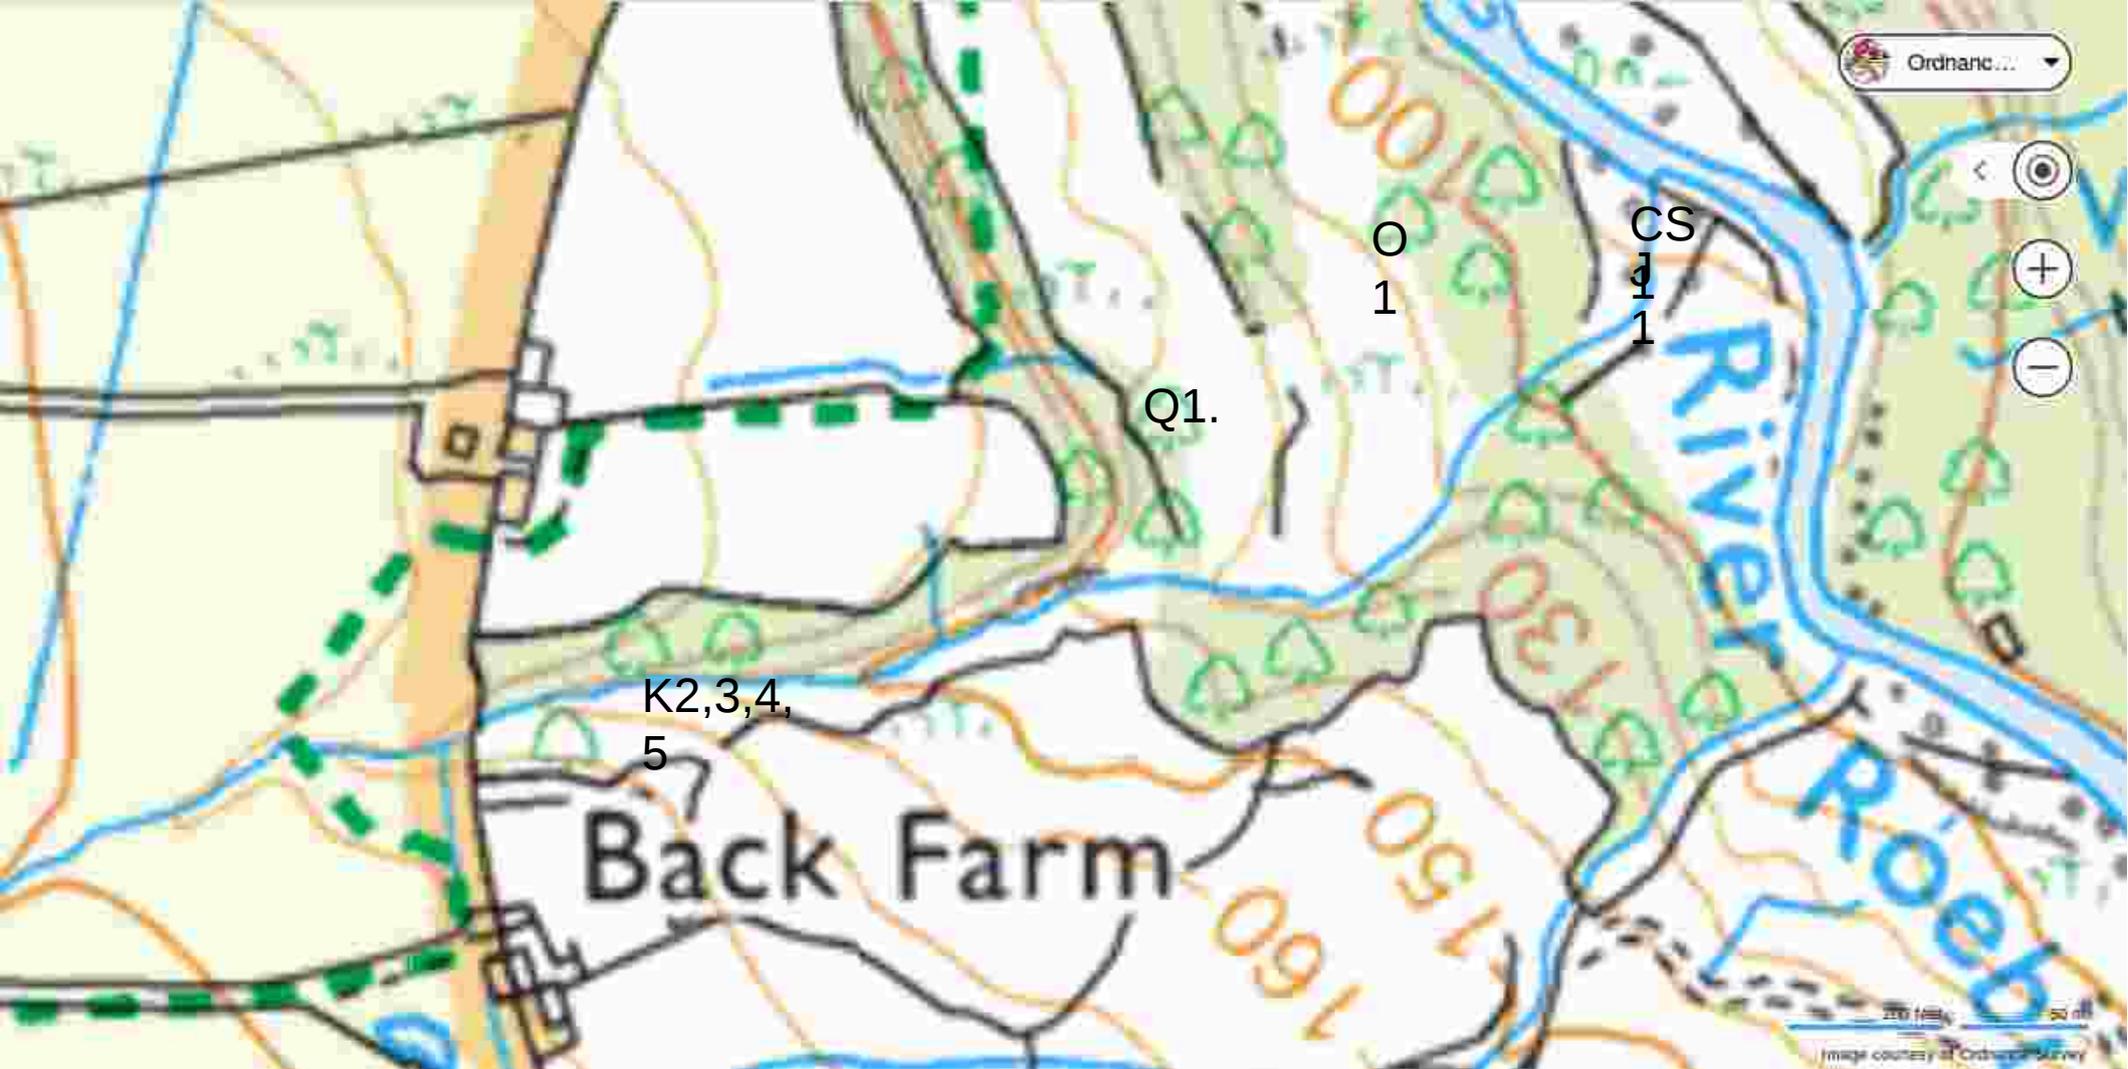
K2,3,4,5 Landslipping woodland becoming a deep gully. Potentially taking trees and boulders into the river if a big landslip occurs.

Q1. Stream floods regularly and has damaged the fence and the nutrient content has caused nettles to grow in the downstream field.

O1. There is a wet rushy ditch that makes its way NEE and has contributed to landslips of the river bank in 1967 and other extreme events. This would make into a series of small ponds with an additional raised leaky dam area that would help steady the flow of extreme rainfall events

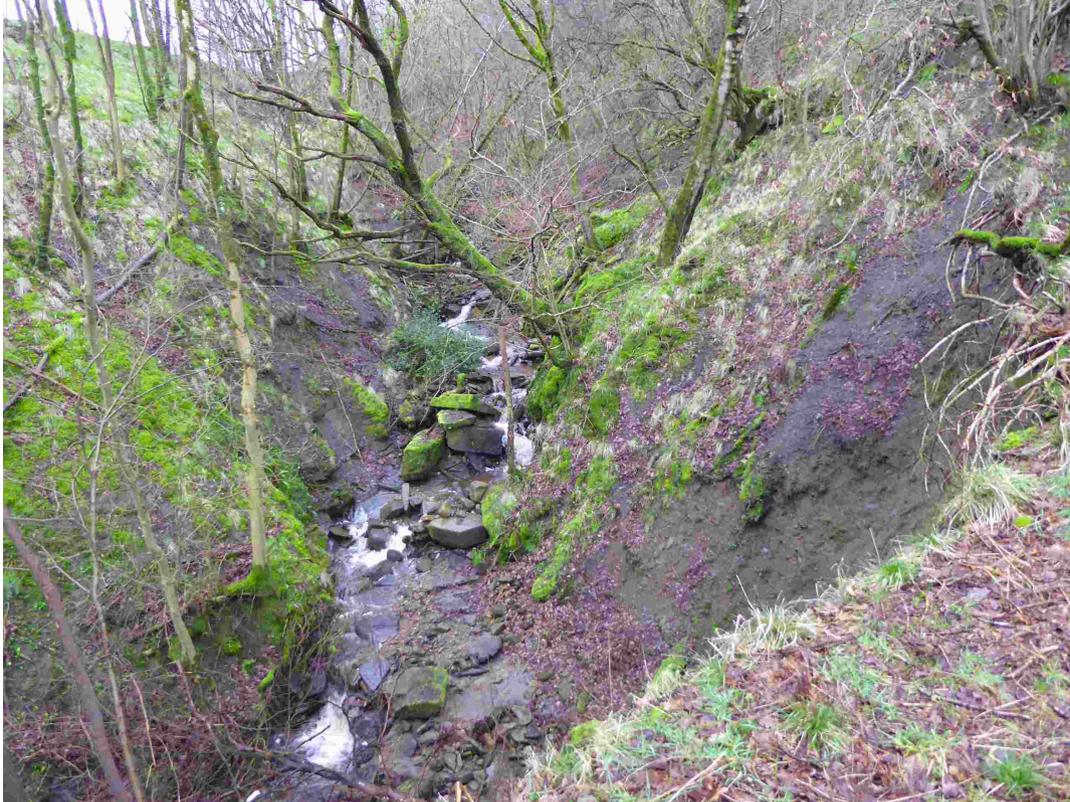
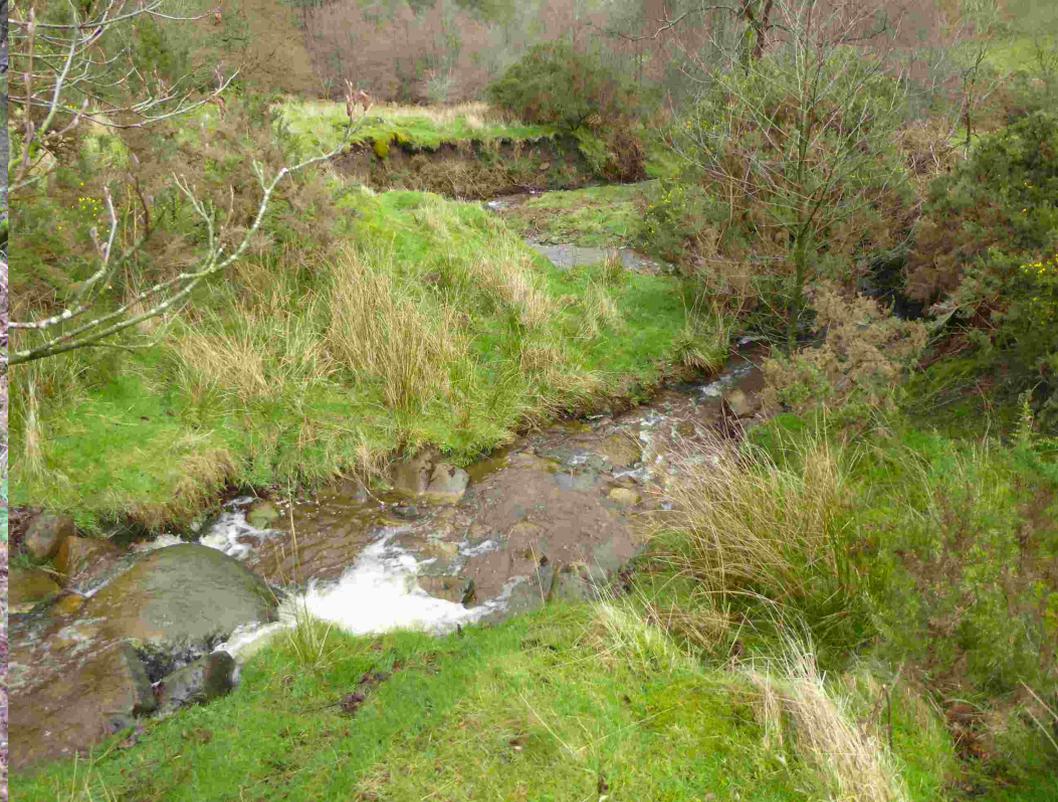
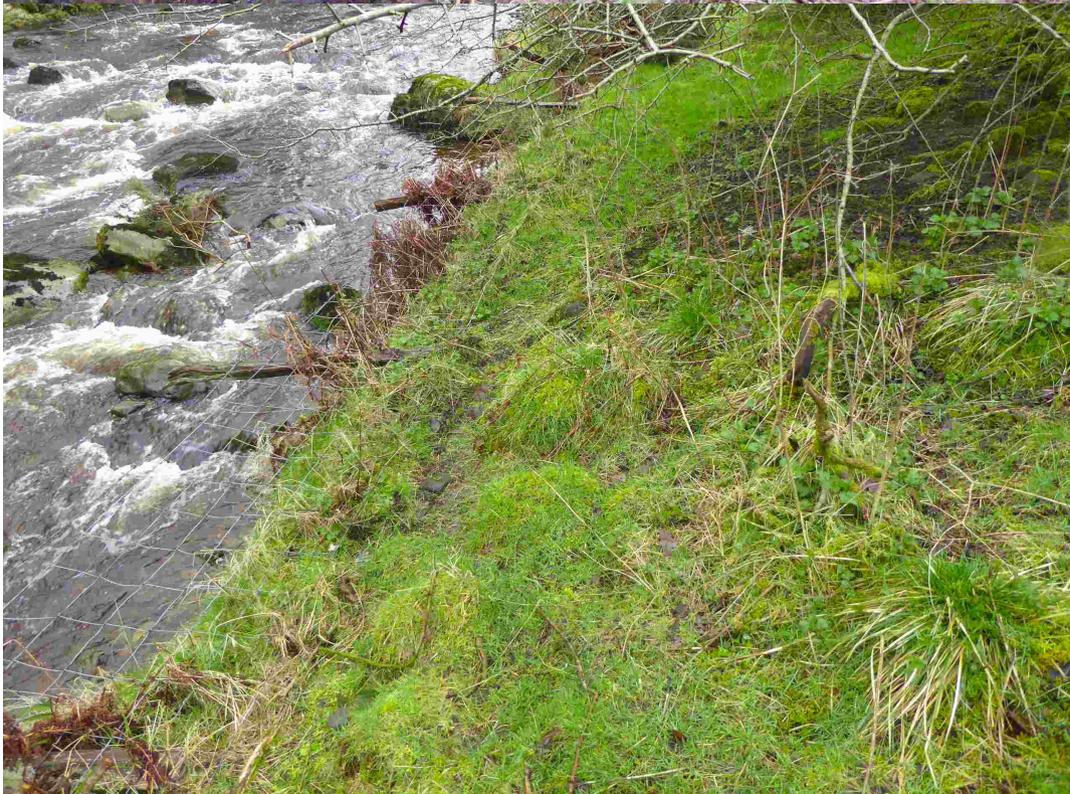
K2,3,4,5 Top left -Erosion in Laneshaw Gill

Bottom left CS1 fence collapsing into river.  
Proposal to plant up area with trees up to 8 m  
from river bank.

Top Right J1 Laneshaw Gill as it enters the  
river

This stream's banks are eroding with the  
flooding and movement of rocks down the  
gill.

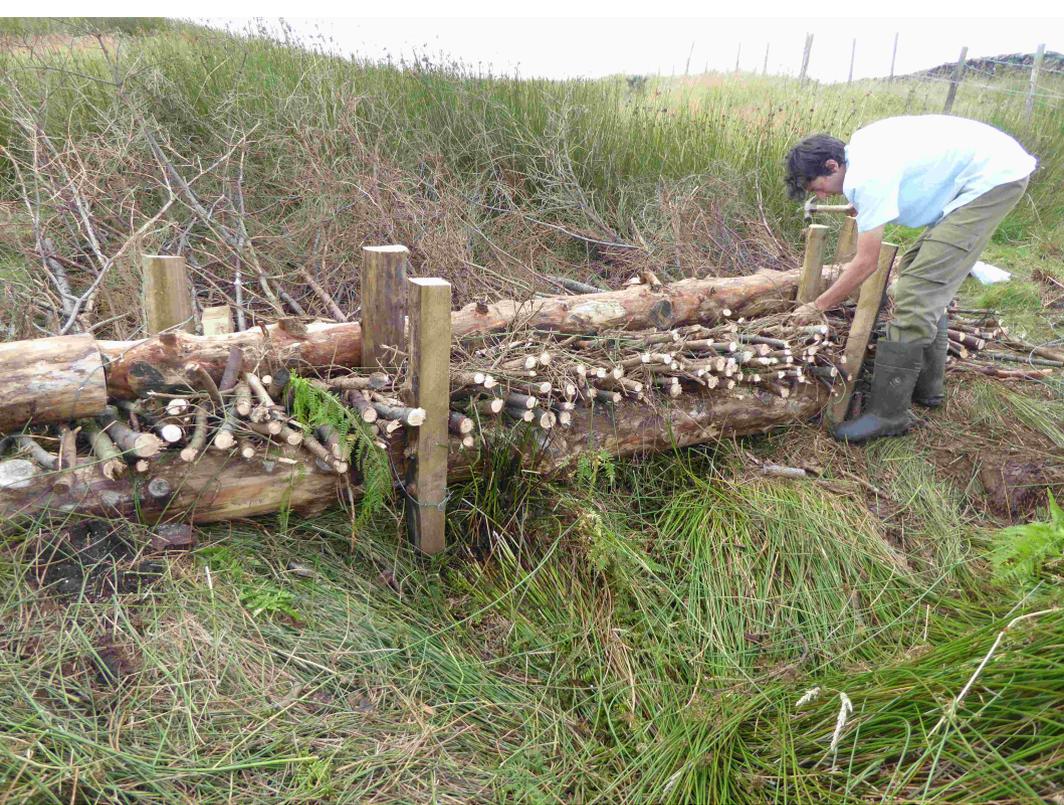
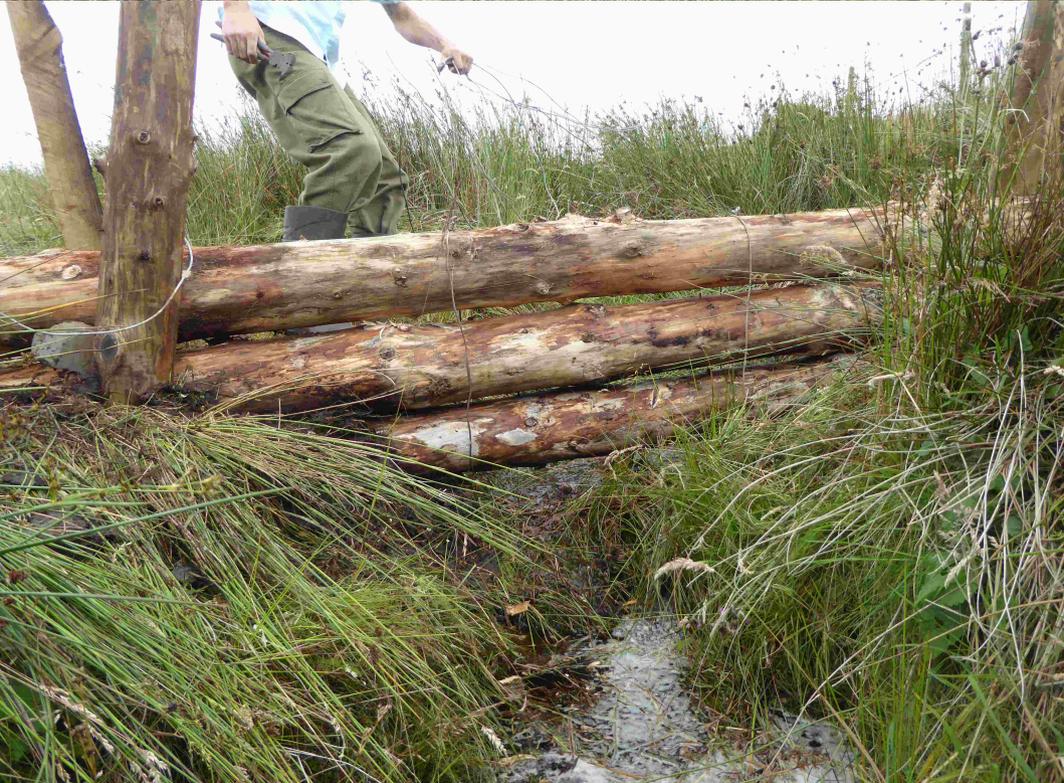
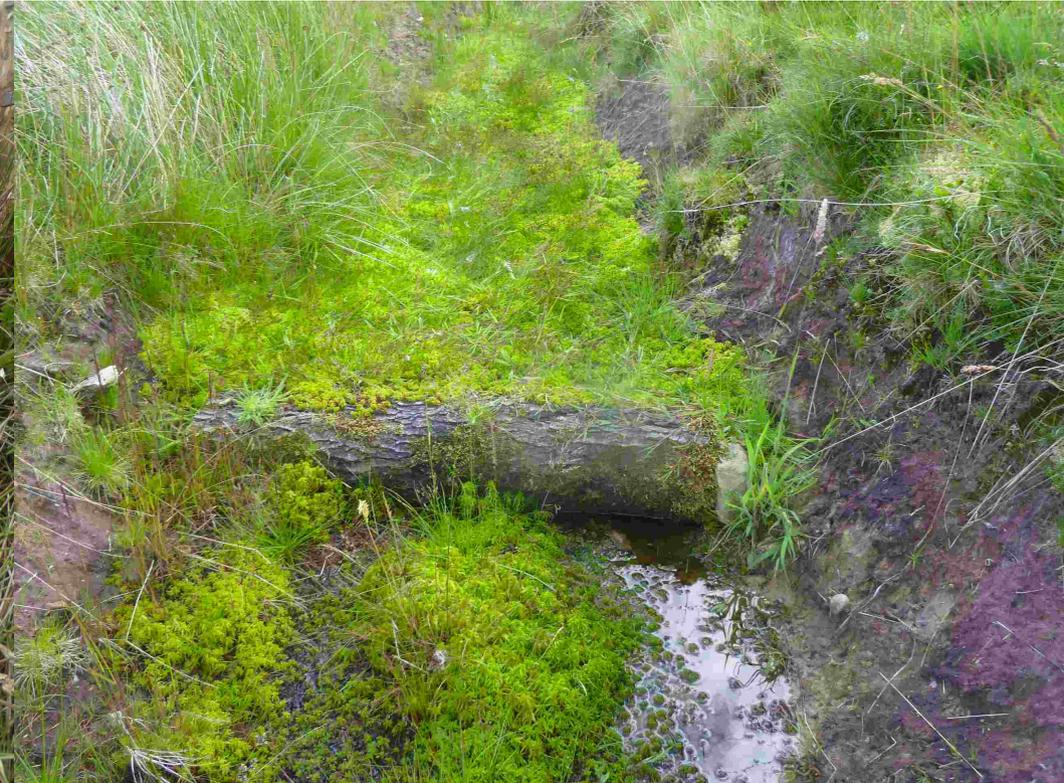
S1 2 woody check dams built in 2018  
Top and bottom left.

V1 Alder log slowing the flow and growing  
sphagnum moss. Bottom right.
