## **Roeburndale Woods WEG**

# **Flood action plan for Backsbottom Farm March 2019**

prepared by Dr Rod Everett

**Context -Water Environment Grant 2018 Saving Roeburndale Woods** (Approved 25 Feb 2019)

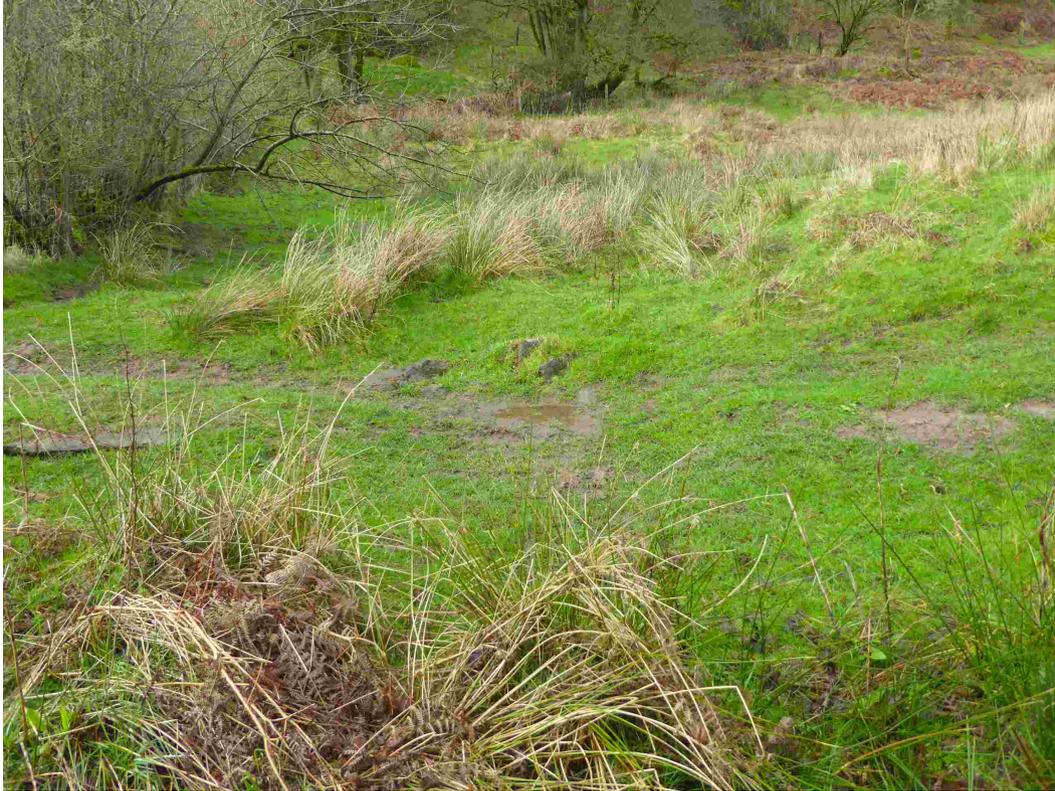
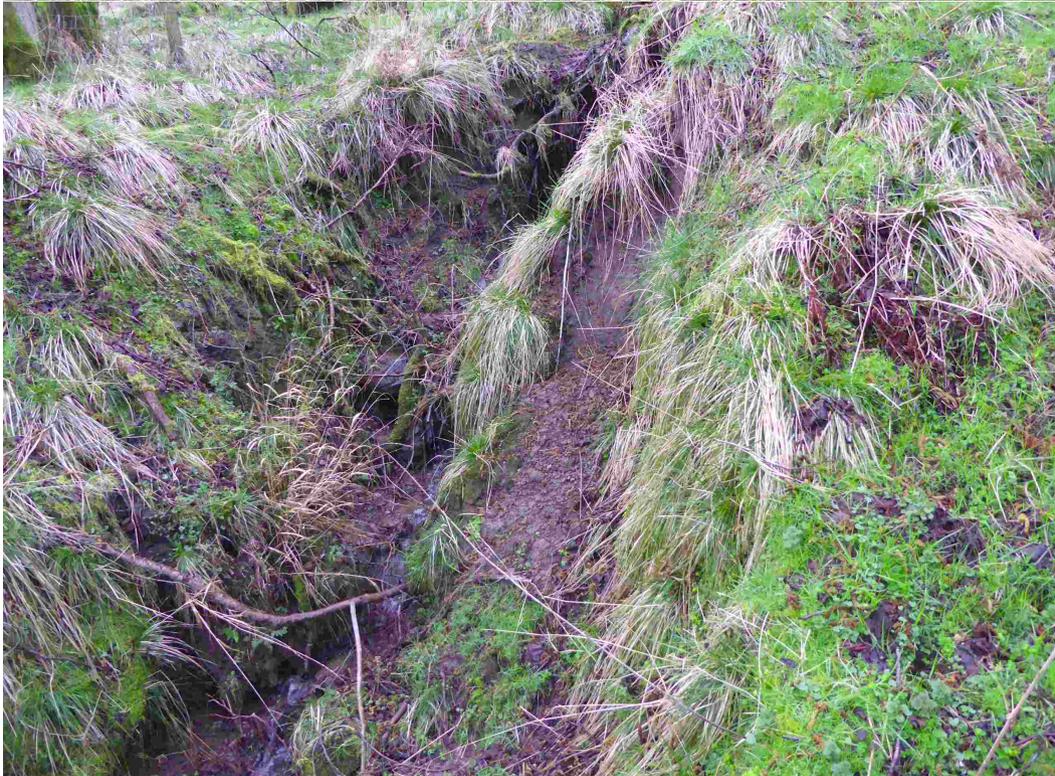
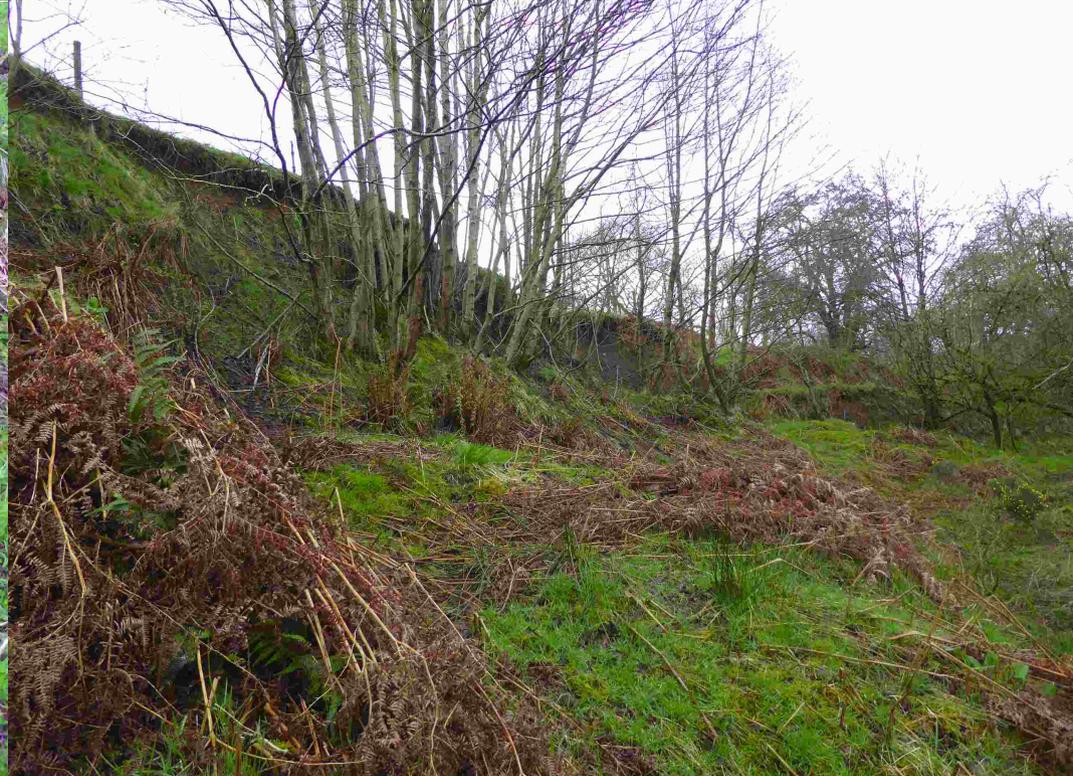
W1 Area (Top Left) that runs water in extreme rainfall conditions. This causes erosion and potential landslip below (bottom left)

W1 Another area to North where the land is slipping is similar.

W1 (Bottom Right) An adjacent area landslipping from wet stream above. Proposal to create a small stone check dam with lime trees and eleagnus shrubs planted in small block above to slow the flow. Good sheep fencing and a water gate will

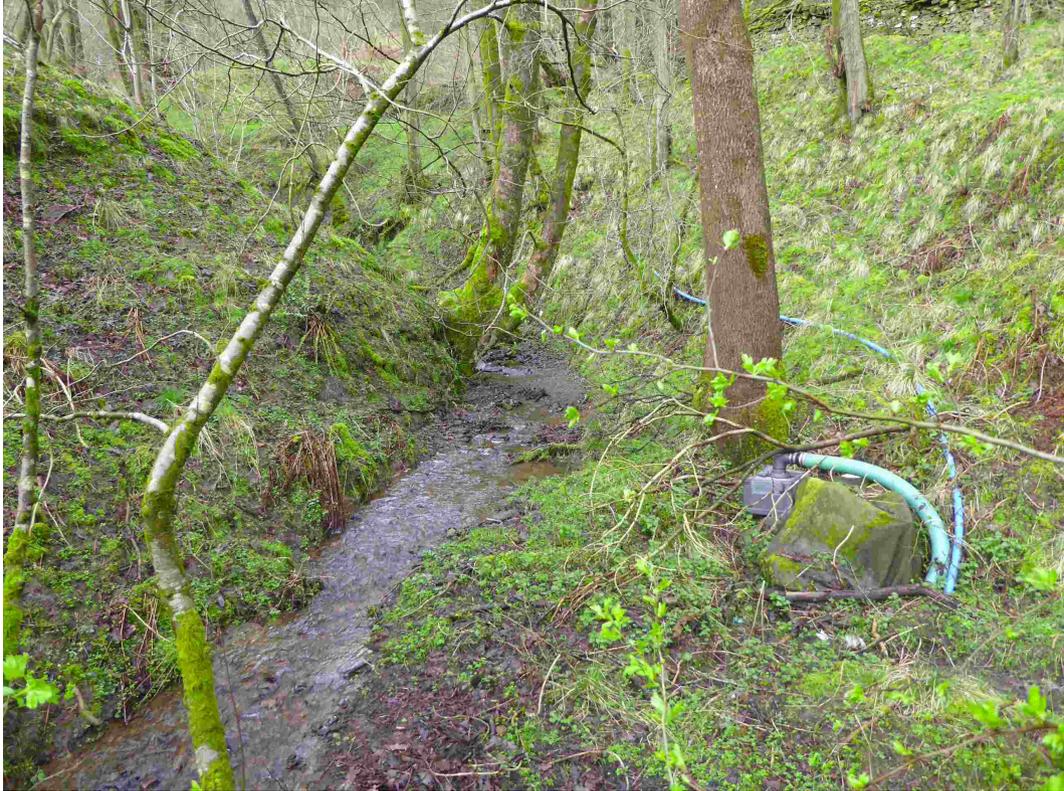
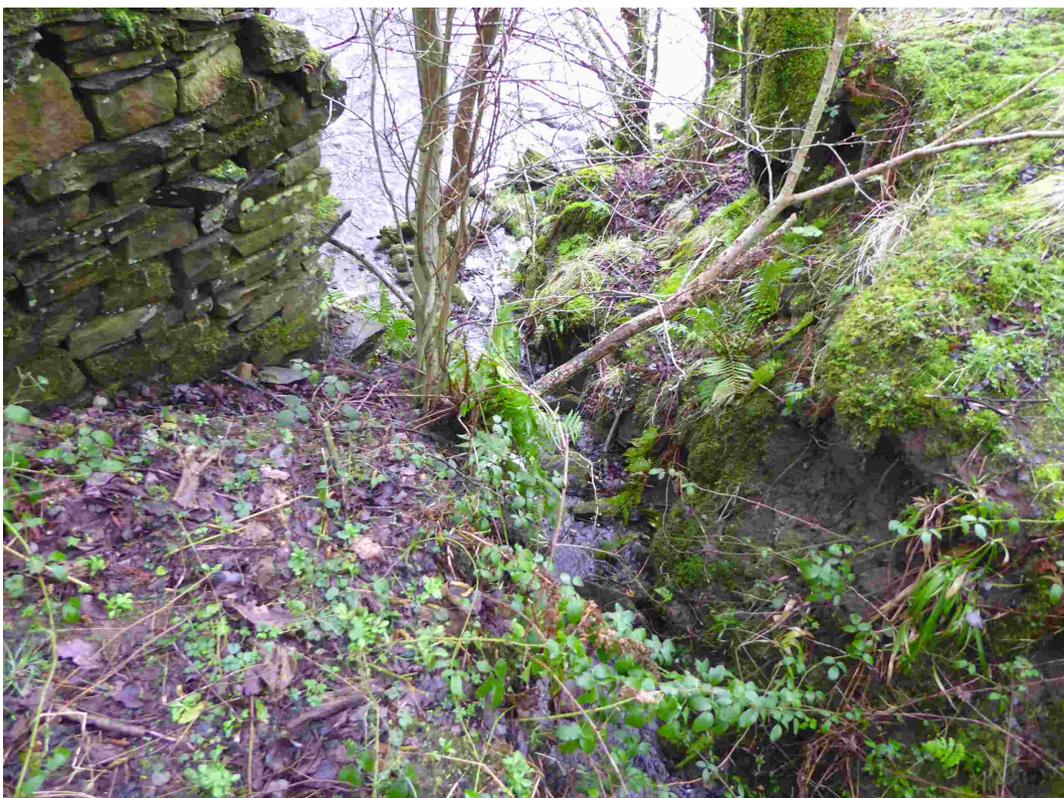
I1 Stream that runs off the Whitmoor area with swales and check dam. This would make a good area for monitoring stream flow.

Bottom photo shows where this stream enters river with a gully below the track.

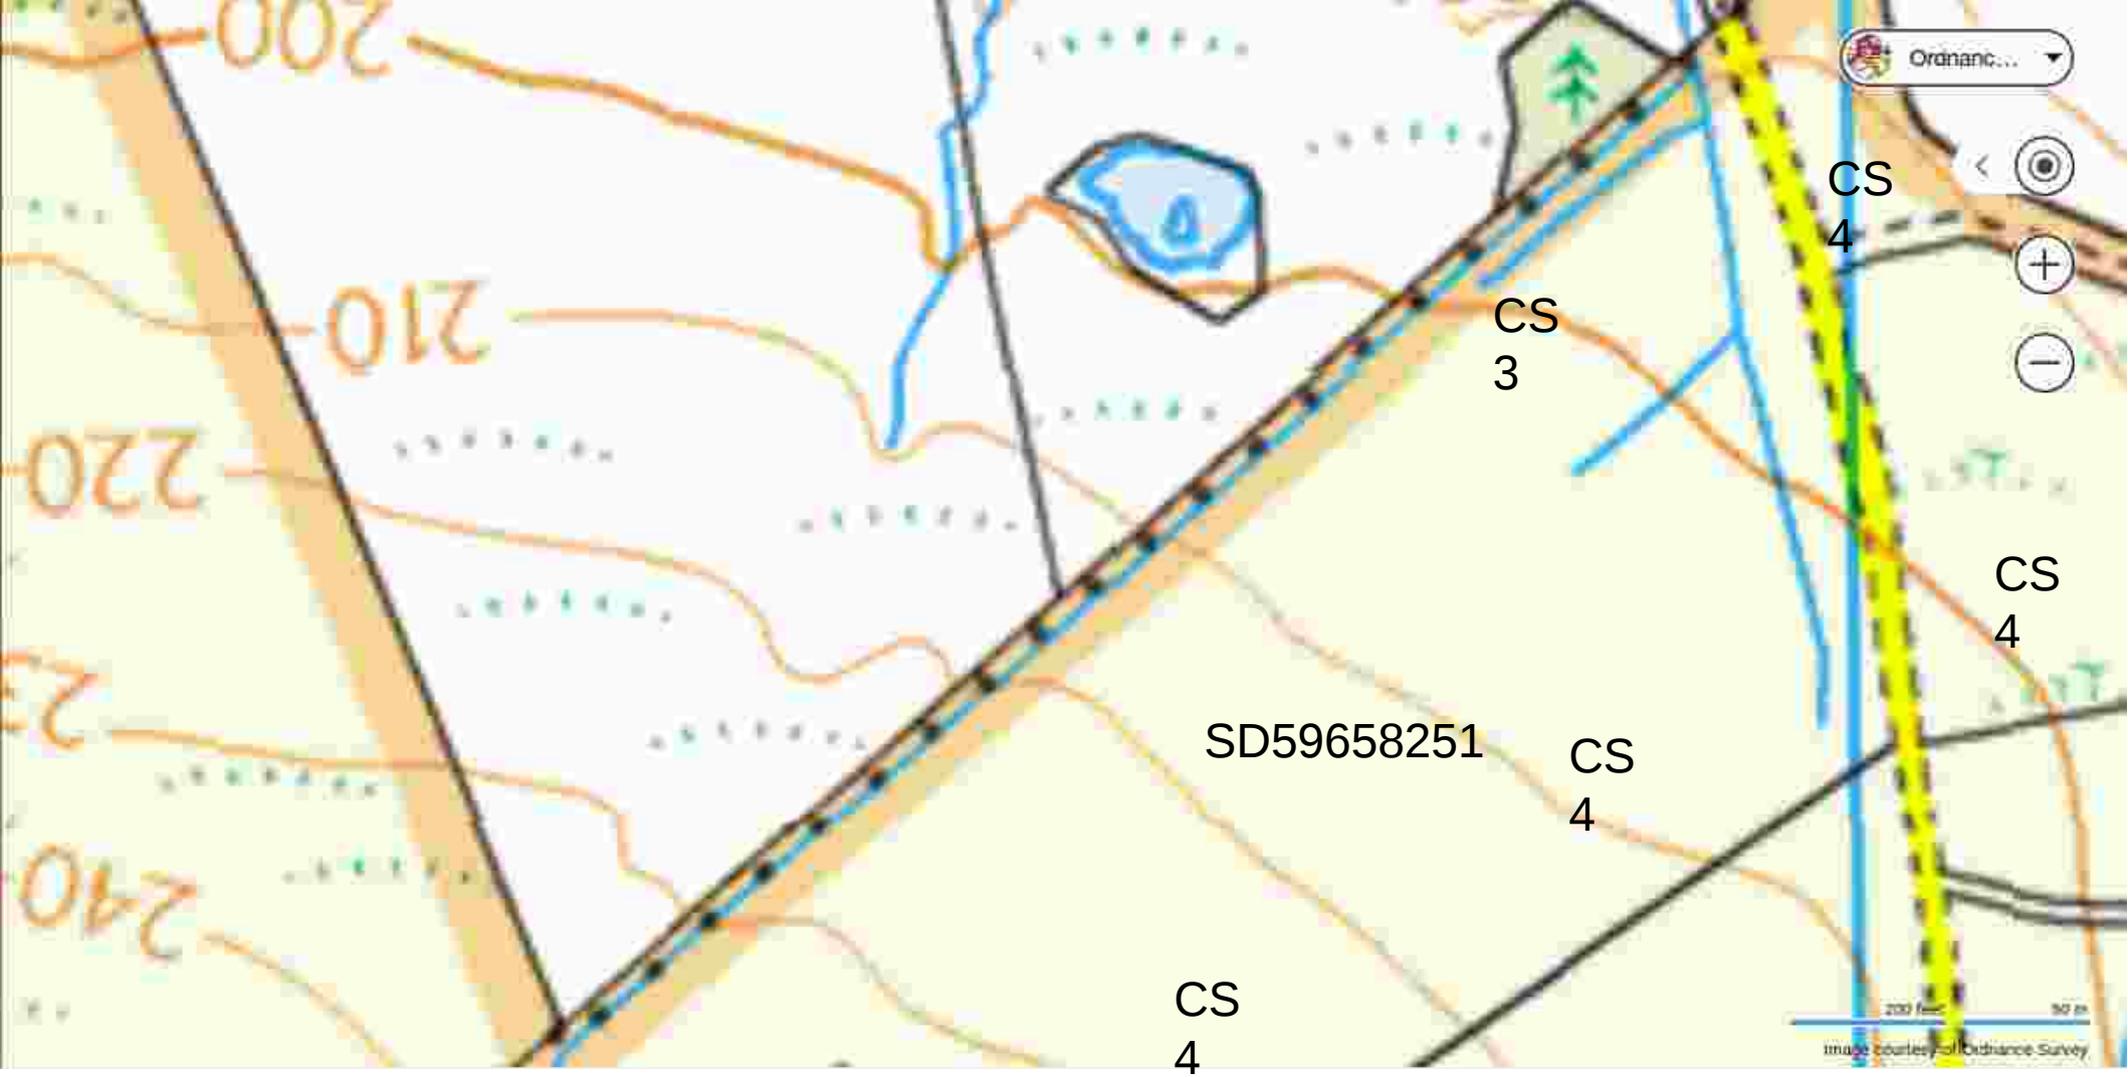
CS3. Old drainage grips. Explore potential for blocking some of these where they have developed into a deep narrow gully.

CS4. Well developed blanket bog slows and sinks heavy rainfall events.

On the West side of the road they help prevent flooding in Farleton and they need to be maintained in good condition by maintaining a reduced stock number. Long term annual payments would help ensure the blanket bog remains in a good condition.

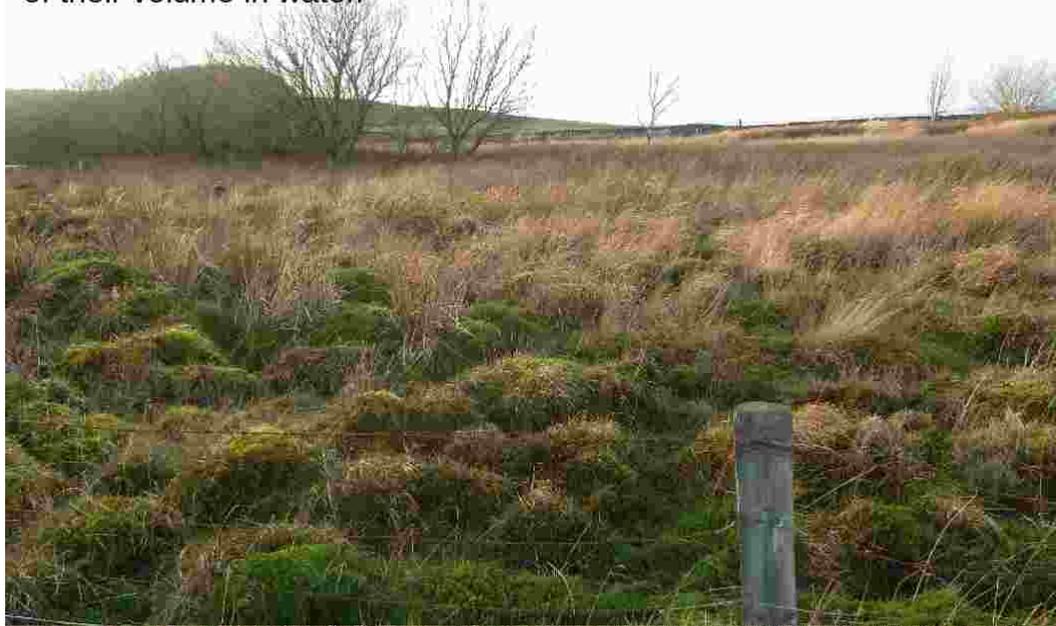
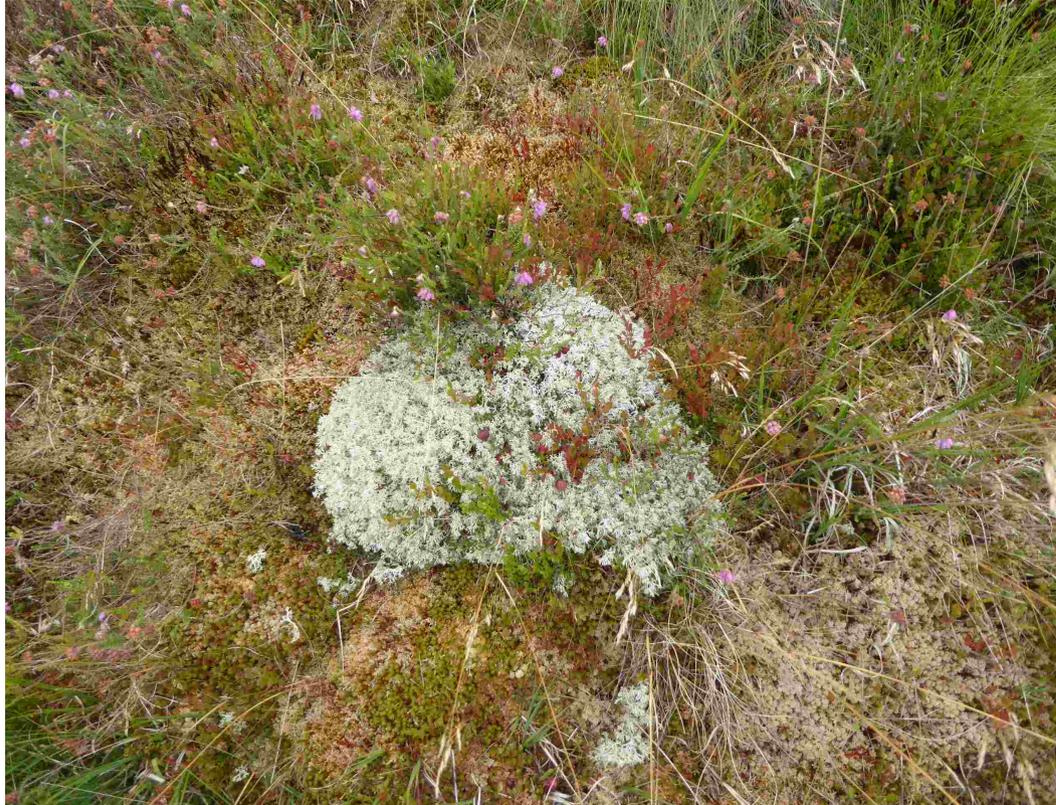
Tussocks of blanket bog with sphagnum moss and dwarf shrubs such as heather, bilberry, crossleaved heath and cranberry hold around 80% of their volume in water.

CS4 Areas of blanket bog that hold water in the tussocks of sphagnum, heather and bilberry and slows the flow.

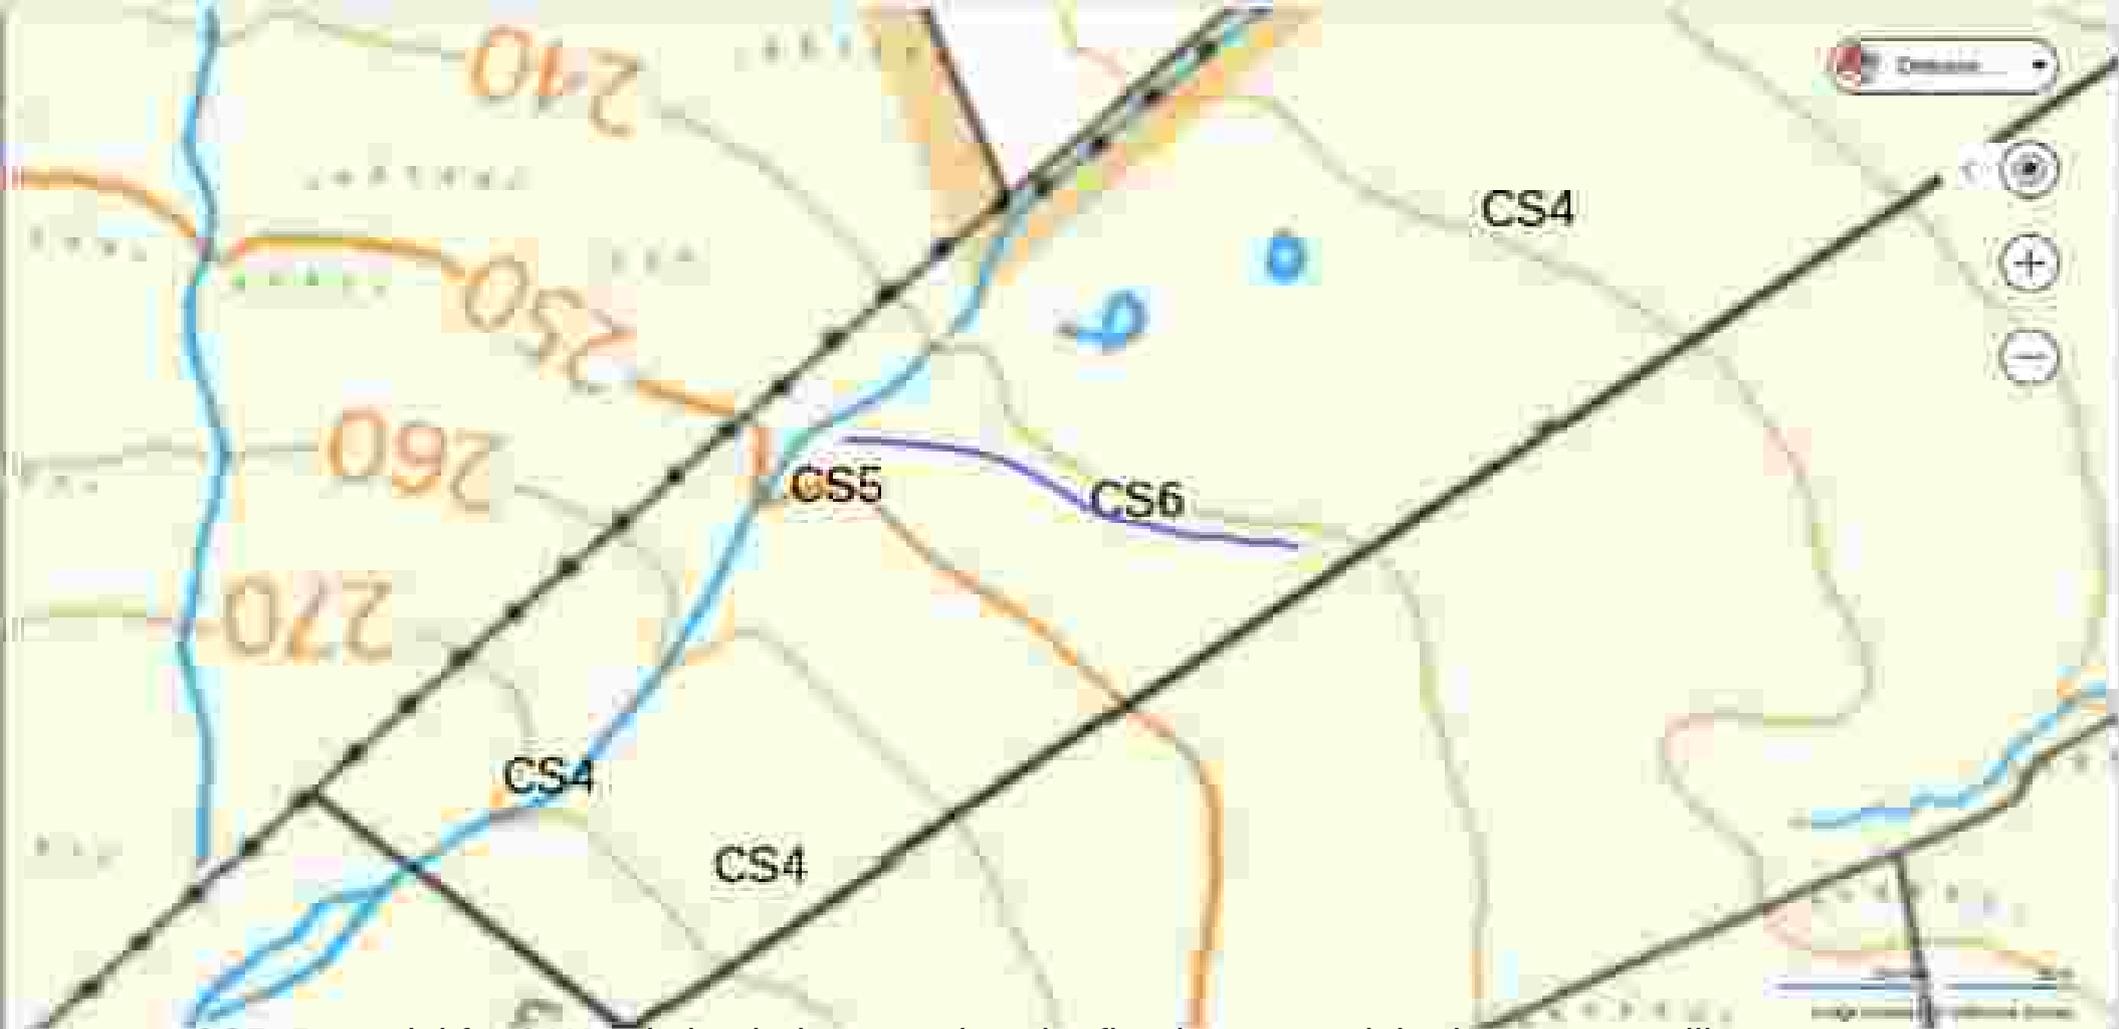
CS5. Potential for 3 Wood check dams to slow the flood water and the lowest one will divert extreme flood water into a level contour swale (darker blue) to slow spread and sink.

CS6. When the swale is full then it will be designed to over flow into rushy area and eventually either sink or return back to the stream.

CS4. Well developed blanket bog with tussocks of sphagnum moss, cotton grass, heather crossleaved heath, bilberry and cranberry. This area holds a lot of water in the sphagnum. This helps cool the ground and encourages the water to infiltrate (at 4C water is at it's most dense.) The roughness of the surface slows the flow of flood water.
