The erosive effect of hard groins seen on the River Lune and River Kent

The River Gauge at Caton on the River Lune recorded the highest ever flow on an English river as 1742 (m³/second) – That's 1742 tonnes of water flowing down the river every second! The flow peak was recorded at 00:15 on 6th December 2015 following the intense sustained rainfall from Storm Desmond.

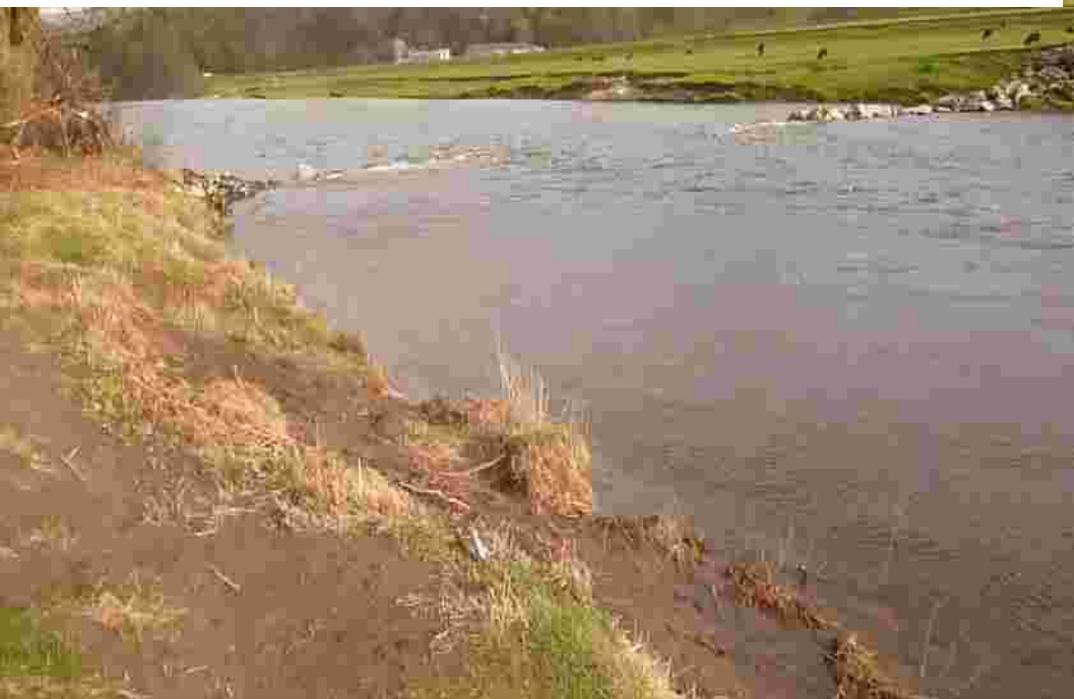
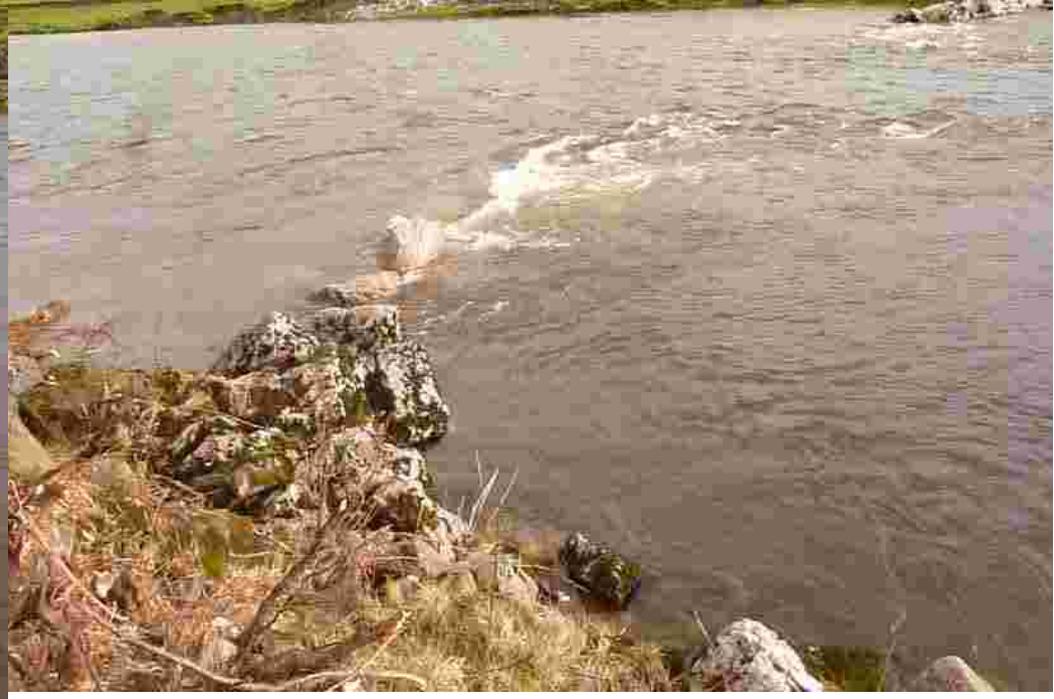
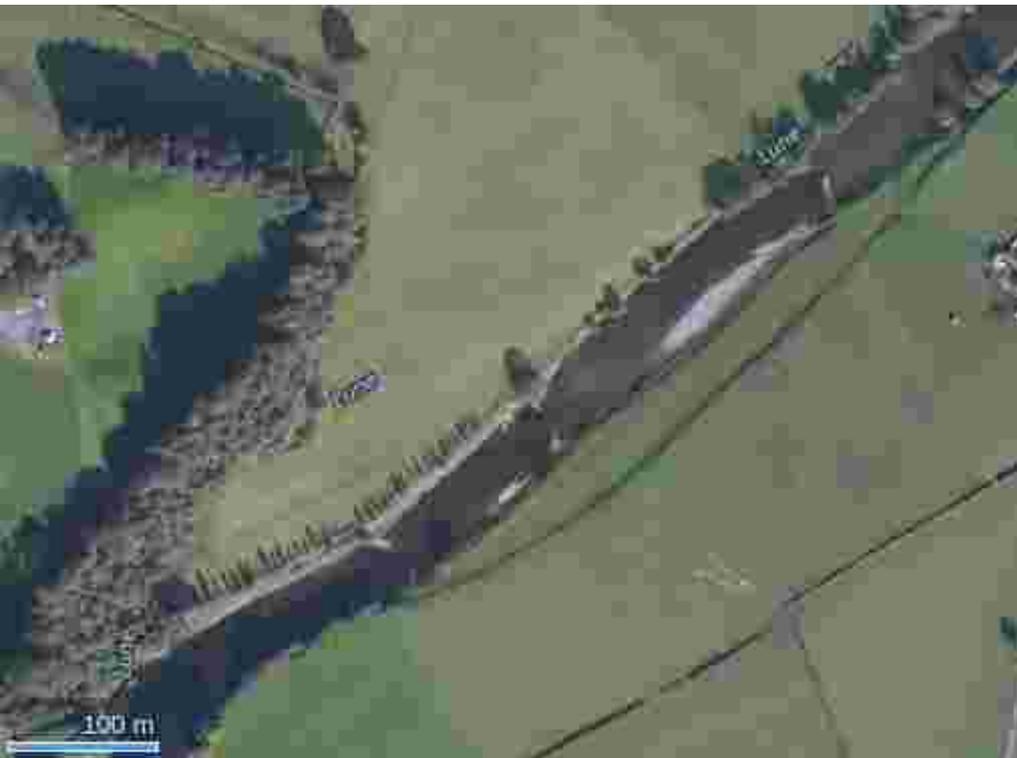
Three twin upstream groins above Kirkby Lonsdale on River Lune.
These slope down into the river and are made from rough limestone blocks piled from the bank. The bank in this area is fairly intact compared to other areas on the river. The river is about 5 metres deep below the groin.

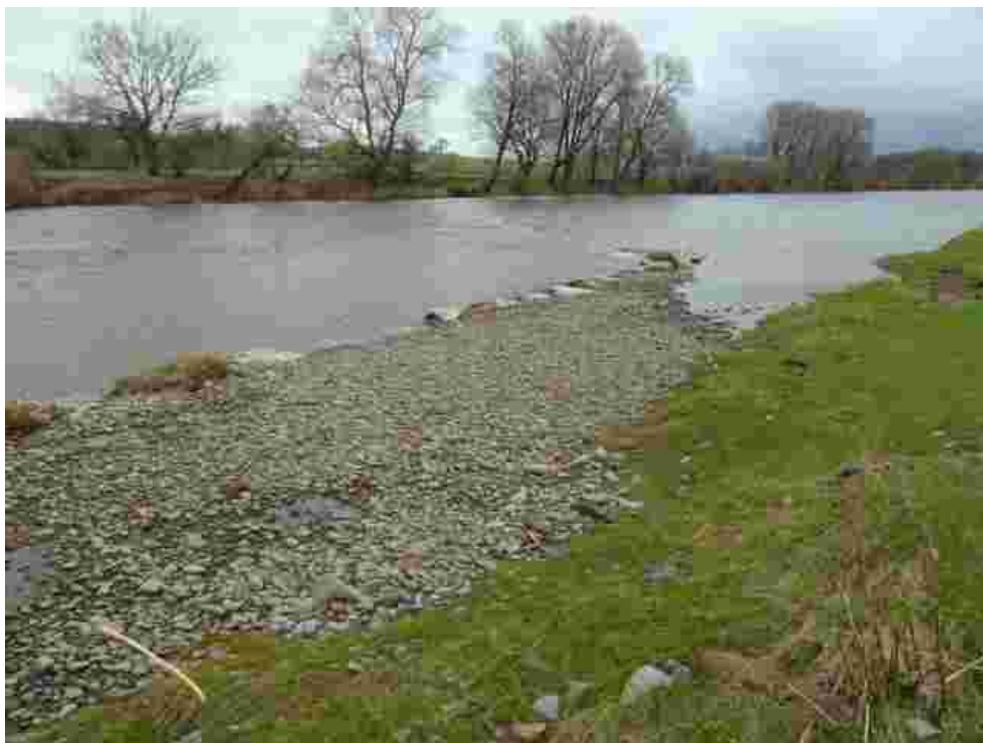
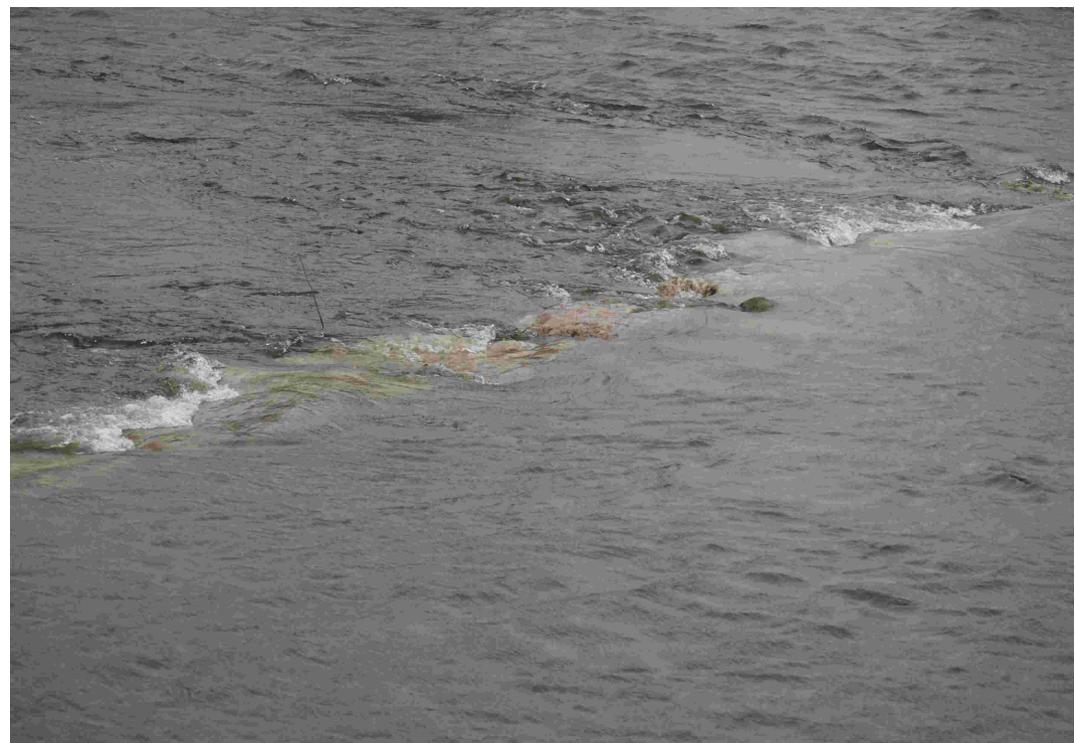
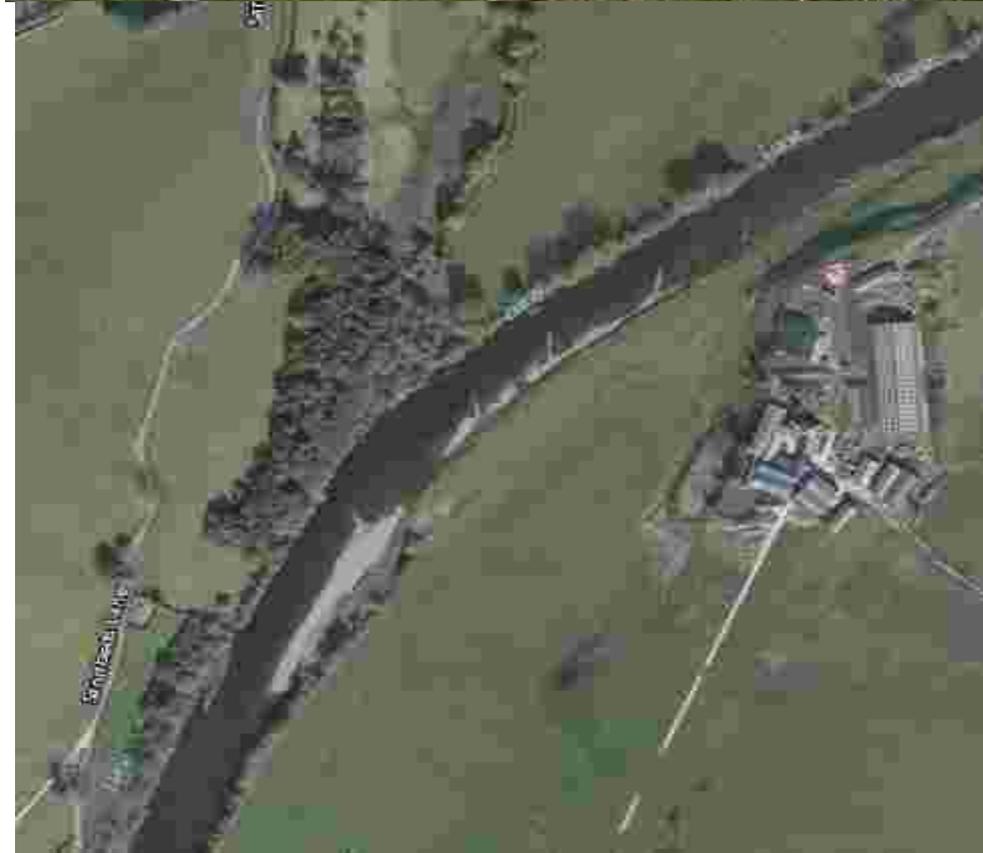
Priory Farm Hornby on the river Lune. Upstream groins on inner bank on slight Corner. Some gravel collection shown on aerial photo. After flood Desmond the gravel has gone. The groin extension along the bank has collected gravel behind it. Slight bank erosion around groins. More damage on opposite bank downstream. The groins may have contributed to this erosion by narrowing the river and speeding up the flow on the opposite bank.

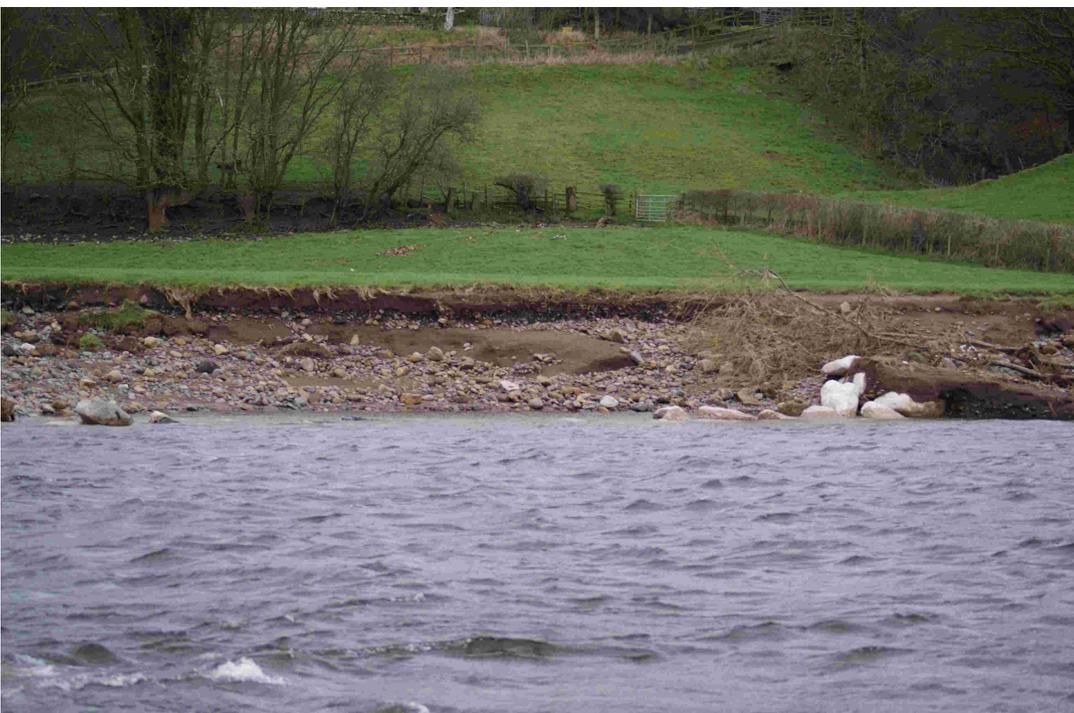
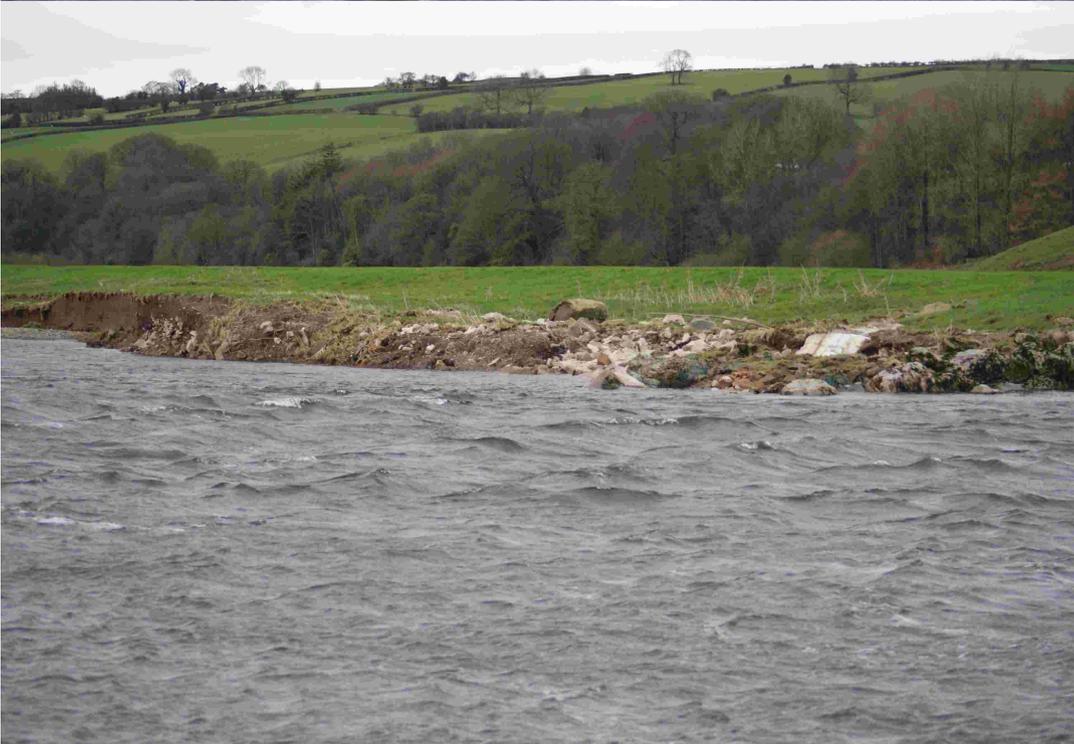
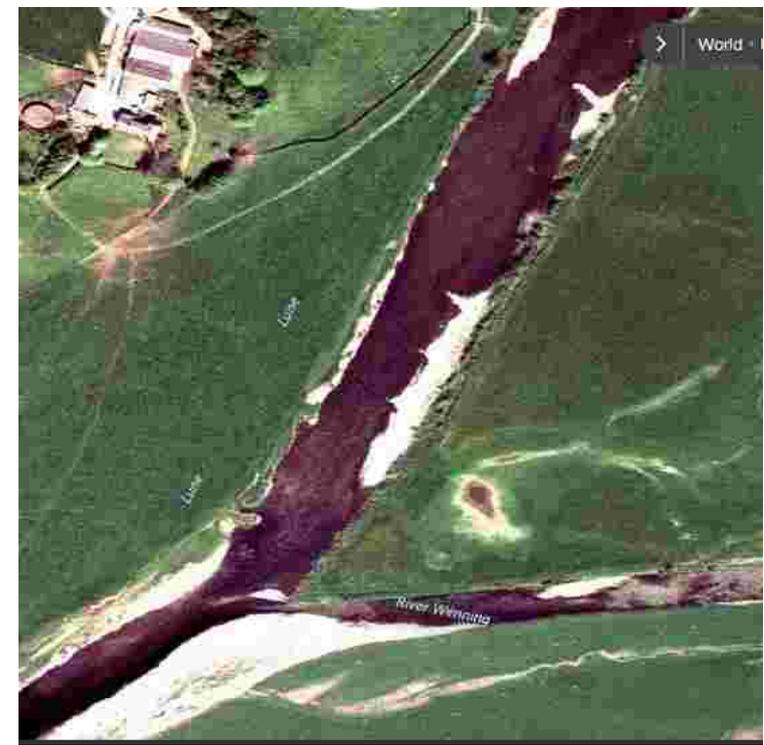
The aerial shows old groins filled with gravel on East bank. This is now growing Willows. - not eroded in flood.

The West bank opposite Priory Farm Hornby on River Lune shows extensive erosion after rocks. These may be the previous groins. The erosion may be exacerbated by the narrower river making the flow faster,

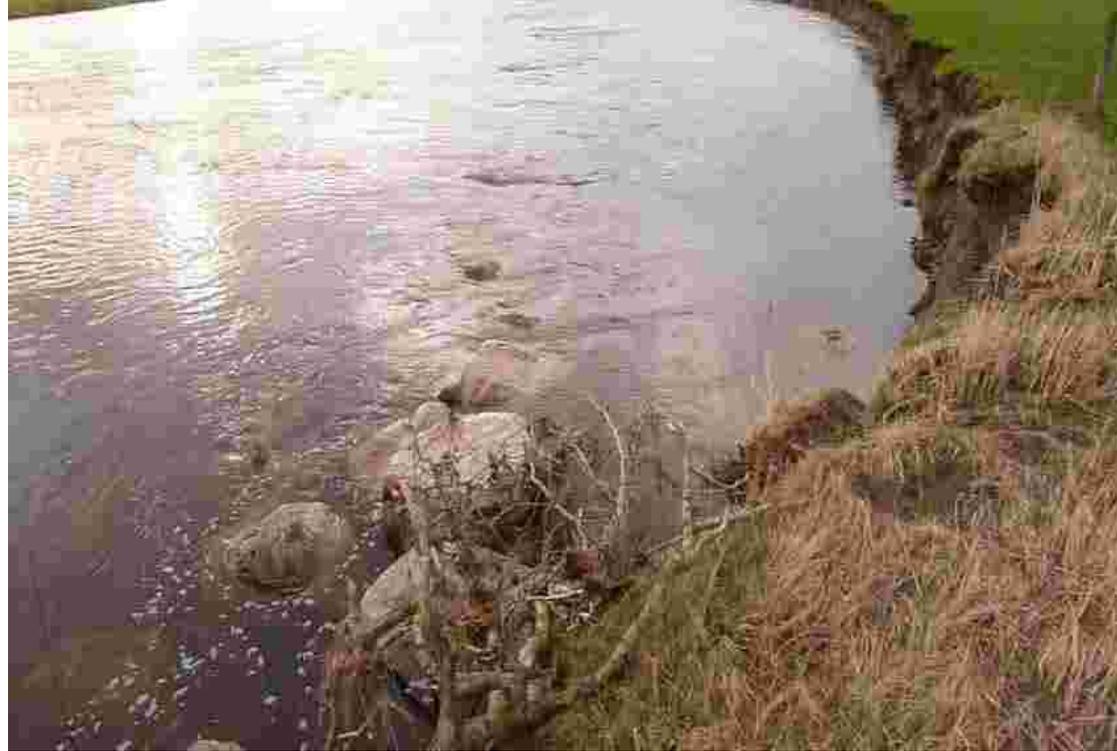
Massive erosion on River Lune below Newton caused by rocks that were supposed to protect the river bank. The aerial shows the rocks had previously been exposed by the water back-cutting behind them (along the left bank). During the Flood Desmond storm the river flow would have been pulled into the bank through the rocks eroding behind them. In the order of 20,000 cubic metres of soil have been lost from this area.

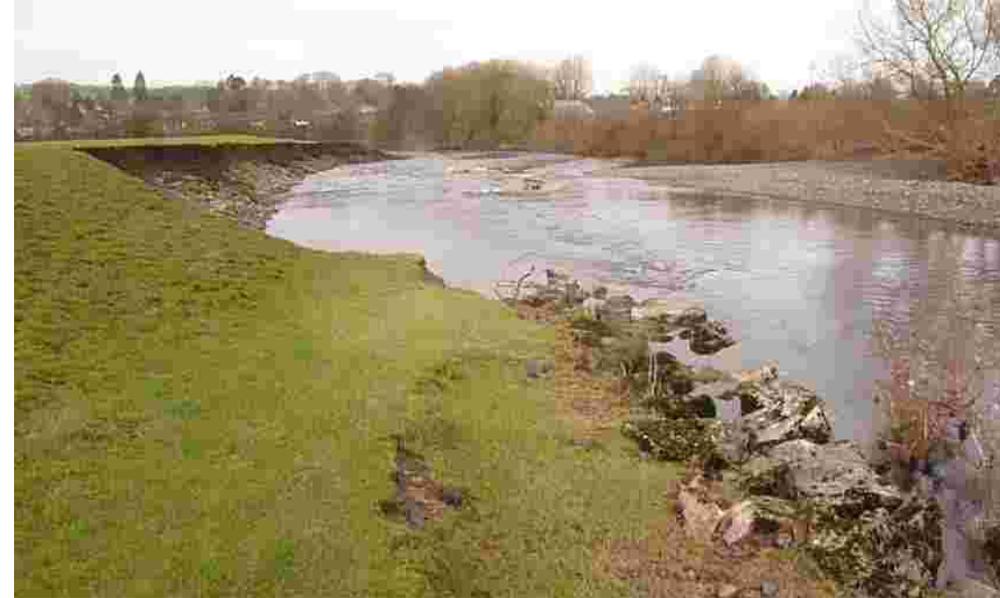
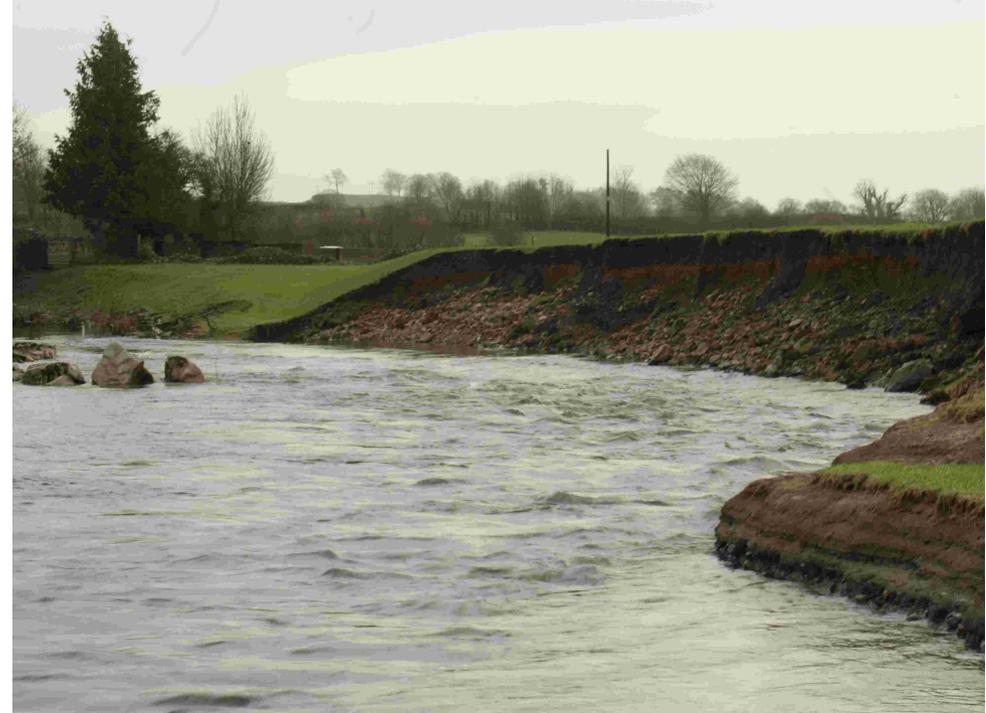
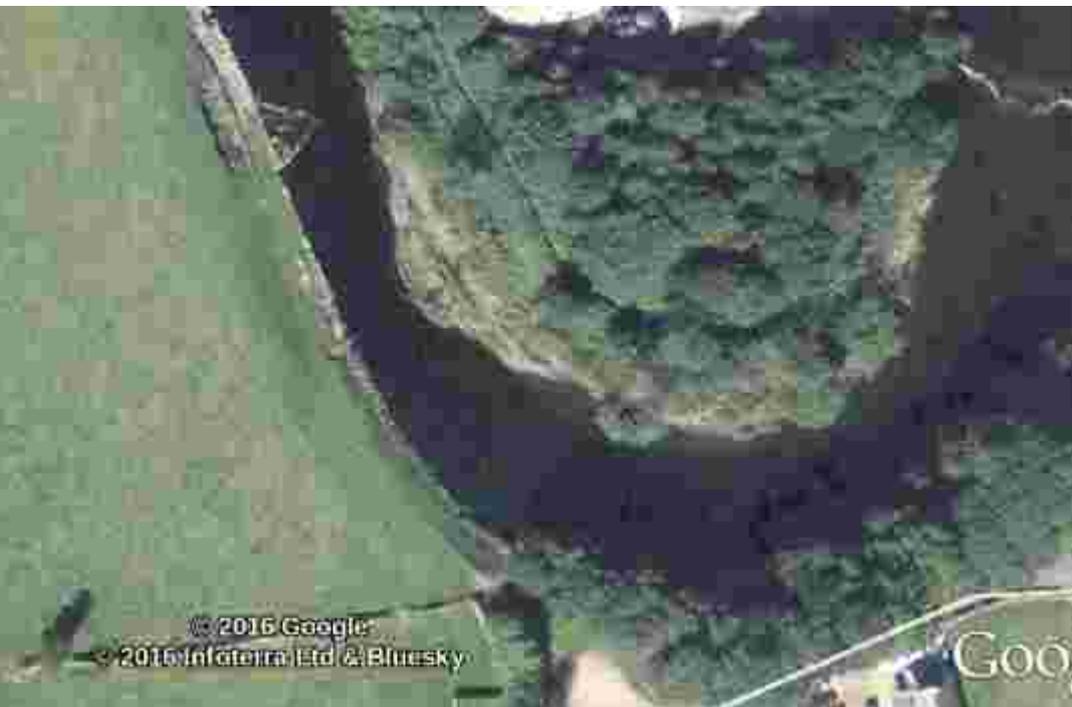
River Kent just South of Kendal. Massive erosion caused by bank armoring with rocks. The flood water has been pulled through the gaps in the rocks and eroded behind them. The triangular groin has gone and may have contributed to the erosion. The old river bed is now filled with gravel

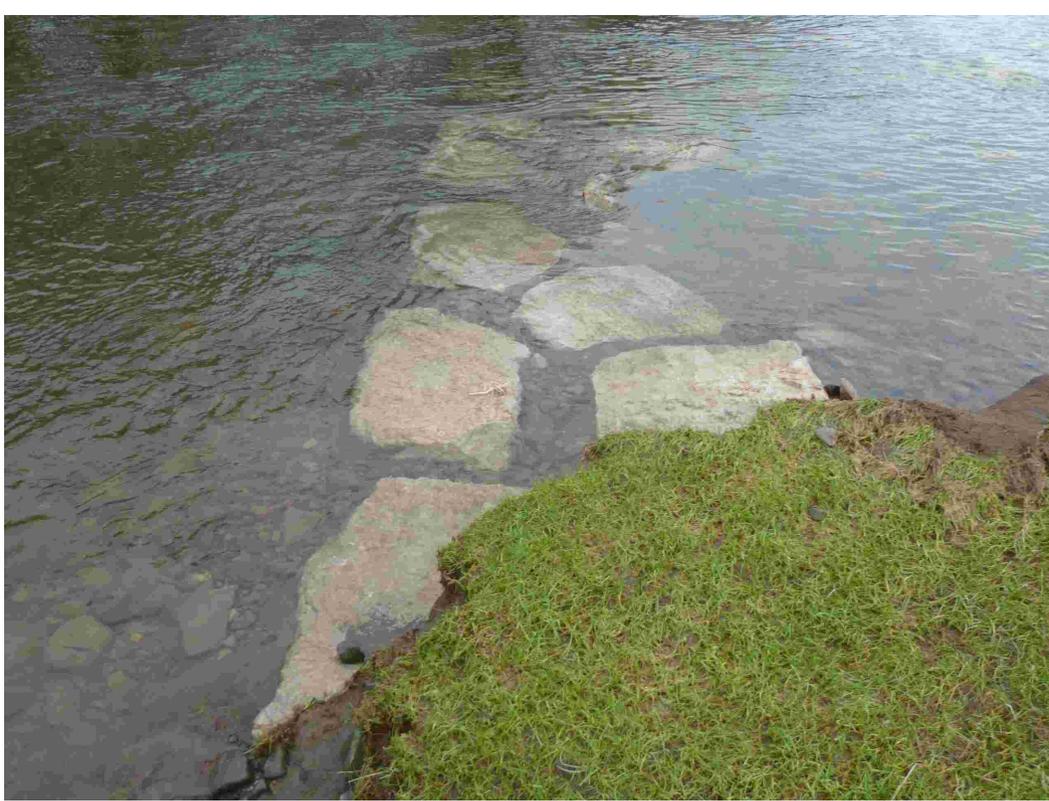
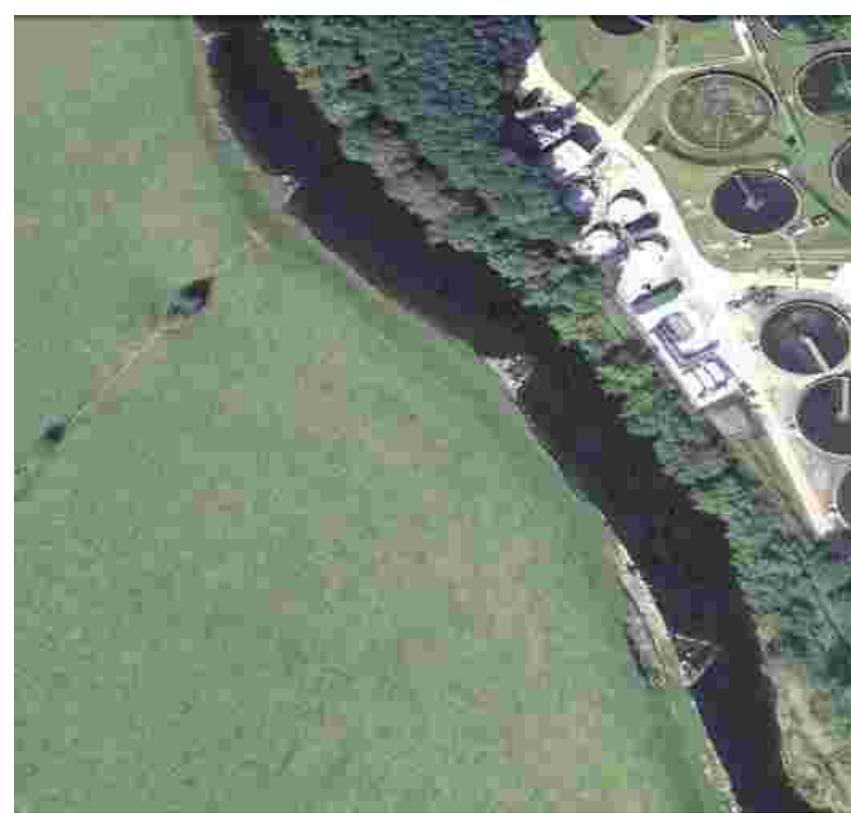
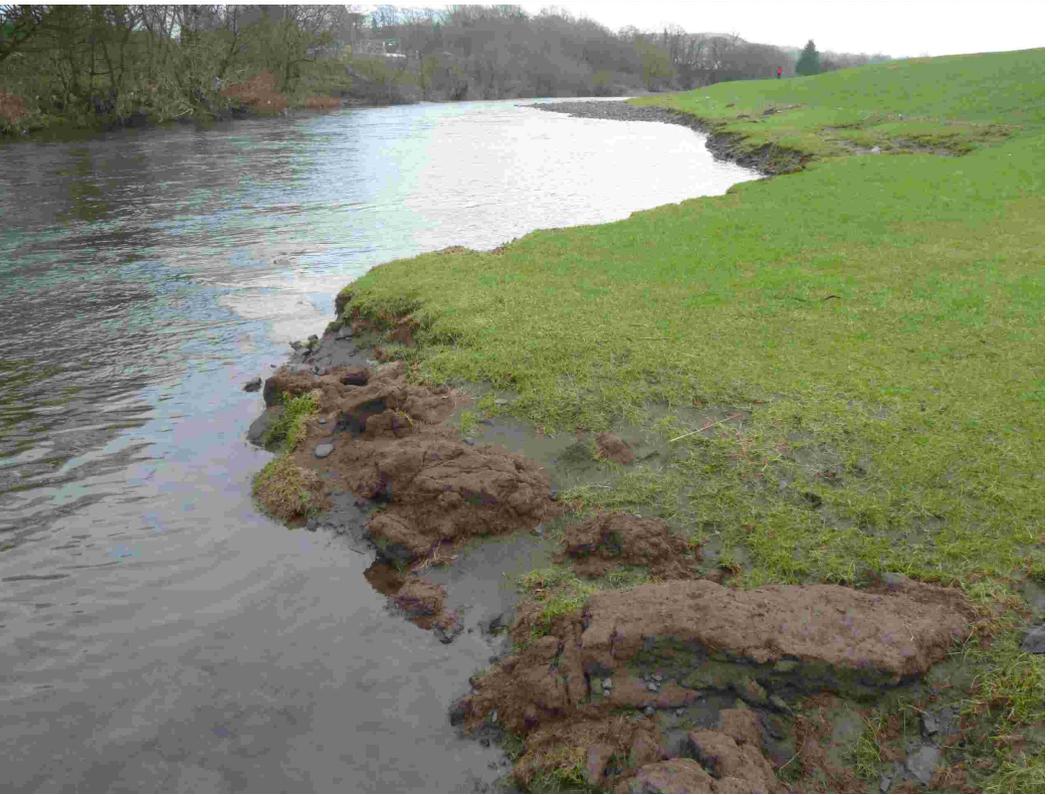
Triangular groins below Kendal on River Kent. The bank has eroded badly but just at the point of these groins there is a projecting bank. Erosion occurred on both sides.

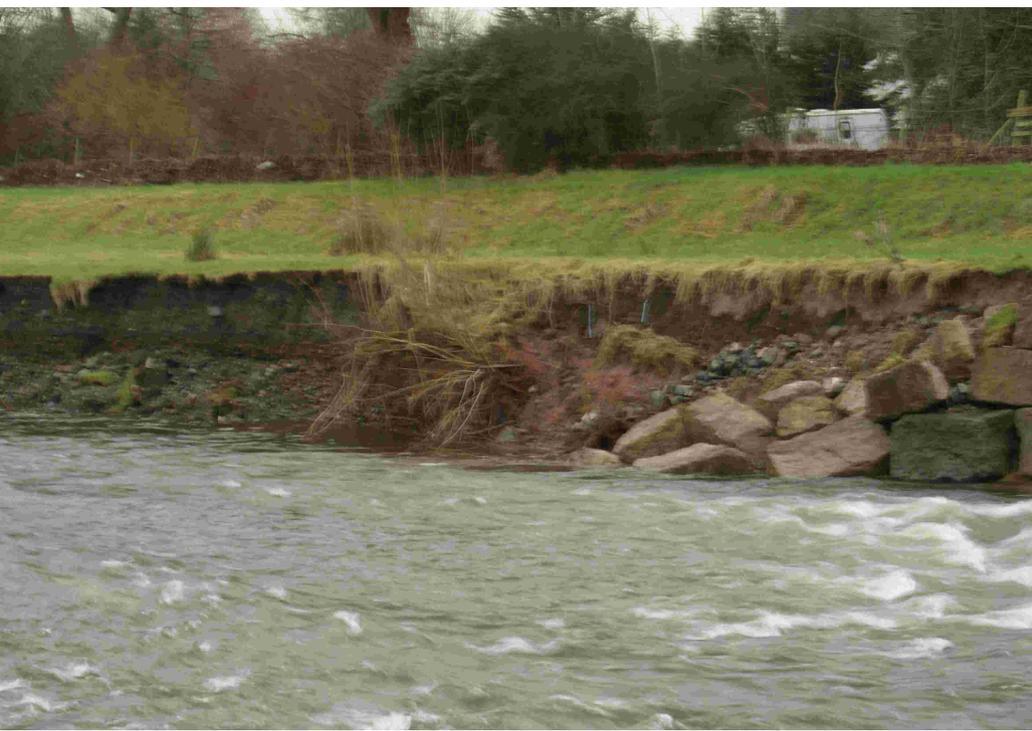
Bank erosion below weir South of Kendal on river Kent. The erosion is on the South bank which had groins and 2 layers of armoured rock along the bank. It looks as though the rock armouring has collapsed at the end of the wall and this has pulled the flow to the bank. There is no sign of the old groins. Were they washed away in the flood or removed earlier?

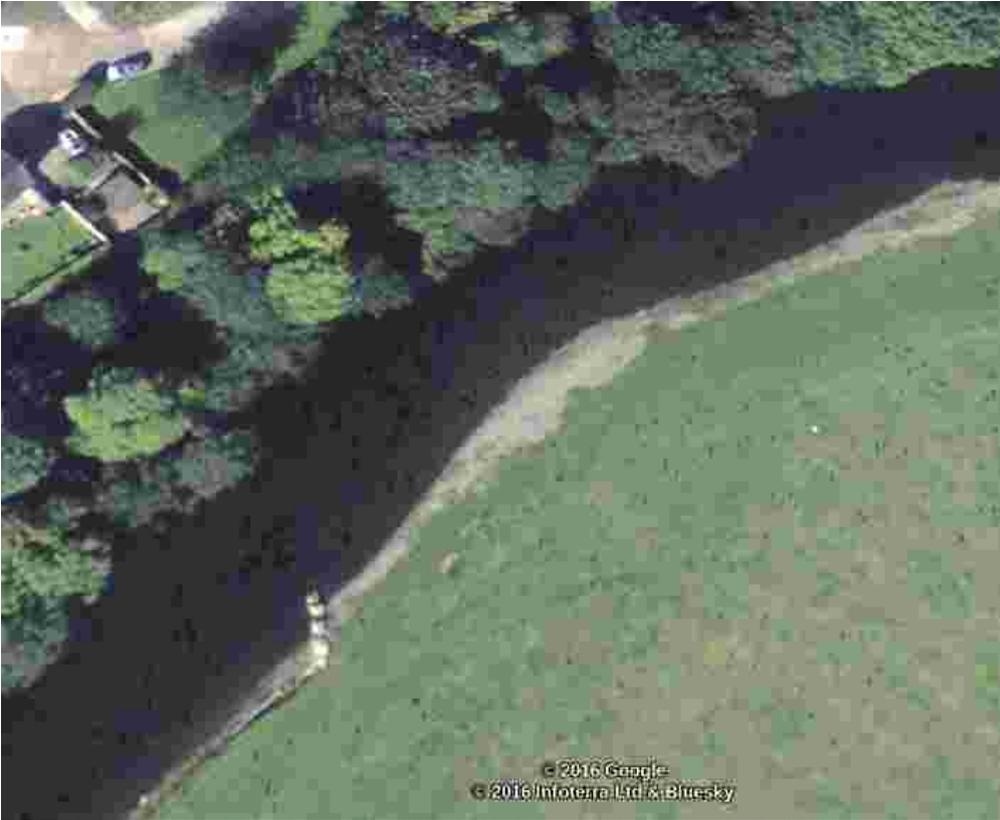
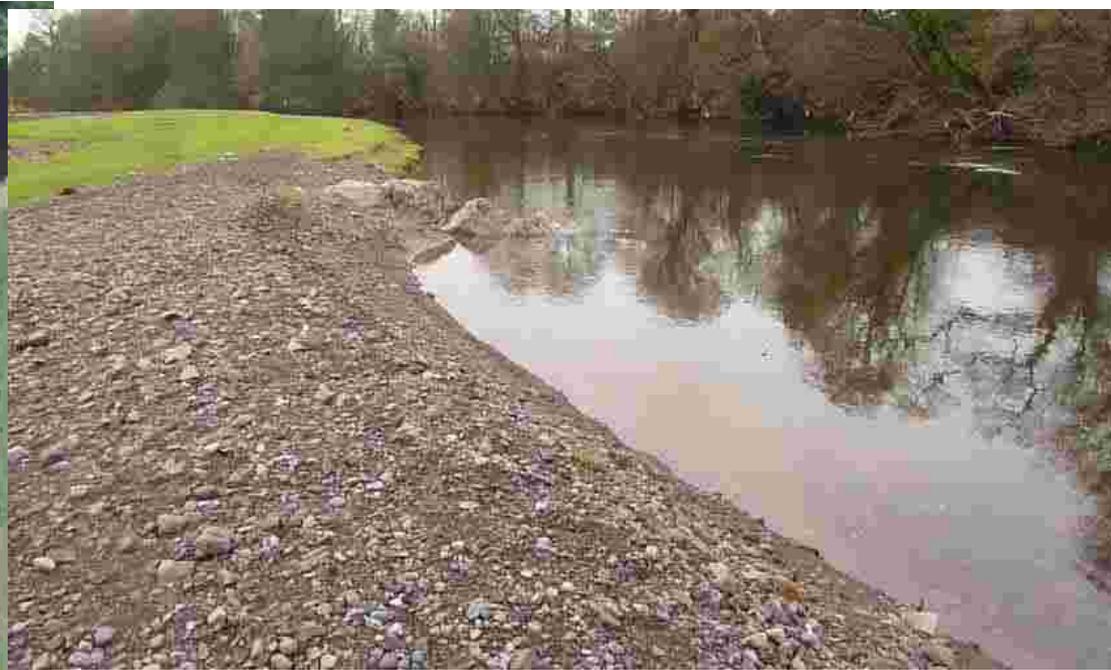
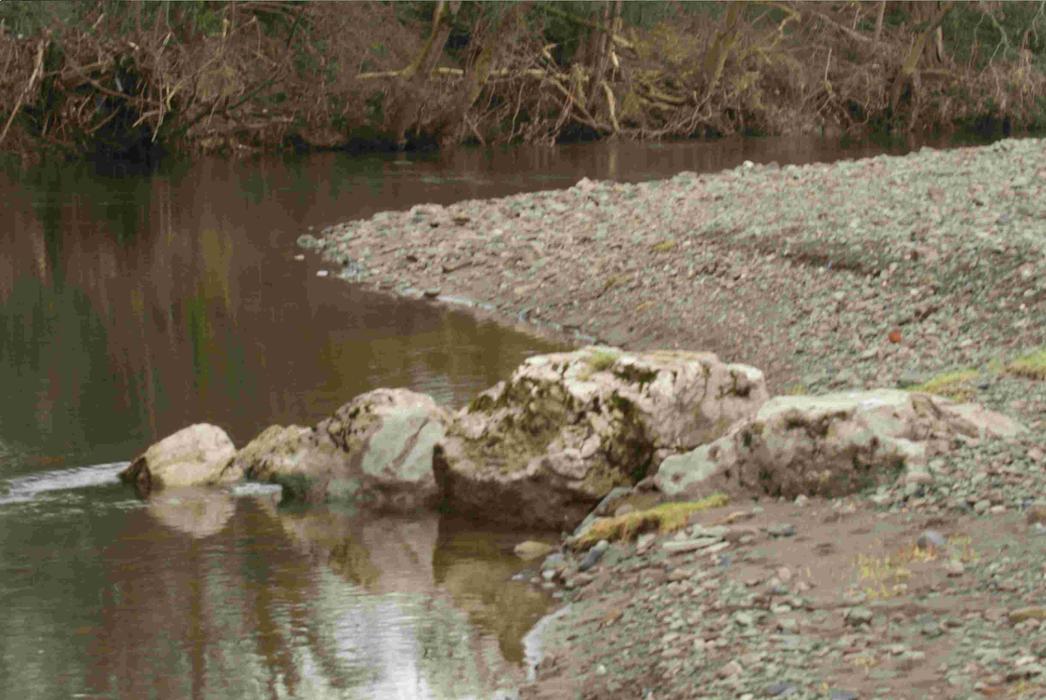
Small upstream vane of a single line of rocks (A micro groin) has collected a massive amount of gravel behind it. Note the gravel curve as it flows through the rocks. On River Kent just South of Kendal downstream from a large stretch of eroded bank.

The only really positive action is with the small six rock groin (a micro-groin) on the River Kent that accumulated rocks and gravel above it along the bank.

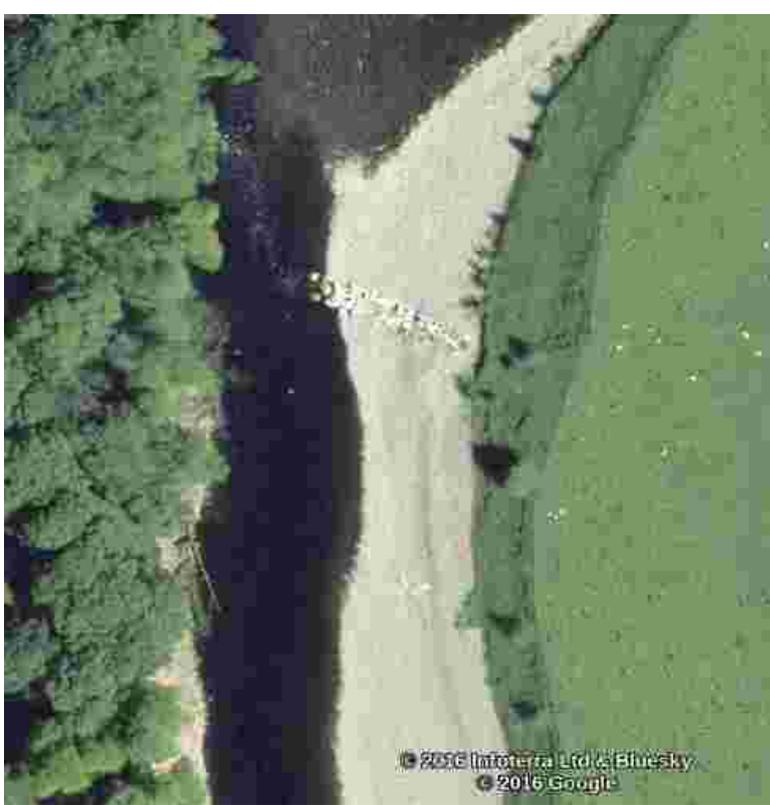
Steep wooded bank undercut and landslip. This is opposite the groin shown on aerial. The groin had built up a gravel bed either side reducing the width of the river and pushing the flow under the bank. River Lune below Mansergh Hall.

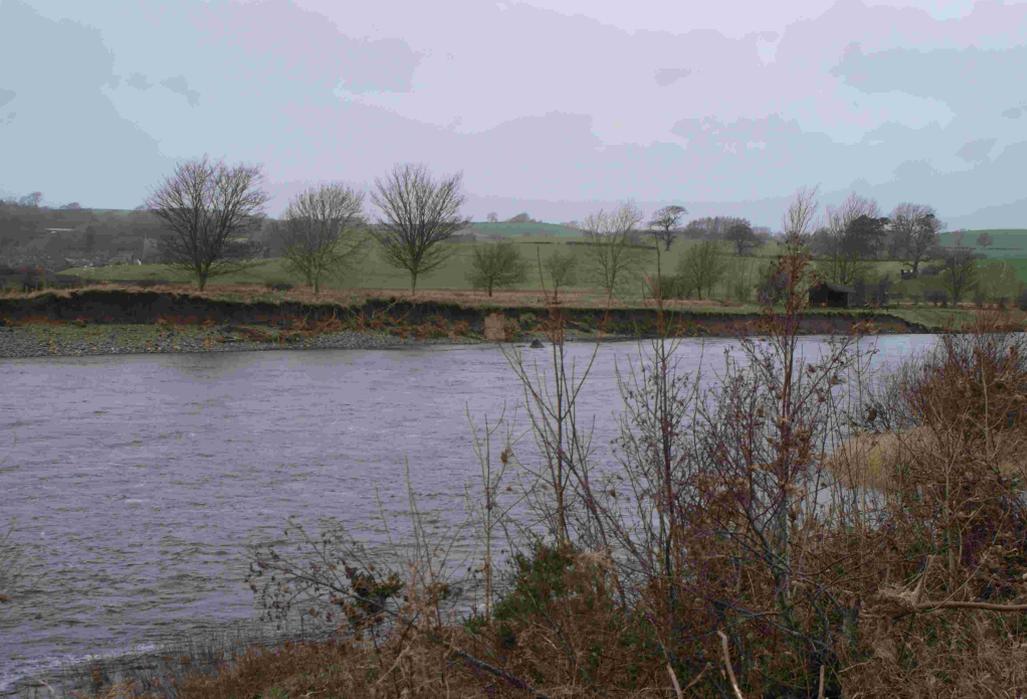
Groins near Nether Burrow along the west bank all failed and bank eroded. The hard groins look like they have pulled the water in below them and washed away the bank.

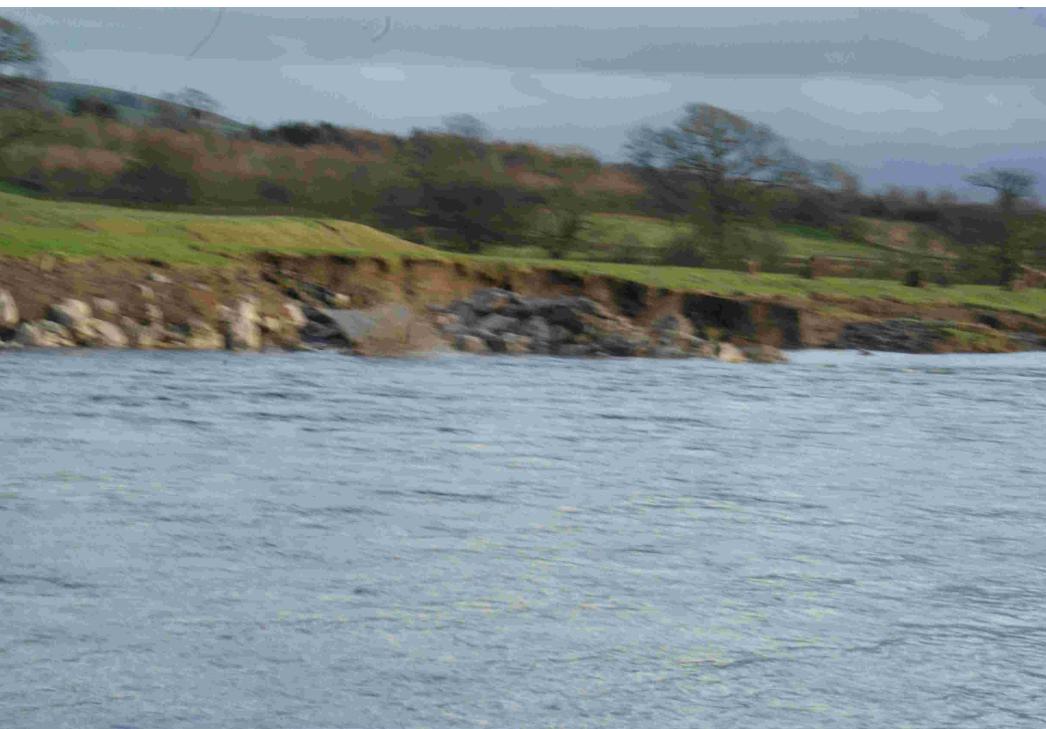
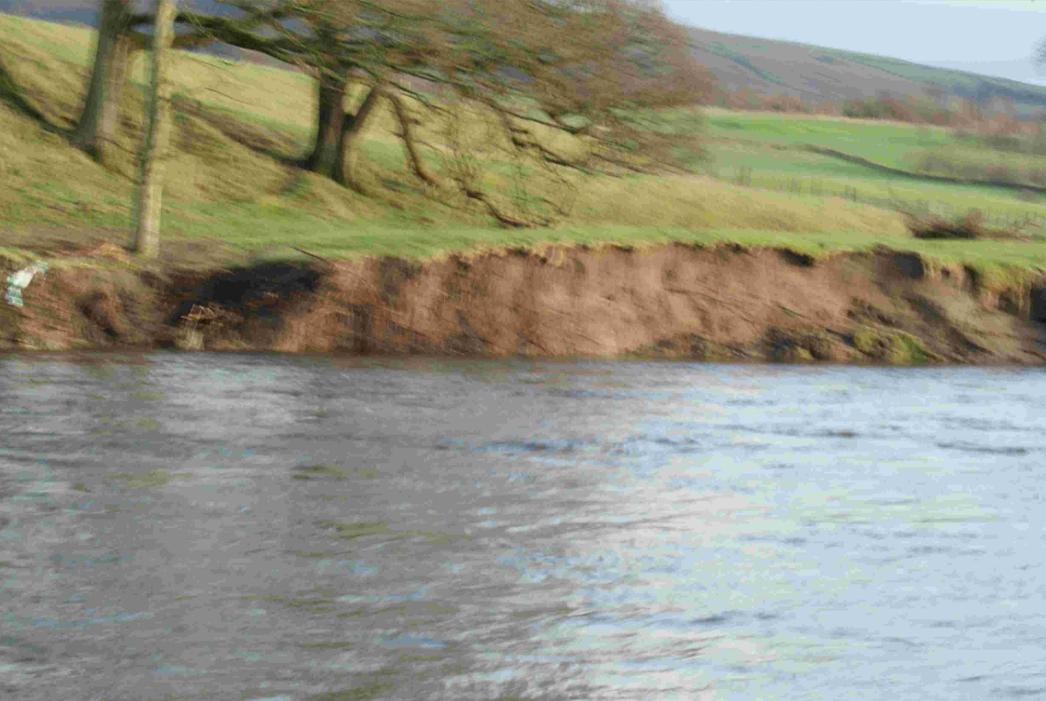
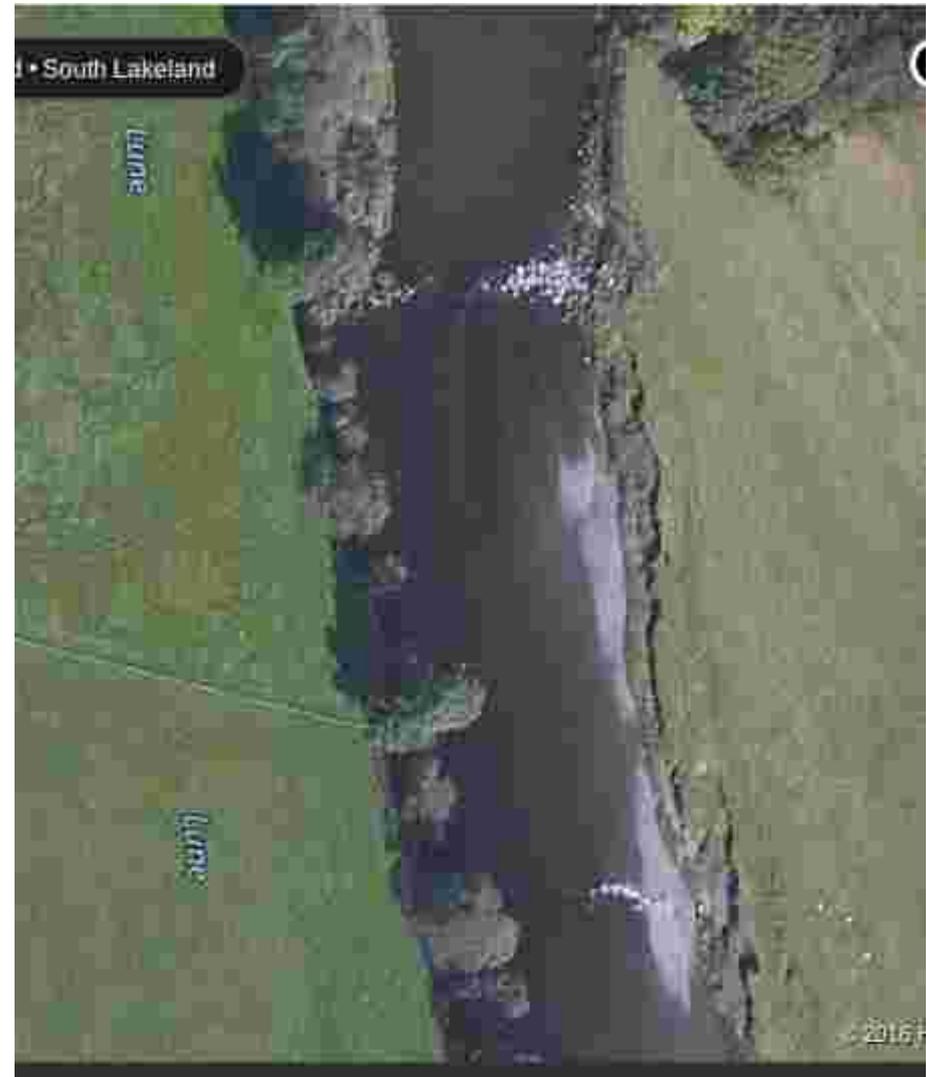
Groins and ford near Fleshfield Farm on River Lune. All groins washed away and bank badly damaged. It looks as though the groins crossed most of the river and would have Restricted the flow and speeded up the flow In the centre of the river. If there is a deep river bed here the current may have undercut the Bank.

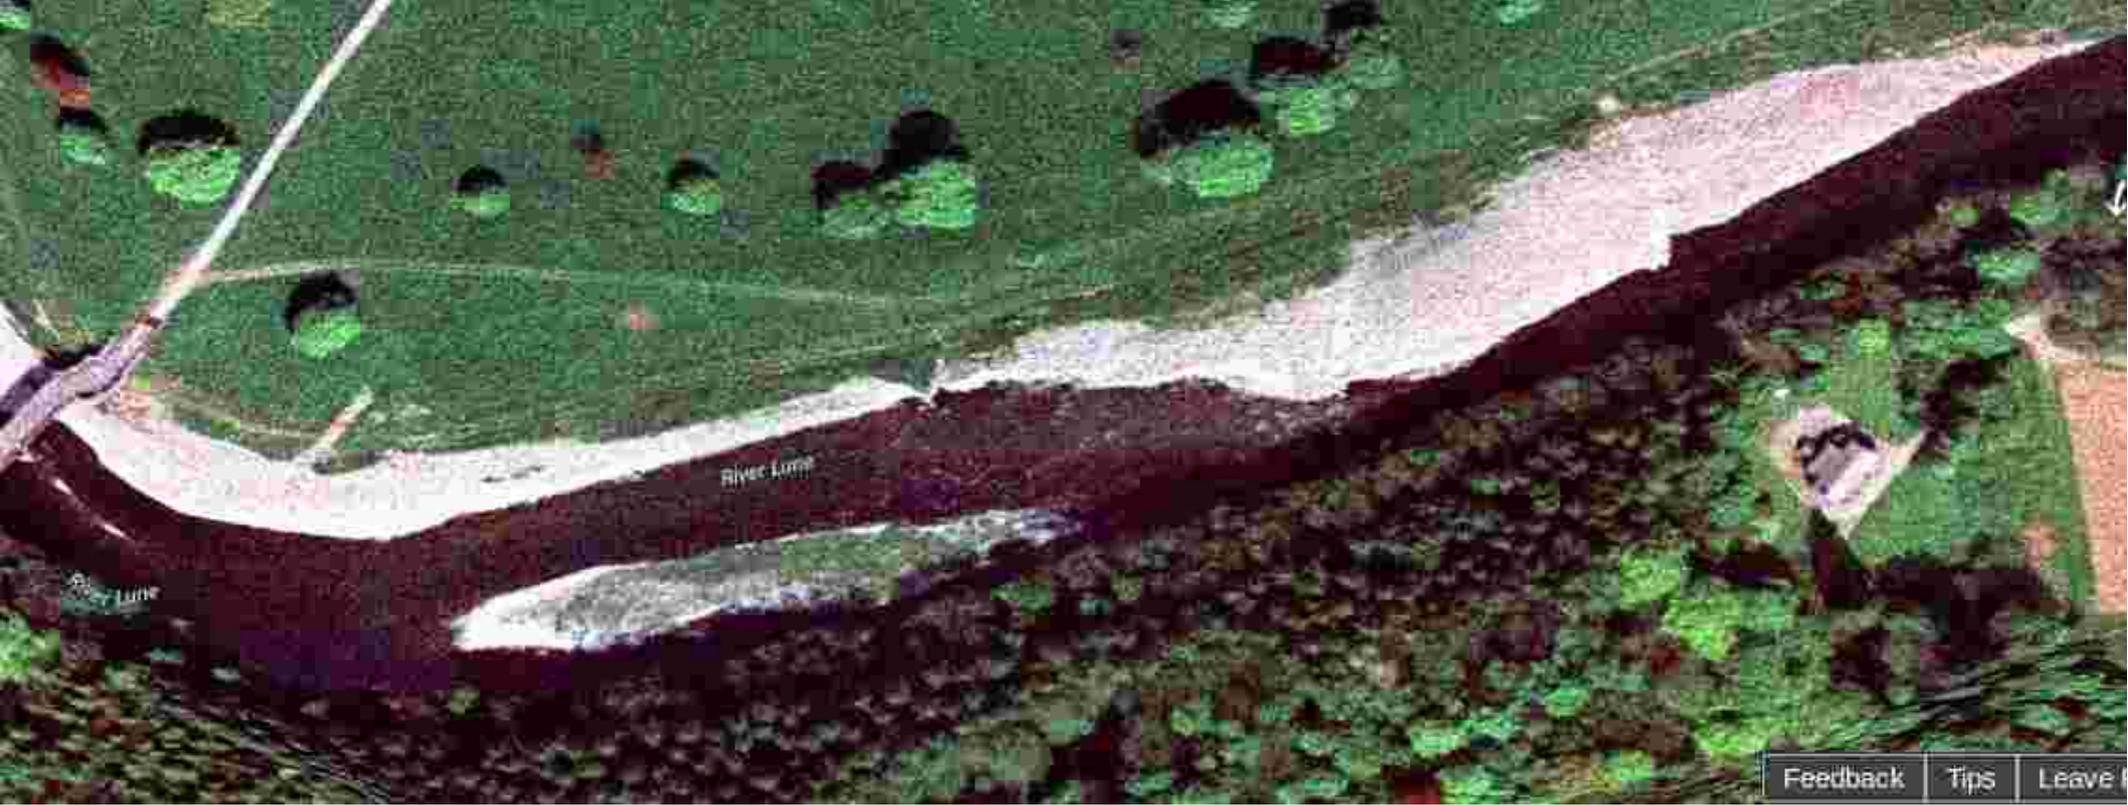
Groins below Underley Bridge collecting rubble. The top groin was damaged before Flood. R. Lune
A big collection of gravel

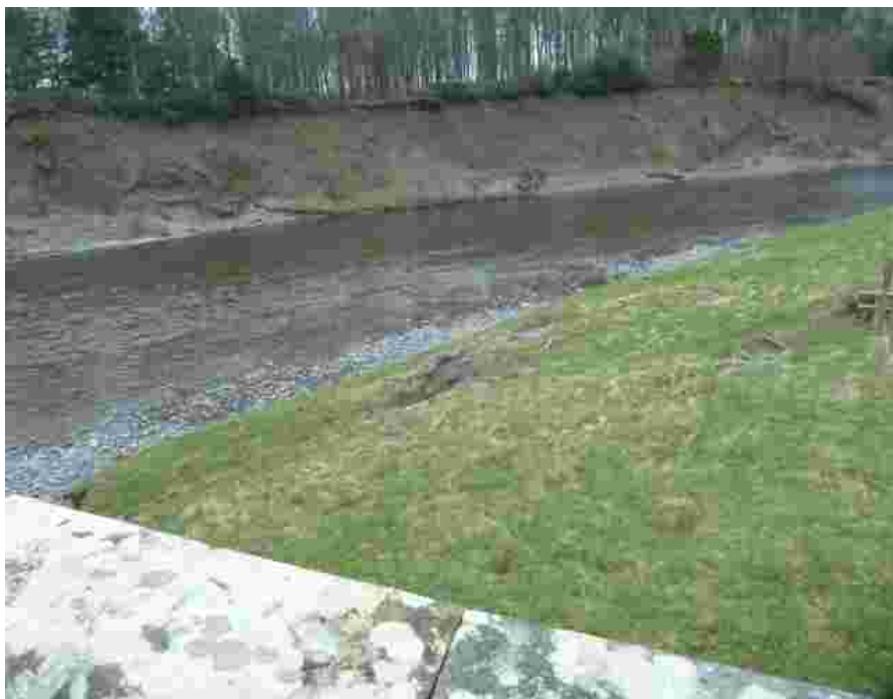
Above Underley Bridge on River Lune. The wooded bank has collapsed in Storm Desmond. It looks as though the water pressure may have backed up while going under the bridge. This could have caused the undercut.

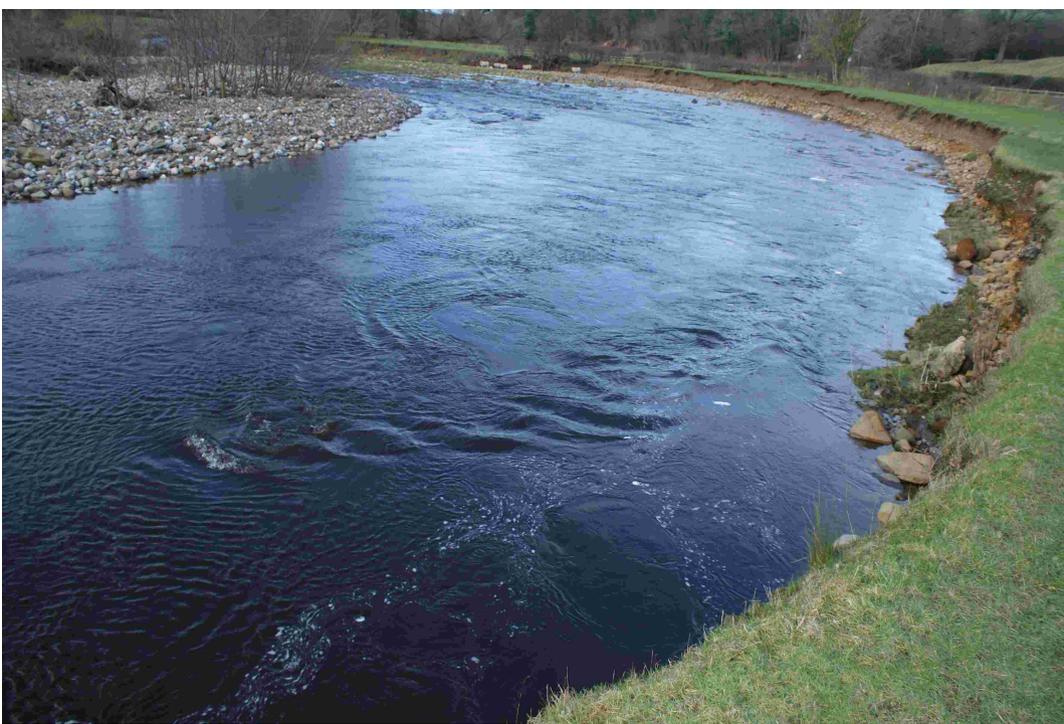
The Low Bentham to Wennington Road has been undercut by the River Wenning. This is on the third eroded bend on the river below the railway bridge. It looks as though the hard vertical rock armoured bank under the bridge has speeded up the river in Storm Desmond. There are some underwater rocks on the first corner that may have contributed to the bank erosion, but it is more likely that the river got into a swing that finally lost its force just after undercutting the road
